# FAILURE ANALYSIS OF A HELICOPTER EXTERNAL FUEL-TANK PYLON

**Abstract:** An eight-inch-long (0.2 m) crack was found in an external helicopter fuel-tank pylon. The damaged pylon was removed from service and analyzed at NASA Langley Research Center to determine the cause of the crack. Results of the analysis revealed that crack initiation occurred at corrosion pits in a fastener hole and crack propagation was a result of fatigue loading.

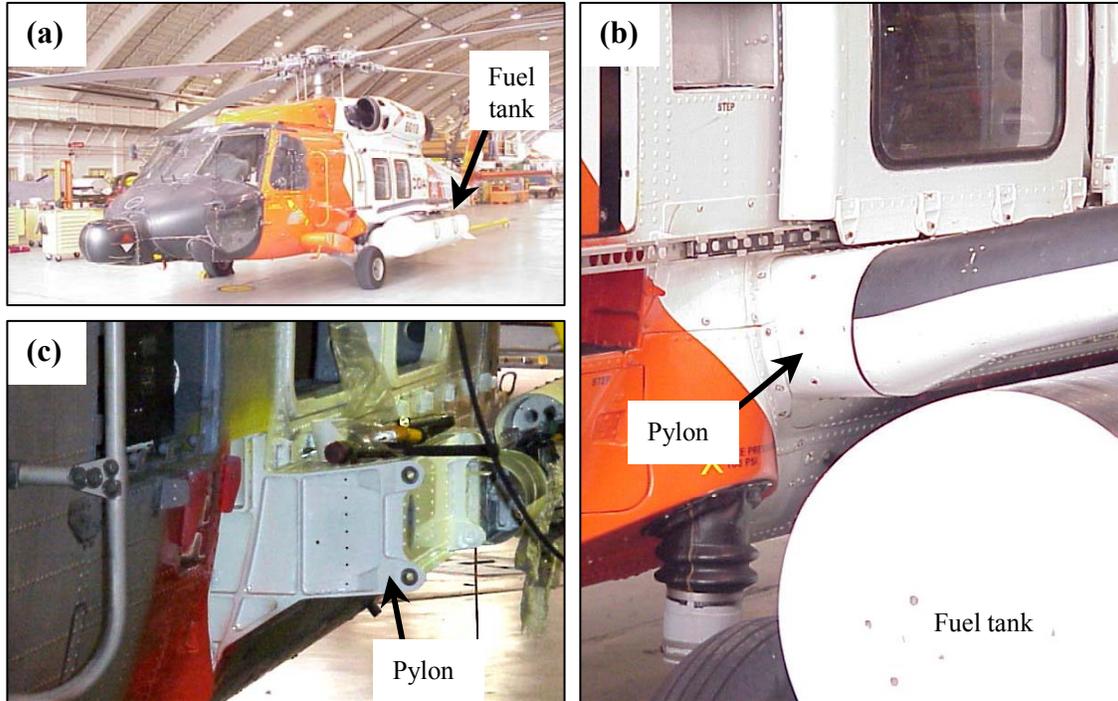
At the U.S. Coast Guard air station in Elizabeth City, North Carolina, an eight-inch-long (0.2 m) crack was found in an external fuel-tank pylon of a HH-60 “Jayhawk” helicopter. External fuel tanks are used to extend the range and operation times of U.S. Coast Guard (USCG) helicopters and are fastened to pylons attached to the helicopter fuselage. Fuel-tank pylons are fabricated from 7075 aluminum alloy forgings that are machined into the final configuration. The HH-60 is capable of carrying three external pylon-drop fuel tanks: one 80-gallon (300 L) tank and two 120-gallon (450 L) tanks. The crack was found in a 120-gallon tank pylon. Photographs of a Coast Guard HH-60 helicopter are shown in Figure 1. The photograph of the entire helicopter fuselage in part (a) shows the location of a 120-gallon fuel tank. As seen in part (b), the pylon that connects the fuel-tank assembly to the fuselage is normally covered and hidden from view. A photograph of a fuel-tank pylon is shown mounted to the fuselage in part (c); the pylon is visible because the covering has been removed for inspection.

**Figure 1** – Photographs are shown of the external pylon-mounted fuel-tank assembly on the HH-60 helicopter. (a) A 120-gallon fuel tank is shown on the fuselage. (b) A more detailed photograph of the fuel-tank pylon attachment is shown. (c) A pylon is seen after the fuel-tank assembly was removed for inspection.

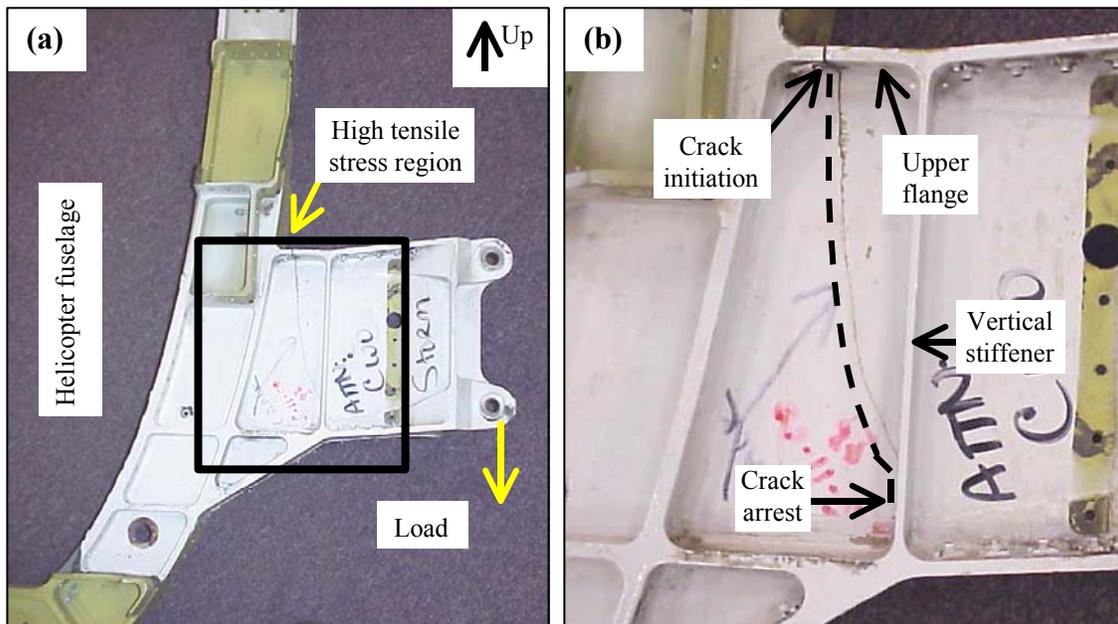
A photograph of the cracked pylon is shown as Figure 2a. The left curved-side of the pylon was mounted vertically to the helicopter fuselage; the arrow in the upper-right corner of Figure 2a indicates the vertical-up direction. The fuel-tank assembly was attached to the pylon through the two holes on the far right side of Figure 2a. Loads applied to the pylon are nominally expected in the vertically downward direction, applied at the end of the horizontal (cantilever) portion of the pylon, creating high bending stresses in the corner region of the pylon as indicated in Figure 2a. The crack appears to have initiated at fastener holes in this high stress region and propagated in a vertically downward direction. Eventually the crack propagated into a vertical stiffener and appeared to have arrested. Figure 2b is a more detailed view of the crack region outlined in Figure 2a. The dashed line in Figure 2b parallels the crack from the apparent region of crack initiation (fastener holes in the upper flange) to crack arrest at a vertical stiffener.

The crack found in the fuel-tank pylon initiated at corrosion pits in the region where the highest stresses were expected. As shown in Figure 2a, vertical-downward loading on the pylon creates a high-stress region in the corner where the cantilever meets the vertical portion of the pylon. The stress concentration effect of fastener holes in this region further increases the local stress state near these discontinuities.<sup>13</sup> Finally, corrosion pitting in these fastener holes creates rough surfaces that further increase the severity of the local stress state.<sup>14-16</sup> Due to these three factors (pylon loading, fastener hole geometry, and corrosion pits) the highest local stress occurred at the fastener hole of Figure 3b, the crack initiation site.

**Figure 2** – Photographs of the cracked pylon are shown. (a) A photograph of most of the pylon is shown. (b) A more detailed image is given of the cracked region.

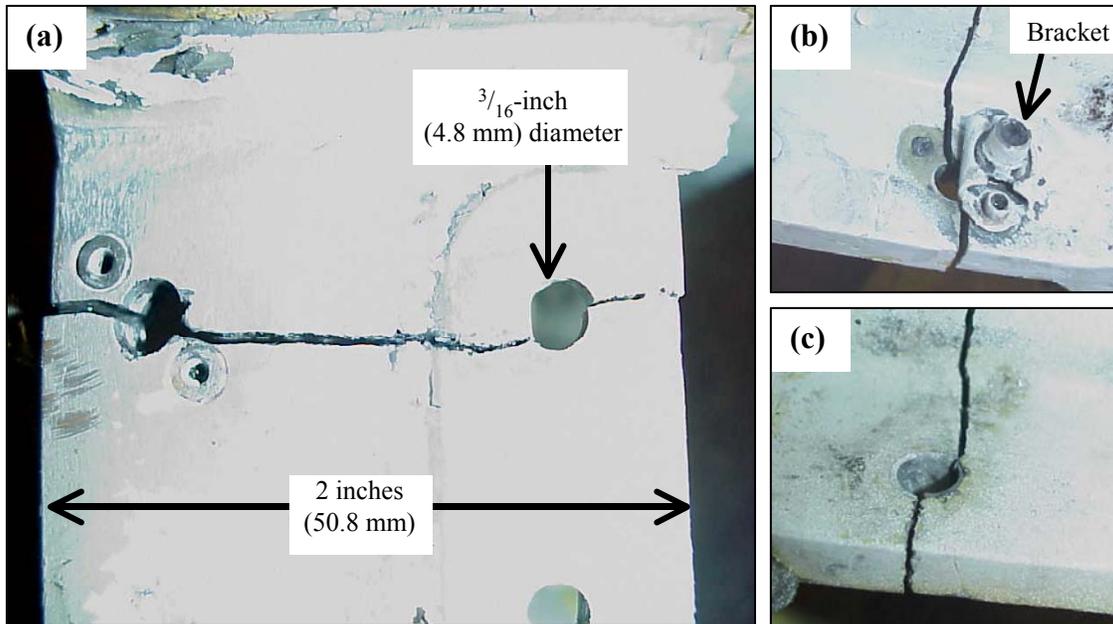
The top of the pylon upper flange, in the crack initiation region, is shown in Figure 3a. Here, the crack is seen bisecting two fastener holes, each  $\frac{3}{16}$ -inch (4.8 mm) in diameter; presumably, the crack initiated at one of these holes. The bottom surfaces of the upper flange near these fastener holes are shown in Figures 3b and 3c. The two smaller holes adjacent to the large hole located on the left of Figure 3a were used to attach the bracket shown in Figure 3b. Results presented later in this paper indicate that crack initiation occurred at the fastener hole shown in Figure 3b.

**Figure 3** – Photographs of the crack initiation region are shown. (a) A photograph of the crack intersecting two fastener holes on the top of the upper flange is shown. (b) The fastener hole on left of (a) is shown from the underside of the flange. (c) The fastener hole on right of (a) is shown from the underside of the flange.

Failure of this pylon was prevented when the vertical stiffener diverted and arrested the propagating fatigue crack. However, prevention of similar cracking problems in the future should focus on preventing the corrosion pitting that lead to crack initiation. In other words, preventing crack initiation (here caused by corrosion pitting) is preferable to, and likely more successful than, relying on techniques to arrest cracks after they develop.

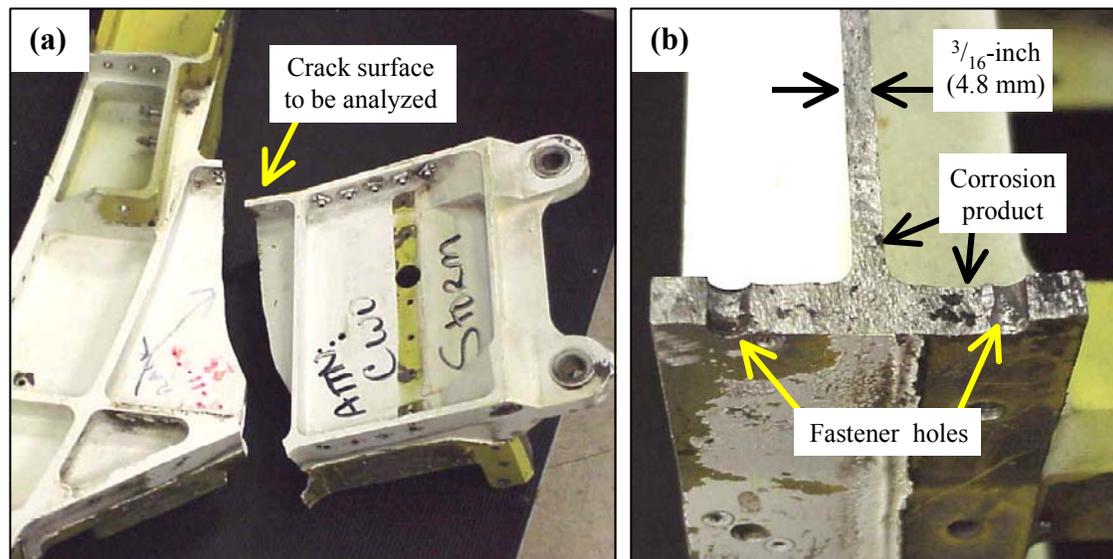
To perform detailed examination of the crack surface, the pylon was broken by carefully applying a load at the end of the horizontal cantilever while the curved vertical portion was locked into position. This loading allowed the horizontal cantilevered portion of the pylon to rotate and fracture the remaining ligament without disturbing the crack surfaces. A photograph of the broken pylon is shown in Figure 4a. Only the crack surface associated with the smaller piece of the pylon was examined; the larger piece was preserved for future examination. A photograph of the crack surface in the upper flange (where crack initiation appeared to occur), and a portion of the web, is shown in Figure 4b. Visual inspection of the crack surfaces revealed dark-colored regions on the crack surfaces, primarily near the fastener holes where the crack appeared to initiate. These dark spots, indicated in Figure 4b, are corrosion products (likely oxide debris) that are typically produced during fatigue crack growth of aluminum alloys in an aggressive environment.<sup>4,5</sup> A photograph of the crack surface as it propagated from right to left into the vertical stiffener is shown in Figure 5. To the right of the curved final crack front, the fatigue crack surface is covered with a uniform dark colored corrosion product layer. To the left of the crack front, the fracture surface (produced as the cracked pylon was broken) is clean and free of corrosion products.

**Figure 4** – Photographs of the broken pylon are shown. (a) A photograph of the broken pylon is shown. (b) A detailed photograph is given of the crack surface in the crack initiation region.

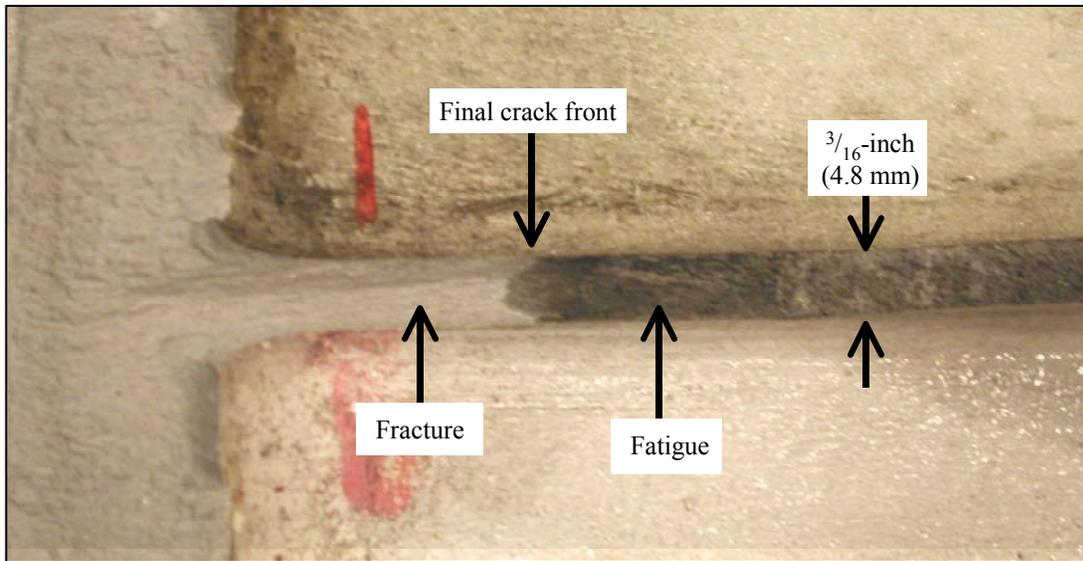
factor ( $K_I$ ) is at its maximum value and the mode II stress intensity factor ( $K_{II}$ ) is zero.<sup>17</sup> This stiffener likely diverted the crack from principal stress directions, resulting in mixed-mode crack-tip loading (*i.e.* both  $K_I$  and  $K_{II}$  are non-zero) and a reduction in  $K_I$ , the crack driving force. Crack arrest was likely a result of a reduction in crack driving force and crack-face contact due to mode II (sliding-mode) displacements further reducing the fatigue crack driving force.<sup>18, 19</sup> The crack surface corrosion product in Figure 5 were likely produced by sliding-mode contact of rough crack surfaces.

**Figure 5** – A photograph of the crack surface as the crack propagated into the vertical stiffener is shown.

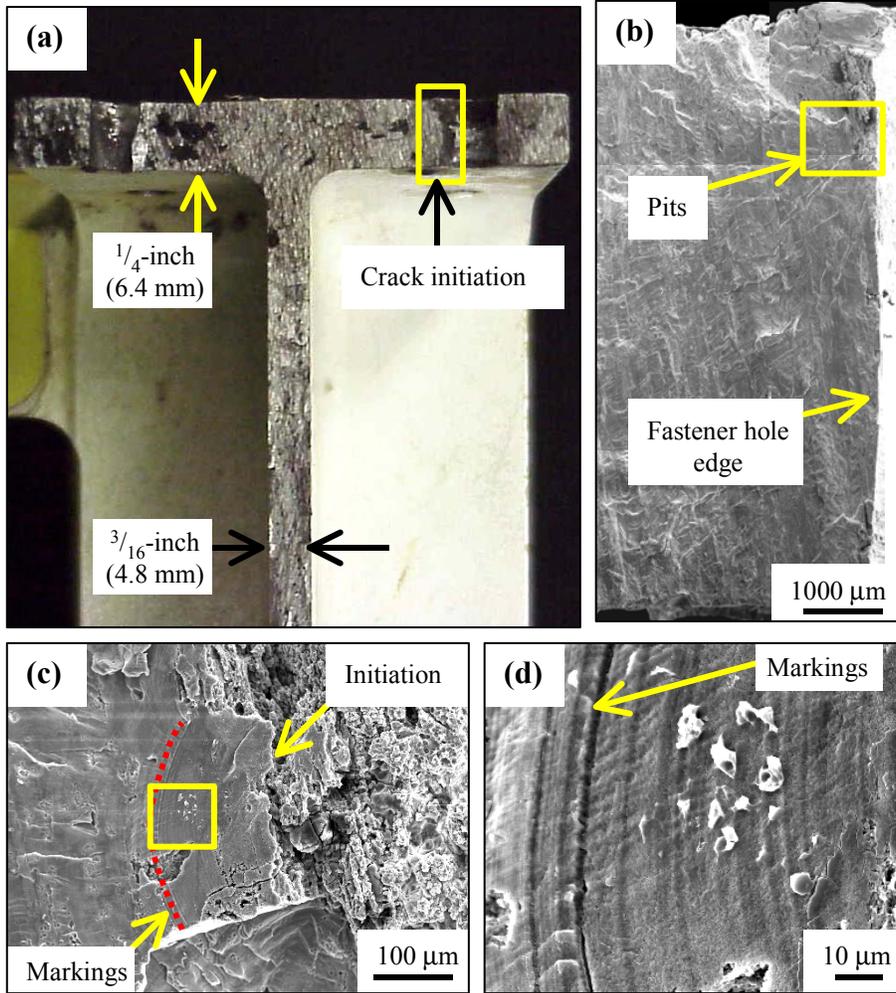
SEM examination of the clean crack surface revealed crack-surface deformation markings, evidence that crack propagation was a result of fatigue loading. The majority of the crack surface did not exhibit deformation markings, but those that were found revealed that crack initiation occurred at corrosion pits in the fastener hole of Figure 3b. The photograph of the crack surface in Figure 7a shows the region of crack initiation; crack initiation occurred at the fastener hole in the upper right corner of the figure, highlighted with a box. The crack surface in Figure 7b is a higher-magnification image of the crack initiation region highlighted (box) in Figure 7a. A region of corrosion pitting is noted in Figure 7b along the inside edge of the fastener hole (right side of the photograph). The region of crack initiation noted in Figure 7b is shown at higher magnification in Figure 7c. Corrosion pits are seen as a rough-textured region on the right side of Figure 7c. Deformation markings on the crack surface are barely visible in Figure 7c. The curved dotted line in Figure 7c shows the curvature of the deformation marks (concave to the right) indicating that crack initiation occurred at the corrosion pits seen on the right side of the figure. These marks are better seen at higher magnification in Figure 7d.

**Figure 7** – The crack initiation region is shown in a series of images, at increasing magnification. (a) Photograph of the crack surface in the pylon upper flange region is shown. Also shown are micrographs of (b) crack surface at edge of fastener hole surface, (c) crack initiation at corrosion pits, and (d) crack surface markings at high-magnification in crack initiation region.

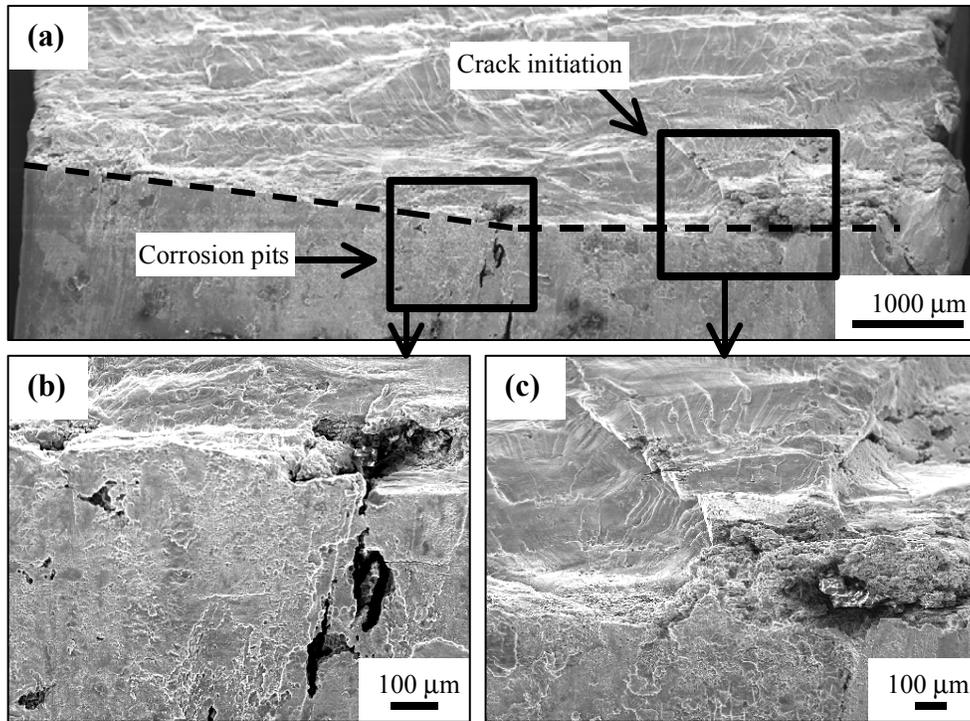
SEM images of the crack initiation region of Figure 7 are shown at a different angle in Figure 8 to illustrate the complex nature of the crack surface and to highlight regions of pitting that did not result in crack initiation. Here, the crack surface was viewed at an angle  $45^\circ$  from the direction normal to the crack surface, and the specimen is rotated  $90^\circ$  (with respect to the orientation of Figure 7) so the fastener hole is oriented horizontally. In Figure 8a, the intersection of the crack surface with the edge of the fastener hole is indicated with a dashed horizontal line; the surface of the hole and the crack surface are below and above the dashed line, respectively. The upper and lower surfaces of the upper flange (shown in Figure 3) are the edges seen on the extreme right and left sides of Figure 8a, respectively. The boxes in Figure 8a identify two regions of corrosion pitting in the fastener hole: one where cracks did not initiate (left box) and one where cracks did initiate (right box). These regions are shown at higher magnification in Figures 8b and 8c, respectively.

**Figure 8** – Micrographs of the crack initiation region, viewed at a 45° angle to the crack surface, are shown. (a) The crack surface at the edge of the fastener hole surface is shown. High-magnification micrographs are shown of corrosion pits (b) where cracks did not initiate and (c) where cracks initiation occurred.

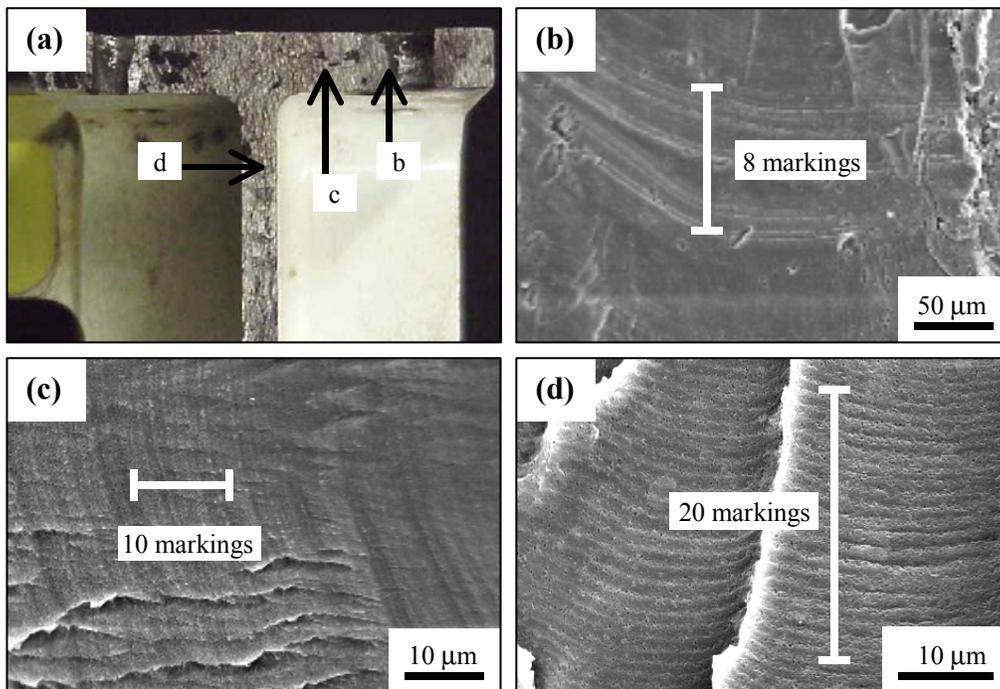
Evidence of crack-surface deformation marks at three locations along the crack surface is shown in Figure 9. These three locations, identified in Figure 9a as b, c, and d, are shown at high-magnification in Figures 9b, 9c, and 9d, respectively. The markings observed in Figures 9b and 9c are not equally spaced, possibly suggesting that complex variable-amplitude loading occurred. The deformation markings shown in Figure 9d are equally spaced and exhibit the morphology typical of fatigue striations. The average spacing between deformation markings is determined by counting the number of marks intersecting lines along the crack growth direction (*i.e.* normal to the marks). In Figure 9b, 8 marks are counted along a line 100  $\mu\text{m}$  long. For Figures 9c and 9d, 10 marks and 20 marks are counted along lines 15  $\mu\text{m}$  and 30  $\mu\text{m}$  long, respectively. If each deformation mark was produced by a single load cycle, the average fatigue crack growth rates corresponding to Figures 9b, 9c, and 9d would be  $1.2 \times 10^{-5}$  m/cycle,  $1.5 \times 10^{-6}$  m/cycle, and  $1.5 \times 10^{-6}$  m/cycle, respectively. The markings in Figures 9b and 9c are not regularly spaced and may not have been produced by single load cycles. Therefore, these markings do not permit a good estimation of fatigue crack growth rates. The crack-surface markings seen in Figure 9d are likely striations, each produced by a single load cycle. Therefore, the calculated fatigue crack growth rate of  $1.5 \times 10^{-6}$  m/cycle is likely a good estimate for the crack surface of Figure 9d. Based on laboratory 7075 aluminum data, the fatigue crack growth rate for Figure 9d corresponds to values of  $\Delta K$  between 15  $\text{MPa}\sqrt{\text{m}}$  and 20  $\text{MPa}\sqrt{\text{m}}$ .<sup>10, 11</sup>

The striation markings seen in Figure 9d indicate that rapid crack propagation occurred in the pylon webbing (approximately 1.5 mm of crack growth per 1000 load cycles). As the crack grew, increases in  $\Delta K$  and fatigue crack growth rates likely occurred. Pylon failure was prevented because a vertical stiffener deflected the crack causing crack arrest. Cracks tend to propagate in the direction perpendicular to the principal (largest) normal stress, the orientation where the mode I stress intensity

**Figure 9** – Micrographs of crack-surface markings are shown at high magnification. (a) A photograph of the crack surface in the pylon upper flange region is shown. High-magnification micrographs are shown of the crack surface (b) near the crack initiation region, (c) between the fastener hole and the web, and (d) in the pylon web.
