# TECHNICAL NOTE

D-535

DAMAGE INCURRED ON A TILT-WING MULTIPROPELLER  
VTOL/STOL AIRCRAFT OPERATING OVER A  
LEVEL, GRAVEL-COVERED SURFACE

By Robert J. Pegg

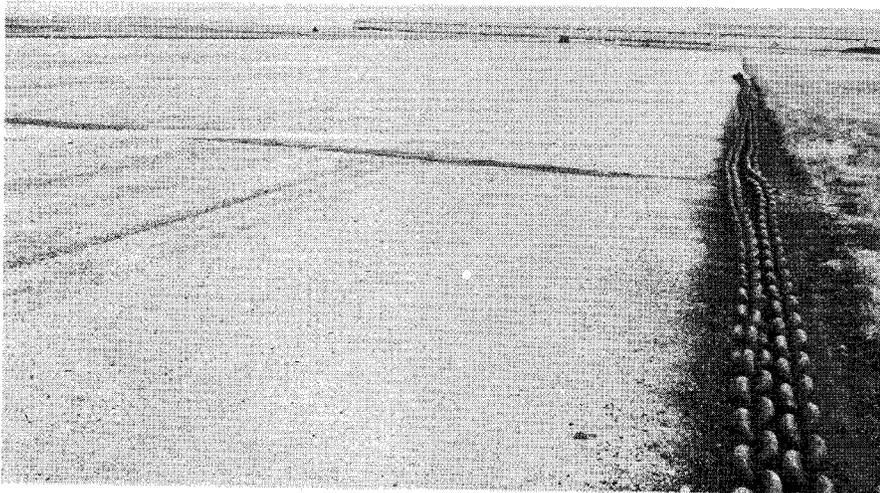
Figure 3 shows a general view of the 900-foot eastern overrun of a runway at Langley Air Force Base. Figure 4 shows the area over which the aircraft rolled and where the gravel concentration was the highest. This surface, as is shown in the closeup of figure 5, is macadam covered with a variety of loose and embedded crushed stone. This area of loose stone was approximately 600 square feet and  $1/2$  inch deep. Approximately 70 percent of the stones were  $1/8$  inch to  $1/2$  inch in diameter, and approximately 30 percent were  $1/2$  inch in diameter or larger.

Figure 4.- Area of concentrated loose stone. L-59-8144

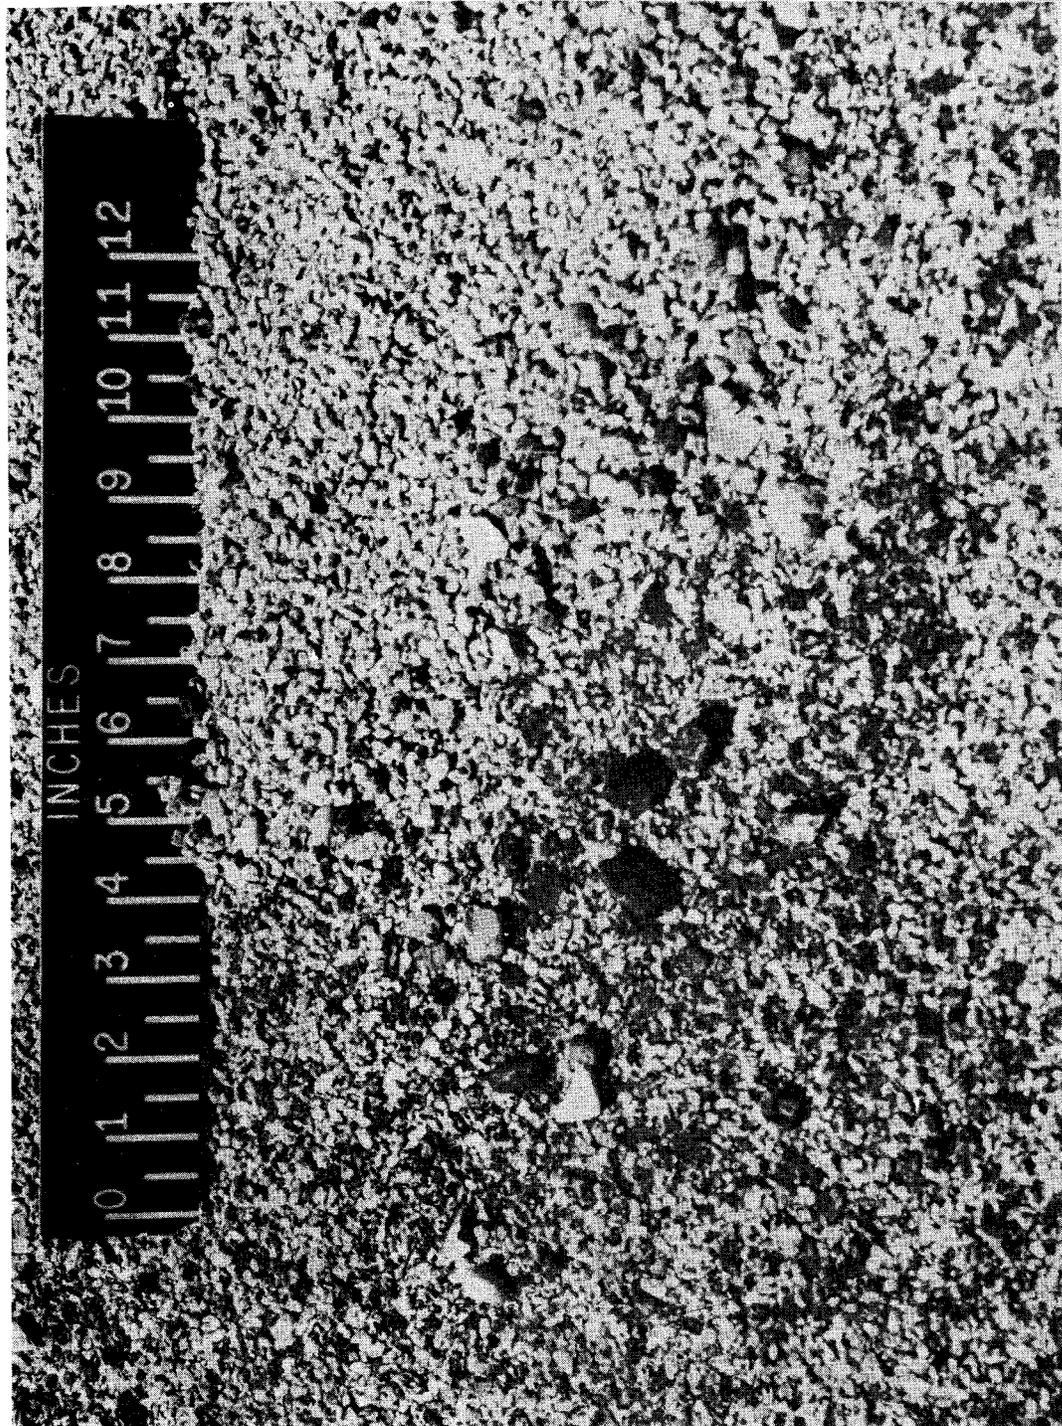
Figure 5.- Closeup of loose and embedded stone on overrun. I-60-4296

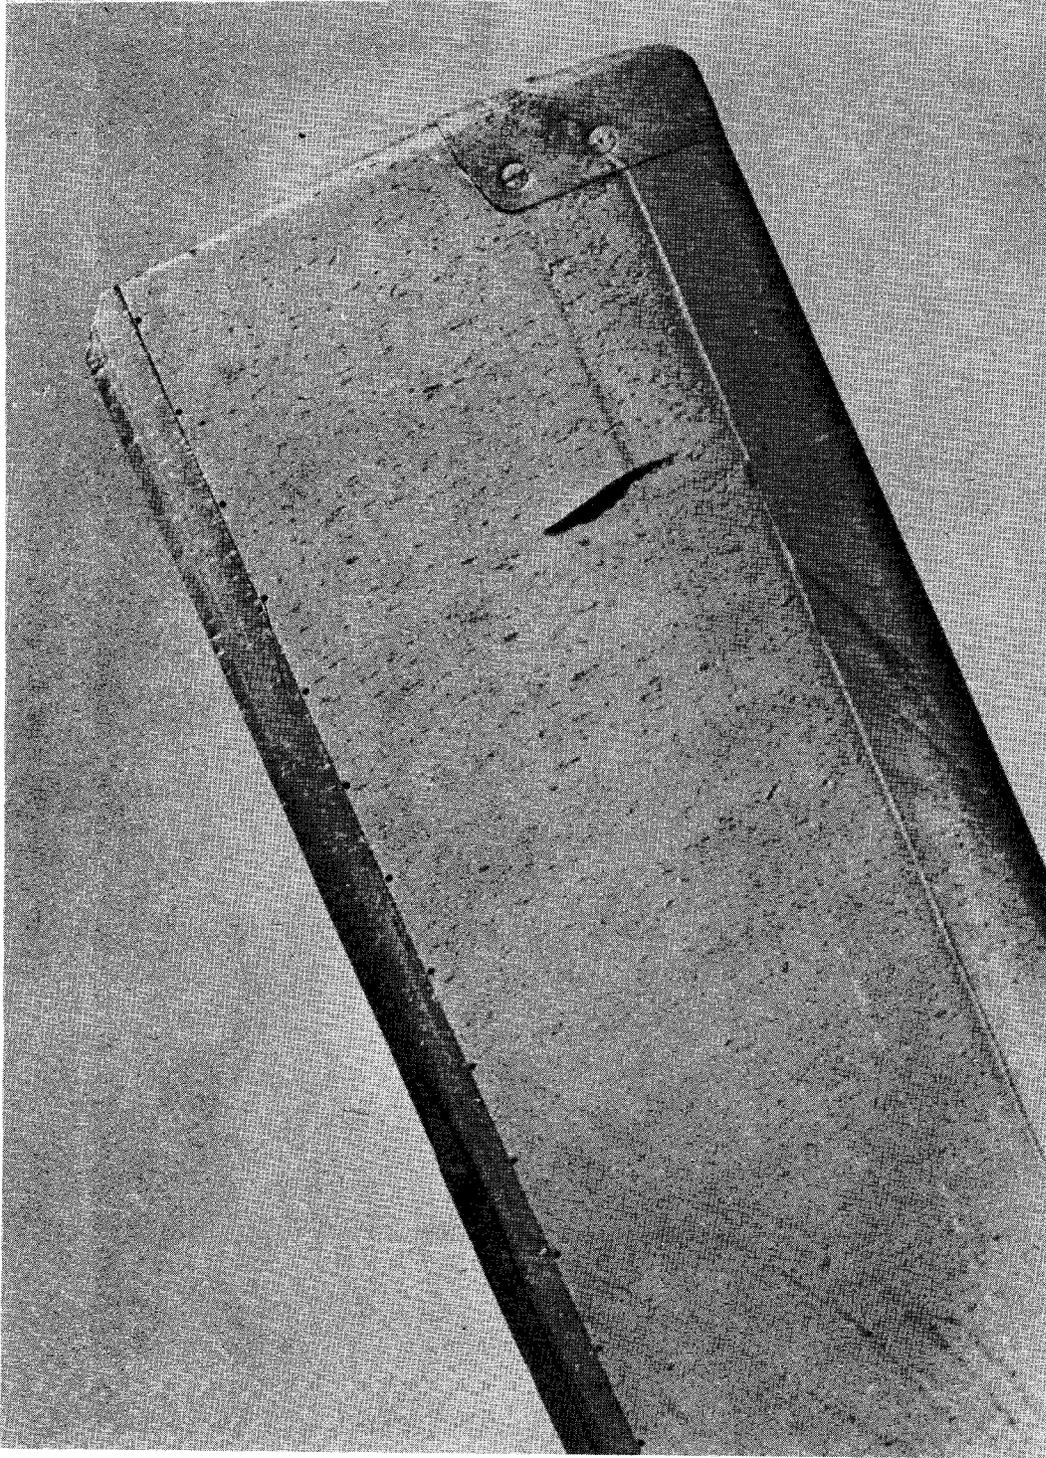
All rotating blades of the aircraft sustained some damage. The main rotor blades were at some angle of attack (approximately  $6^{\circ}$ ) and the undersides of the blades showed the greater percentage of the damage. Figure 6 shows typical damage to the blades. This damage includes complete punctures of one side of the 0.070-inch-thick mahogany plywood skin on two blades, deep marring on all six blades, and peeling of the 0.008-inch-thick trailing-edge stiffener on one of the blades.

Figure 6.- Typical damage to main rotor blades. L-59-8139

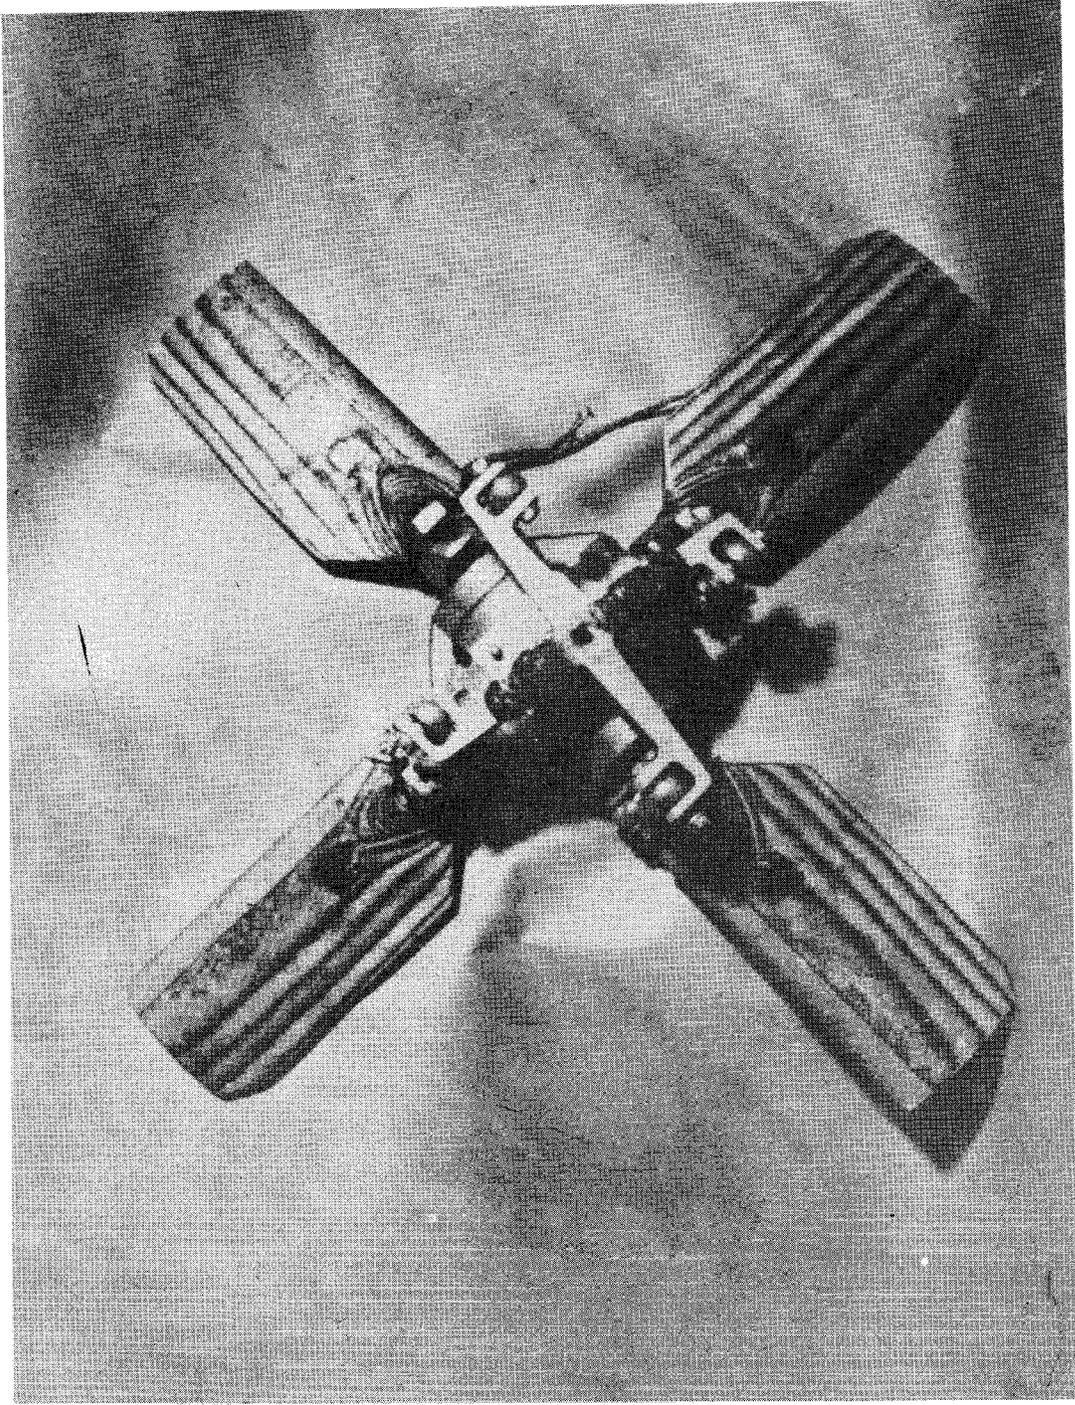
Serious gouging by flying stones marred the upper surfaces of the pitch fan (fig. 7) which was providing a downward thrust, and the right-hand surfaces of the yaw fan (fig. 8) which was providing thrust in the left-hand direction. The opposite surfaces showed relatively few scars except on the metal leading edge.

Figure 7.- Damage to pitch fan. I-60-4297

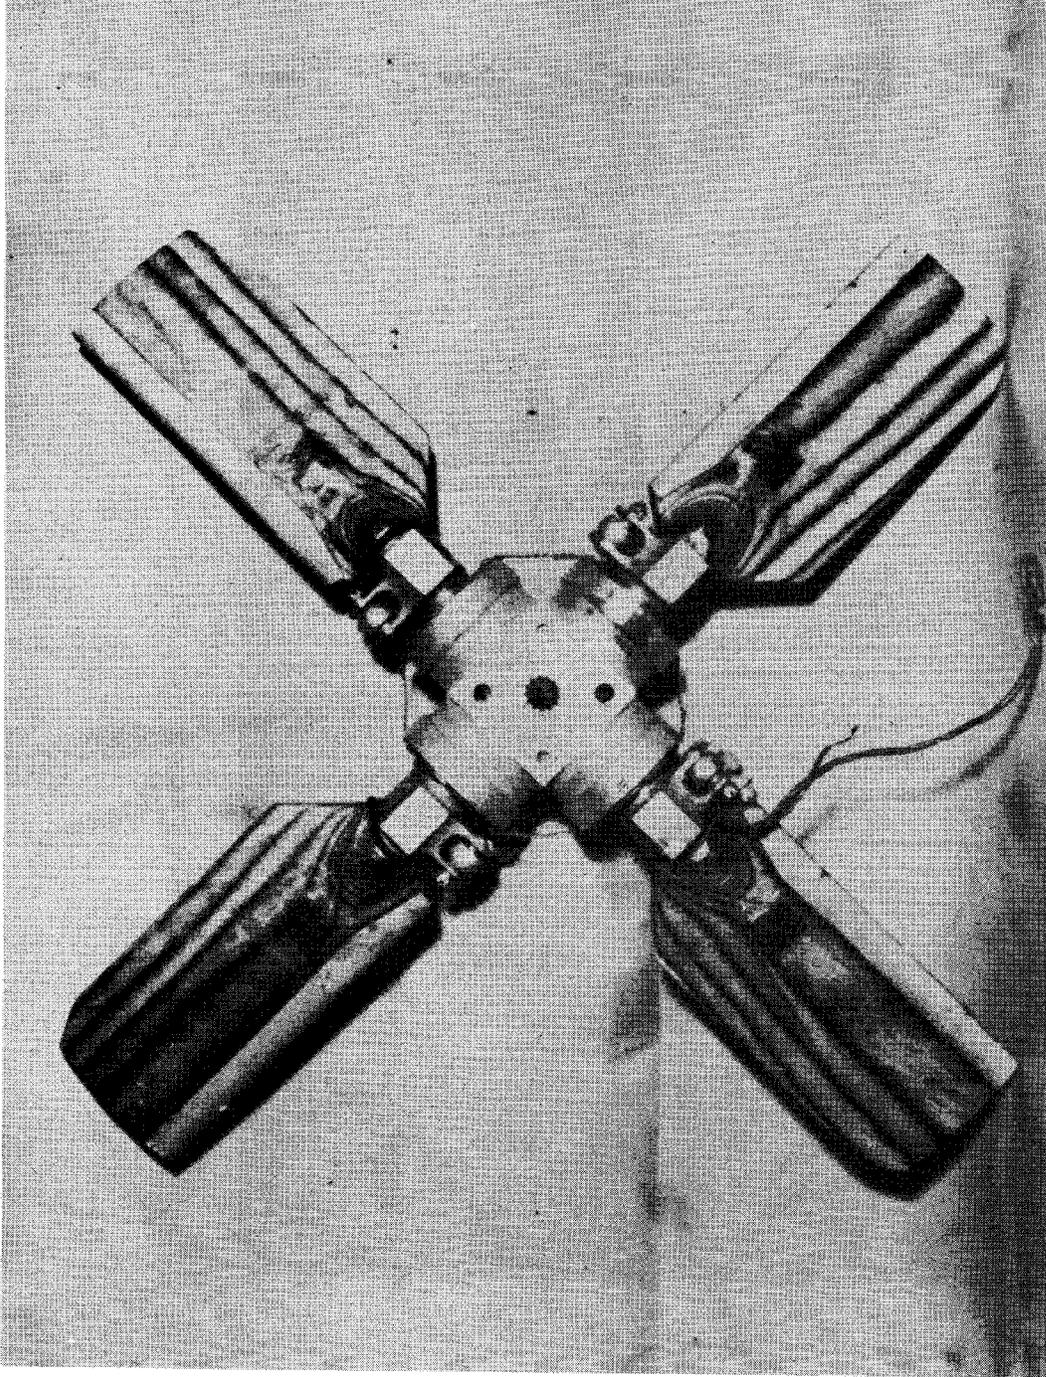
Figure 8.- Damage to yaw fan. L-60-4298

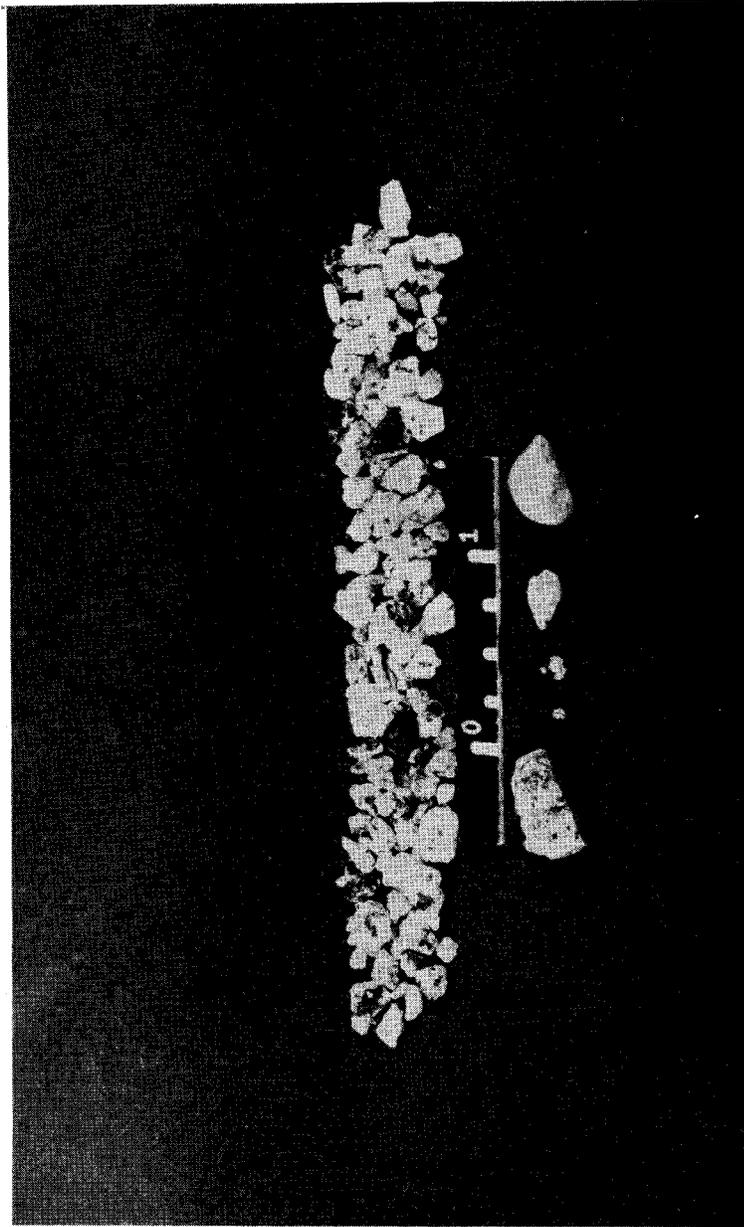
Little damage was incurred by the aircraft itself, but the upwash through the uncovered fuselage structure deposited a great deal of dirt and small stones throughout the open fuselage and cockpit and necessitated a thorough cleaning. Examples of the particles found on and inside the aircraft are shown in figure 9. No damage could be found to external and uncovered bearings. The pilot indicated that he experienced no abnormal handling difficulties during the return flight after the damage had occurred.

Figure 9.- Examples of stones found in fuselage. L-59-8146
