NASA/TM-1998-207668

# Characterization of Al-Cu-Li Alloy 2090 Near Net Shape Extrusion

*Aluminum-lithium (Al-Li) alloy near net shape extrusions are being evaluated for potential application in launch vehicle structures. The objective of this study was to determine tensile and fracture properties, corrosion resistance, and weldability of integrally stiffened panels of Al-Cu-Li alloy 2090 in the T8 temper. The microstructure was predominantly unrecrystallized. Texture analyses revealed the presence of fiber components in the stiffeners and a combination of fiber and rolling components in the skin. Variations in grain morphology and texture through the extruded cross section were correlated with the tensile, fracture, and corrosion behavior. Tensile strengths at room and cryogenic temperatures of the 2090 extrusions were similar to other 2090 product forms and were higher than aluminum alloy 2219-T87, the primary structural material in the Space Shuttle external tank; however, ductilities were lower. The fracture resistance of the 2090 extrusion was lower than 2219-T87 plate at room temperature. At cryogenic temperatures, tensile ductility and fracture behavior of the 2090 extrusio

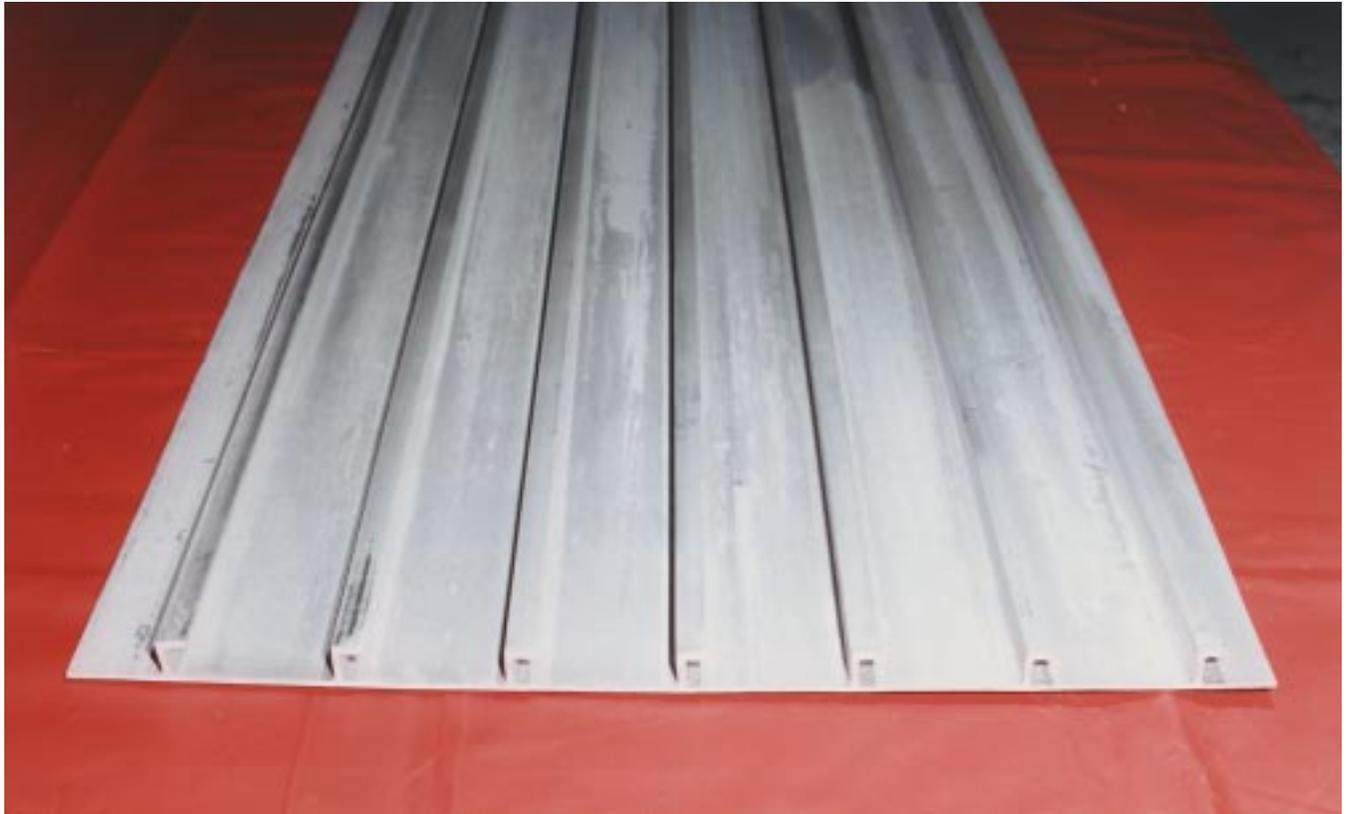
Figure 1. Extruded 2090 panel in as-received condition.

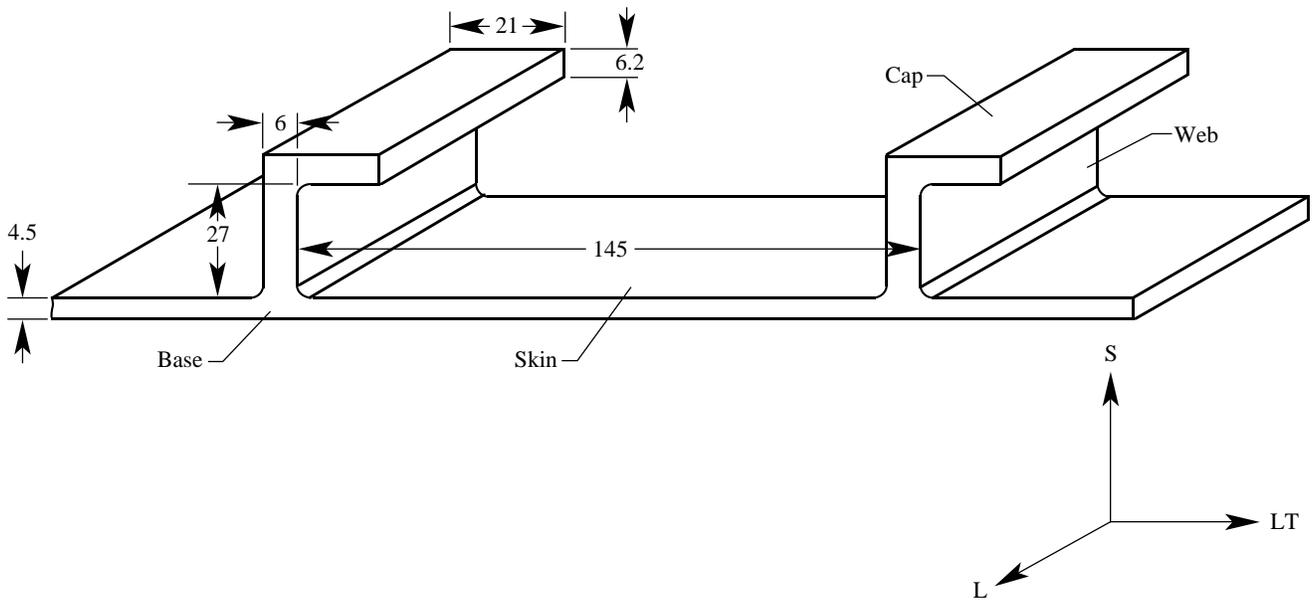
Figure 2. Schematic section of extruded panel (nominal dimensions in mm).

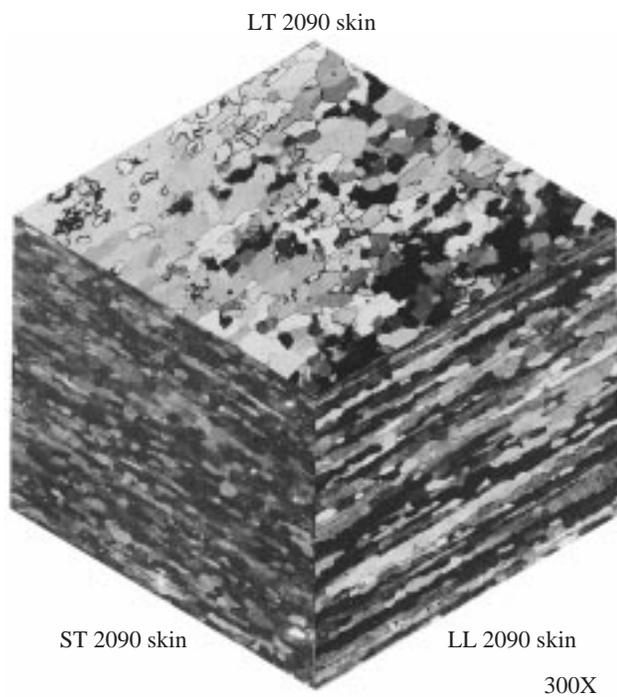
Figure 3. Triplanar optical micrograph of center of skin (anodized by using Barker's reagent and viewed under cross-polarized light).

**4.1.1. Metallography.** Optical macrographs of panels 2, 6, and 11 indicated that the grain morphology was similar for these three panels. Further metallographic examination was performed on panel 11 only. Triplanar micrographs of the skin and cap for panel 11 are shown in figures 3 and 4, respectively. The structures shown are typical, regardless of location along the length of the panel. Figure 3 reveals that a pancake-shaped grain morphology dominated the skin, which is similar to that of a rolled product (refs. 19 and 20). High aspect ratio (>20:1) extrusions would be expected to have a microstructure of pancake-shaped grains similar to a rolled product (ref. 19). Figure 4 shows that the grain morphology was fibrous in the cap, which corresponds to an extrusion

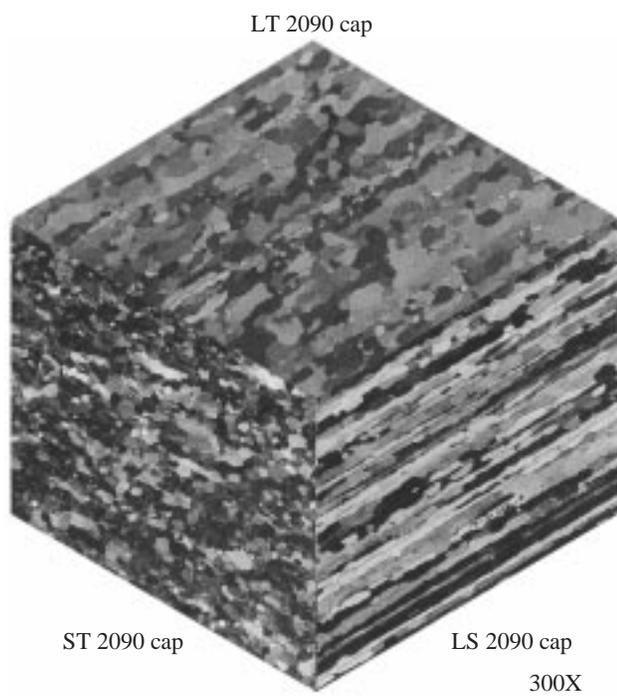
Figure 4. Triplanar optical micrograph of center of cap (anodized by using Barker's reagent and viewed under cross-polarized light).

formed at a low aspect ratio (refs. 17, 19, and 20). In an axisymmetric extrusion, where the aspect ratio is close to unity, the grain structure will be fibrous (ref. 19). In this study the lowest extrusion aspect ratios were found in the cap ( $\sim 4:1$ ), while the skin had an aspect ratio  $>25:1$ .

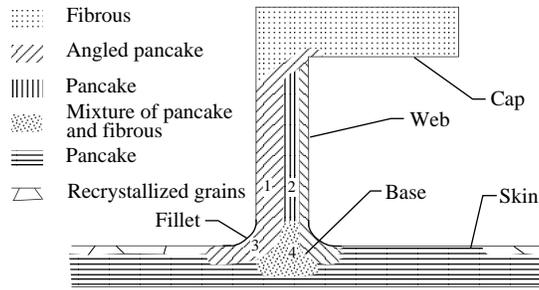
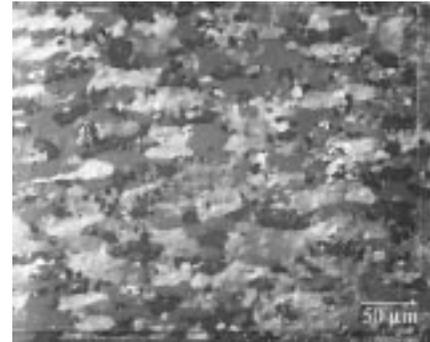
(a) Panel element schematic.

(e) Base interior, region 4.

Figure 5. Skin-stiffener cross section showing microstructural variations resulting from extrusion process (anodized with Barker's reagent and viewed under cross-polarized light).

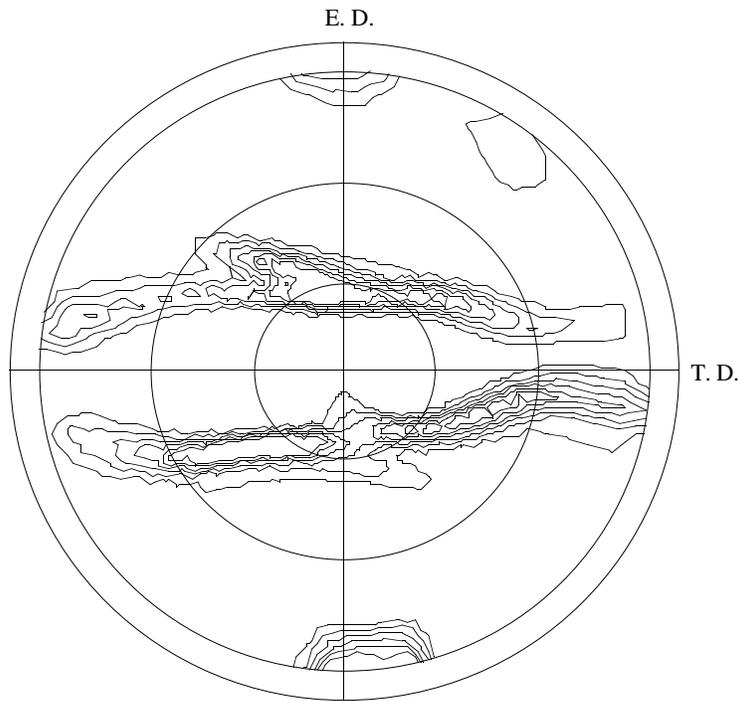
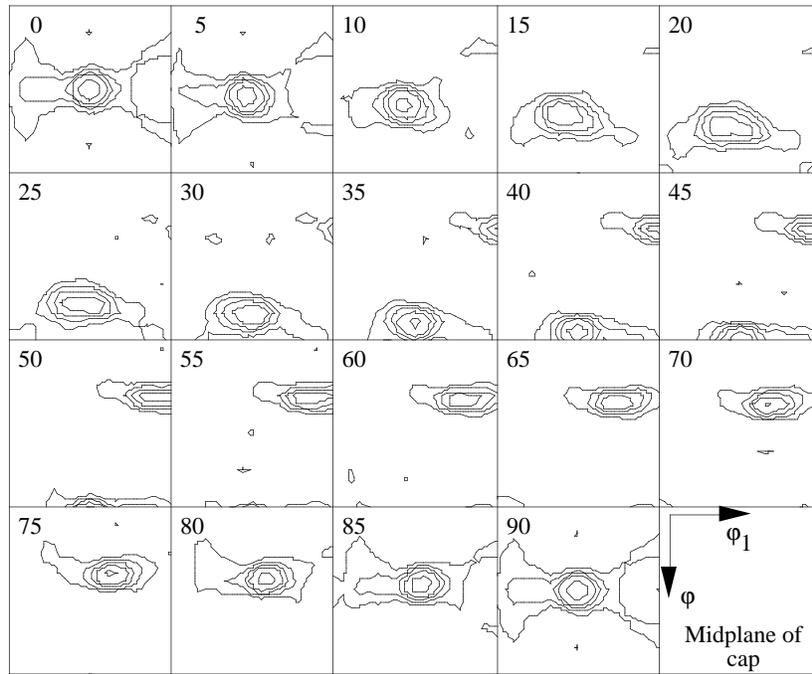
Figure 6. Texture results for midplane of cap.

**4.1.2. Texture analyses.** The results obtained from preferred orientation measurements are shown in figures 6 through 9. Data are presented in the form of  $\{111\}$  pole figures and orientation distribution function (ODF) plots, which were constructed using the  $\{111\}$ ,  $\{200\}$ ,

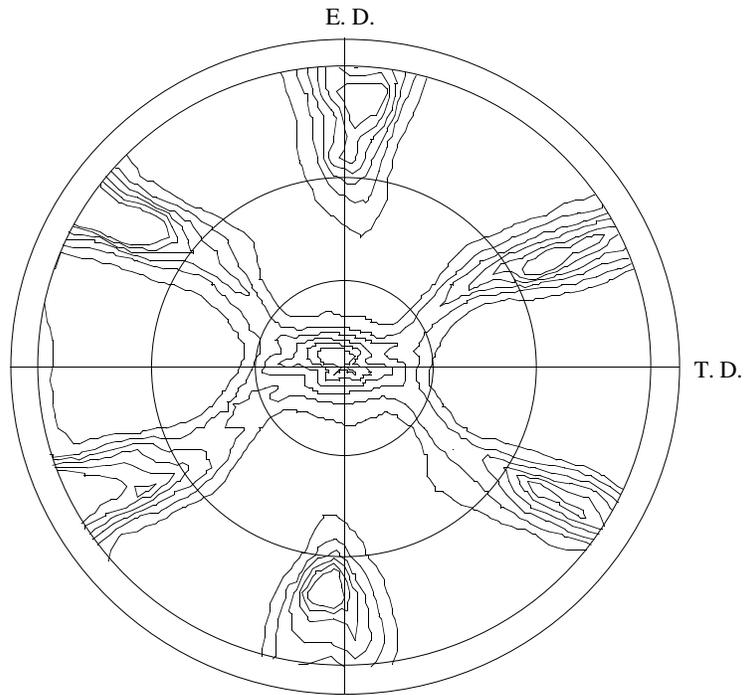
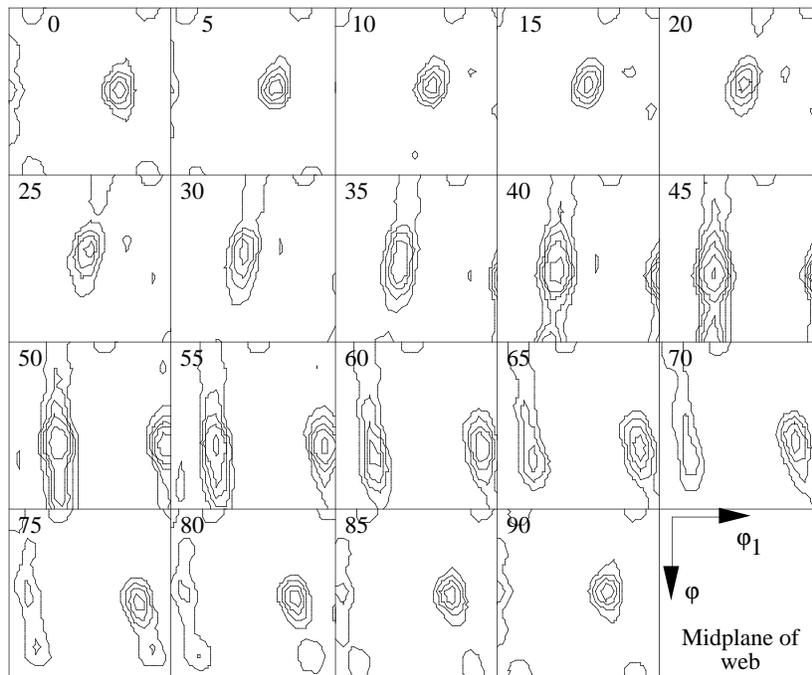
Figure 7. Texture results for midplane of web.

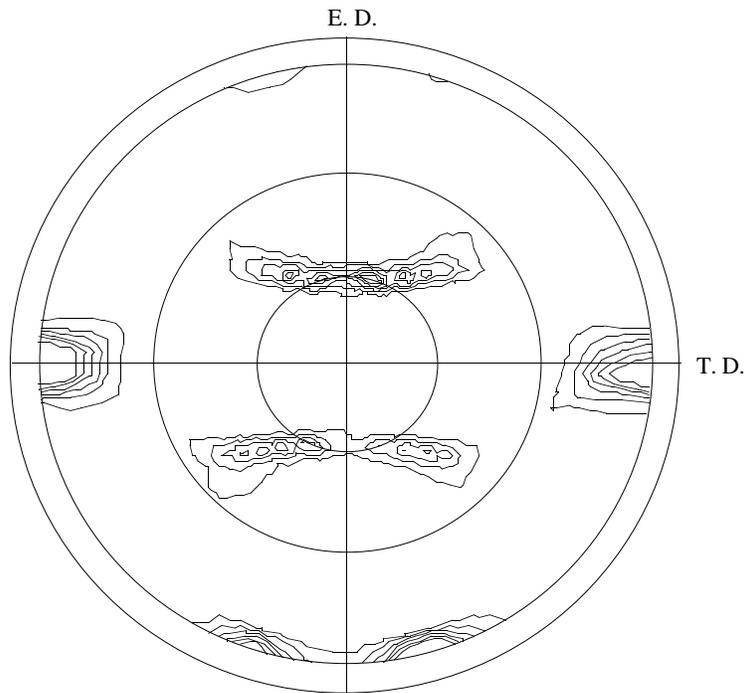
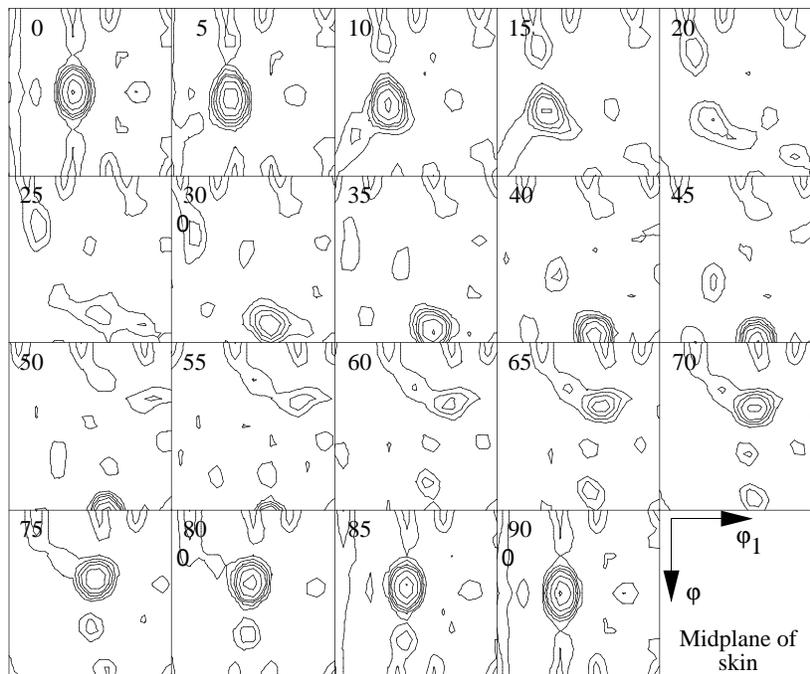
Figure 8. Texture results for midplane of skin.

**Skin:** The  $\{111\}$  pole figure and the ODF plot obtained from material in the center of the skin are shown in figure 8. This figure indicates that the

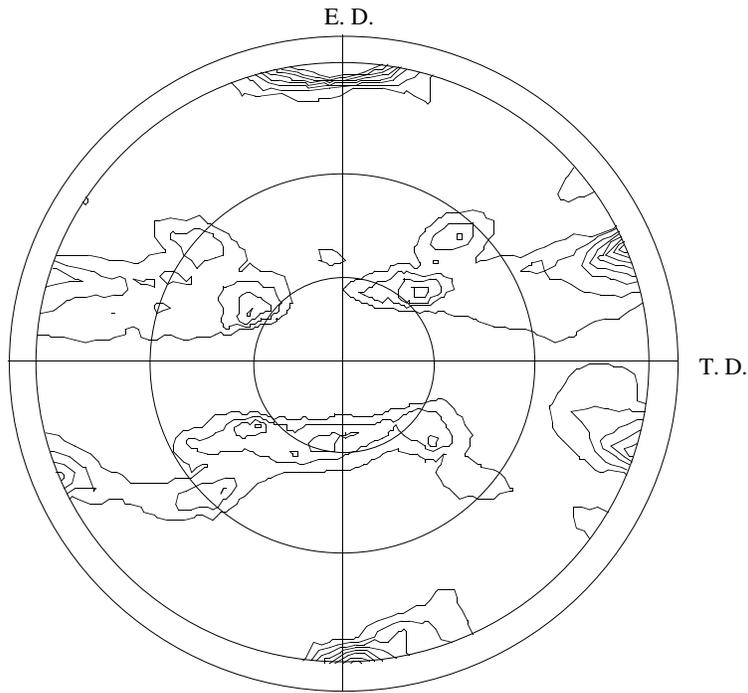
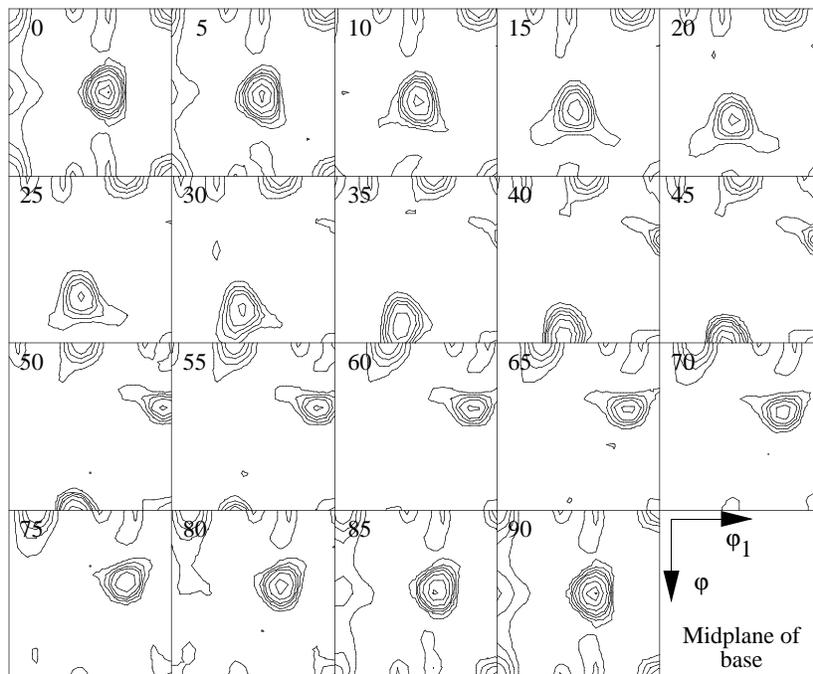
Figure 9. Texture results for midplane of base.

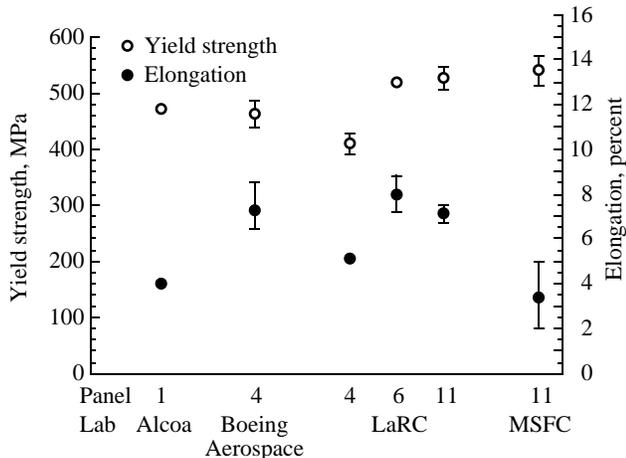
Figure 10. Panel-to-panel variation in yield strength and elongation to failure. Results for all LT skin tests at 25°C for each panel (bars represent range of data).

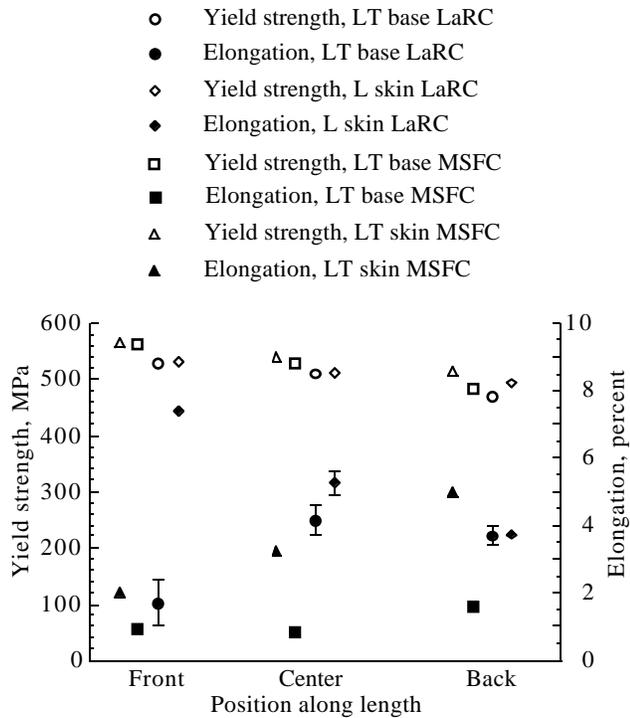
Figure 11. Variation in yield strength and elongation to failure along panel length. Results for panel 11 L skin, LT skin, and LT base at 25°C. Bars represent range of data.

**Panel length variation:** Data for panel 11 (from LaRC and MSFC) were reviewed to assess the variation in tensile properties along the length of the near net shape extruded panel. Room temperature yield strength and elongation to failure are shown in figure 11 and in appendix C, tables C4 and C5, for the L skin, the LT skin, and the LT base orientations measured at three panel locations. The data plotted in figure 11 represent averages of duplicate tests from LaRC and single tests from MSFC. The yield strength for each orientation decreased from the front to the back end of the panel, with the reduction ranging from 7 percent for the L skin to 14 percent for the LT base. This reduction may be associated with recovery processes due to billet heating during extrusion (ref. 17). Optical metallography of the microstructure at locations along the length of the panel did not indicate evidence of recrystallization. However, texture analyses at the midplane of the skin revealed the presence of recrystallization. The relative degree of recrystallization along the panel length was not determined. The data in figure 11 indicate that the room temperature elongation to failure increased from front to back for the LT skin but decreased for the L skin. The variation in elongation for the LT base was not as systematic, but there was an overall increase from front to back for both the LaRC and

MSFC data. The differences in LaRC and MSFC values may be related to the different methods used to measure elongation to failure.

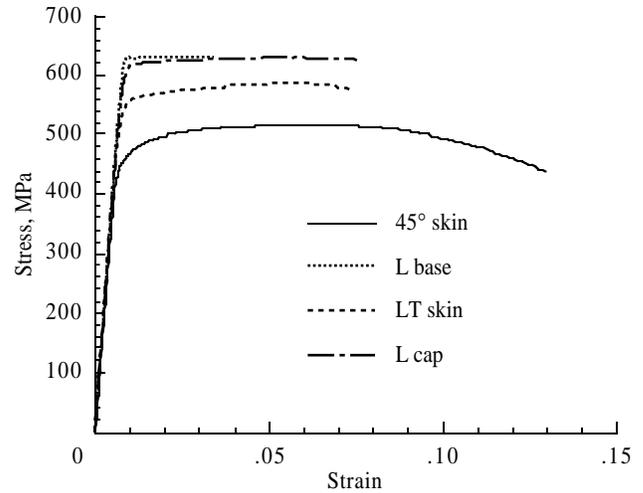
Figure 12. Variation in stress-strain behavior with respect to panel element and orientation. Individual tests at 25°C from center of panel 11.

**Stress-strain behavior:** The variation in the stress-strain behavior at 25°C for the base, cap, and skin is shown by the curves in figure 12. The data shown are for panel 11 and are typical of the results obtained on other panels. Al-Li extrusions with axisymmetric shapes and a concomitant <111> fiber texture tend to have high yield strength and low elongation to failure, whereas extrusions of high aspect ratio, which exhibit rolling-type textures, tend to have lower strengths and higher elongations to failure (refs. 19 and 21). The present data for the 2090 extrusions tend to support these observations, and as figure 12 shows, the highest overall stress-strain curves are associated with areas of the extrusion that have low aspect ratio (cap and base), while areas of high aspect ratio have lower strength with the highest elongation to failure observed in the 45° skin. Where regions of

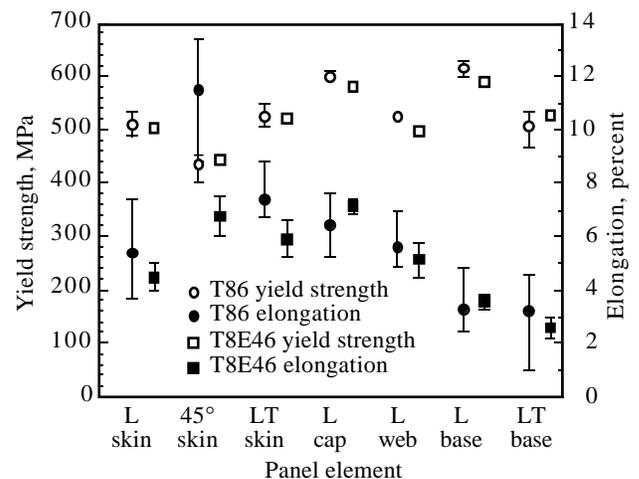
Figure 13. Variation in yield strength and elongation to failure with panel element. LaRC results for panels 6 and 11 (T86) and panel 2 (T8E46) at 25°C. Bars represent range of data.

**Panel element variation:** Tensile yield strength and elongation to failure are plotted in figure 13 from LaRC data shown in appendix C, table C4, for several panel elements and orientations. The T86 data represent averages of room temperature tests for each panel element along the length of panel 11 and the front of panel 6. The T8E46 data represent averages of room temperature tests for each panel element at the middle of panel 2. Trends in yield strength for each panel element were the same for

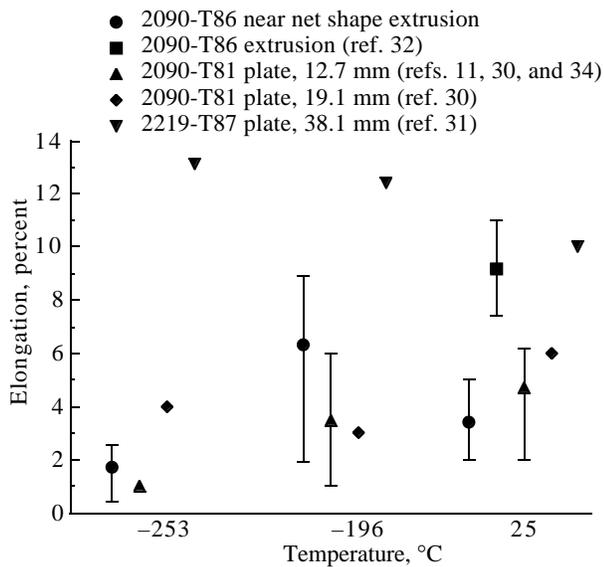
Figure 15. Variation in elongation to failure with temperature for various 2090 product forms and 2219 plate. Bars represent range of data.

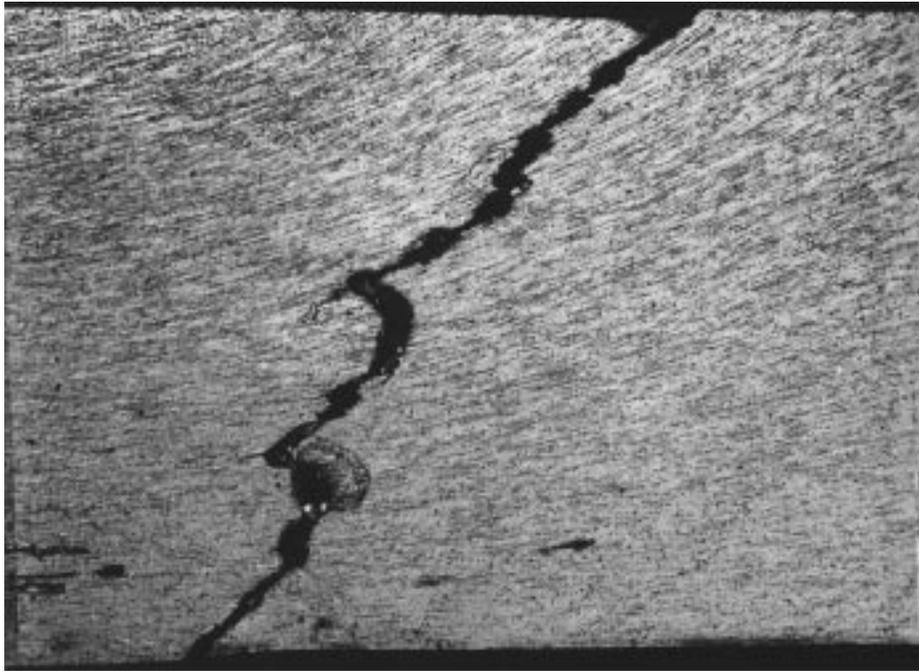
Figure 16. Through-thickness cross section of tensile failure in base tested at 25°C in the LT orientation.

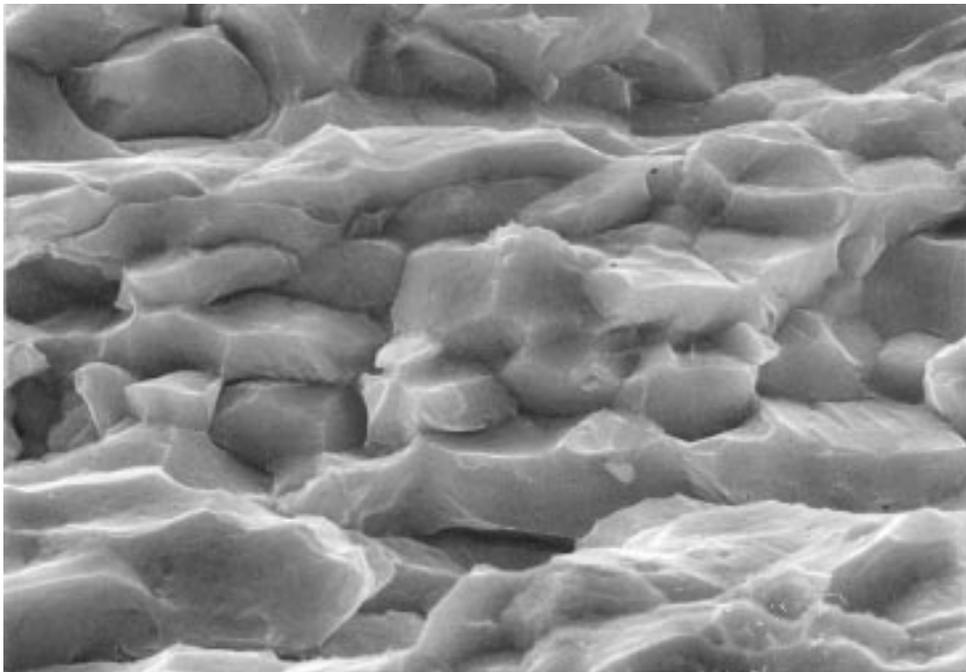
Figure 17. Typical intersubgranular tensile failure at 25°C showing pancake-shaped grains.

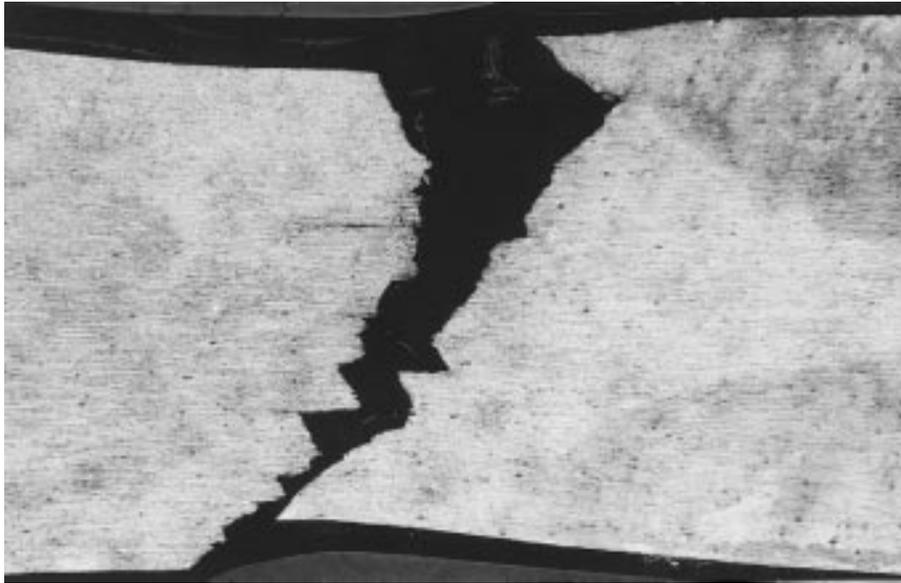
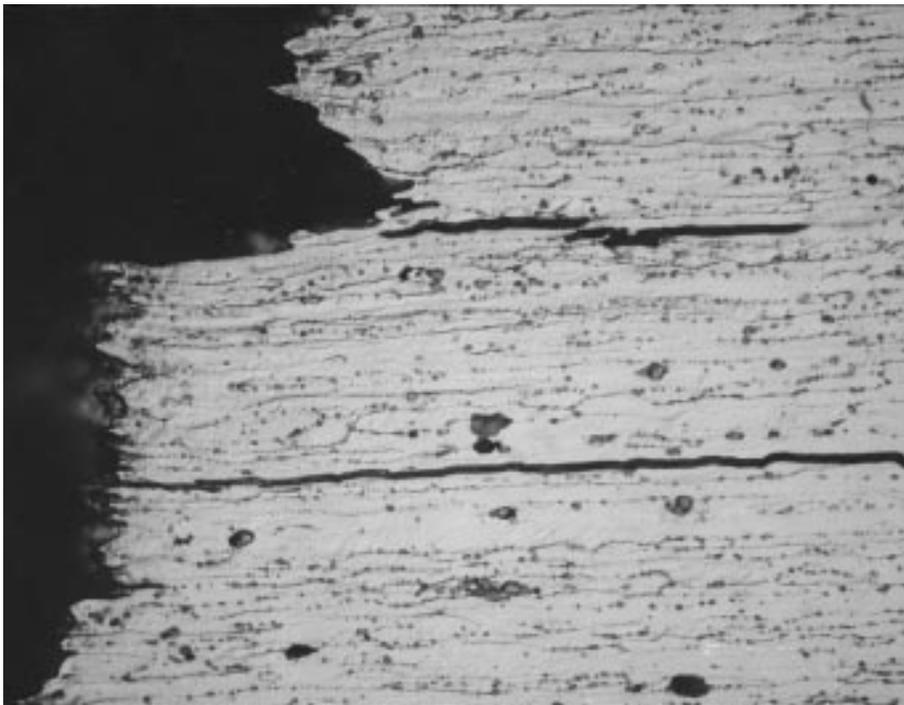
(a) Low-magnification micrograph showing steps caused by delamination.

(b) High-magnification micrograph showing delamination along grain boundaries.

Figure 18. Typical tensile failure in skin tested at 25°C in 45° orientation.

The tensile fracture of all skin specimens was by macroscopic shear. Grain boundary delamination was observed in specimens tested in the  $45^{\circ}$  orientation at

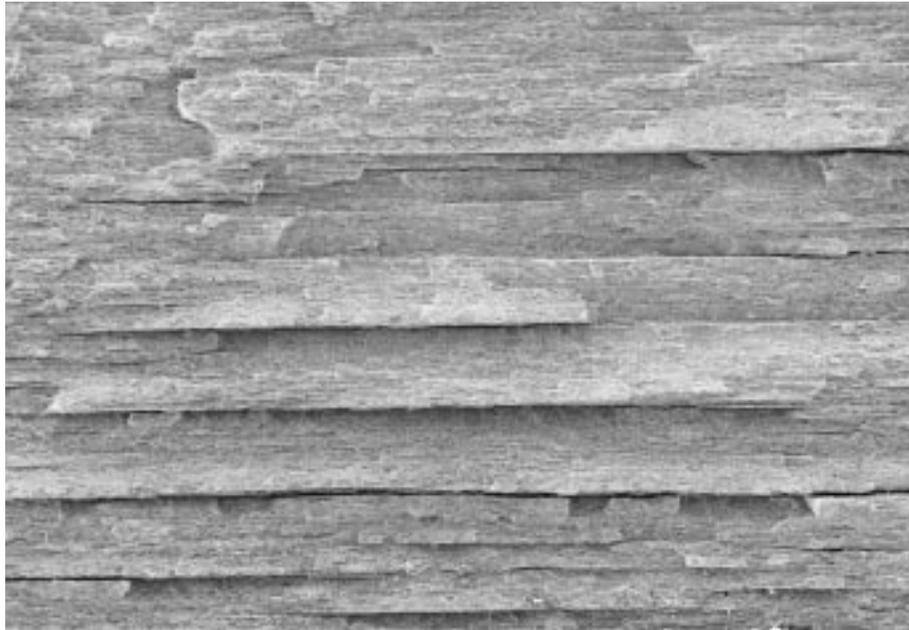
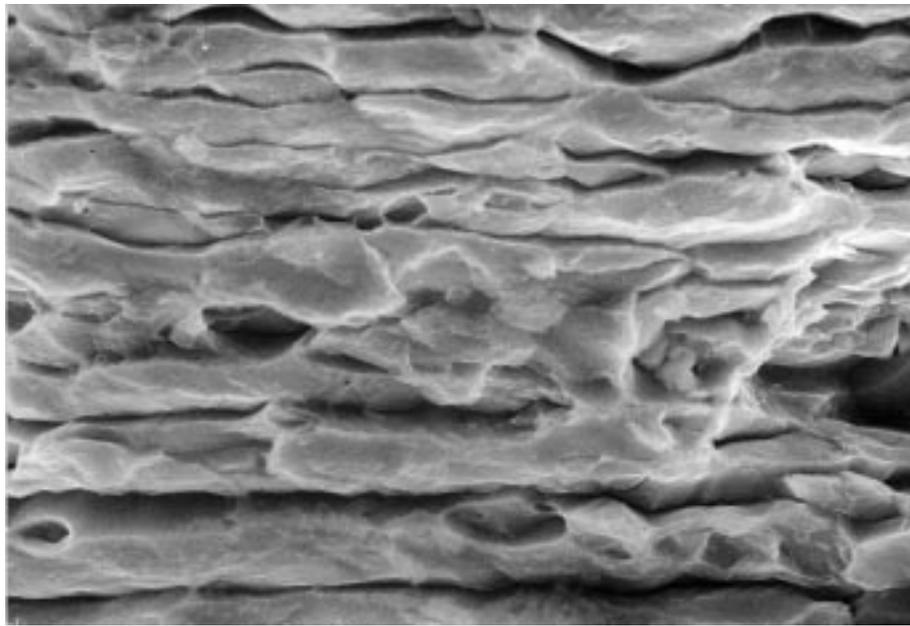
(a) Low-magnification fractograph showing extensive delamination.

Figure 19. Typical tensile failure in skin tested at  $-196^{\circ}\text{C}$  in LT orientation.

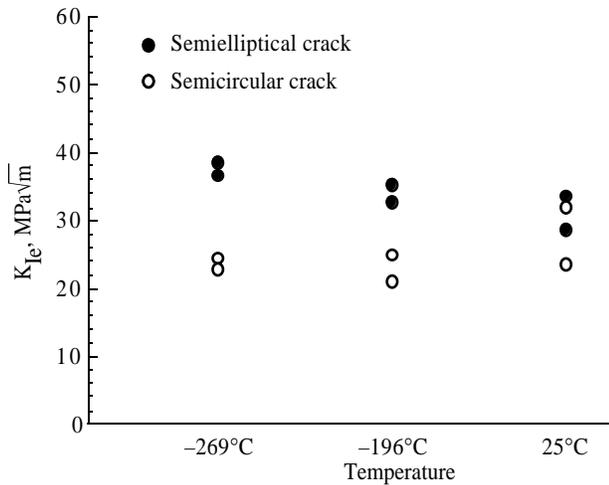
Figure 20. Effect of surface crack shape and temperature on toughness. Results for individual tests at NIST on panel 6 in T-S orientation.

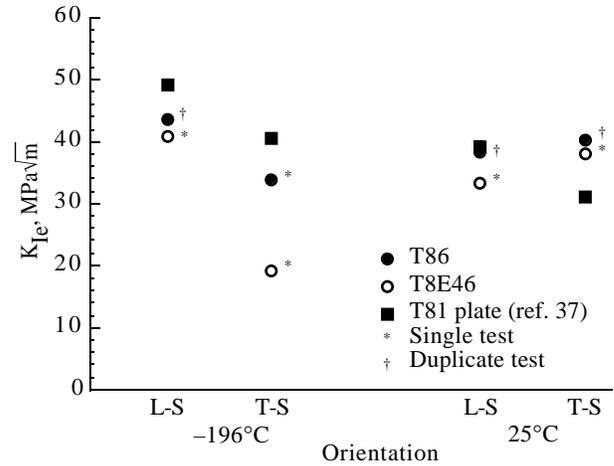
Figure 21. Comparison of surface crack test results from Boeing Aerospace for 2090 extrusions with 2090 plate.

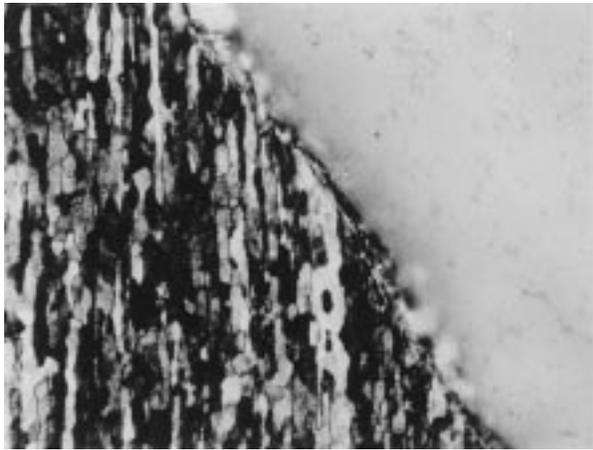
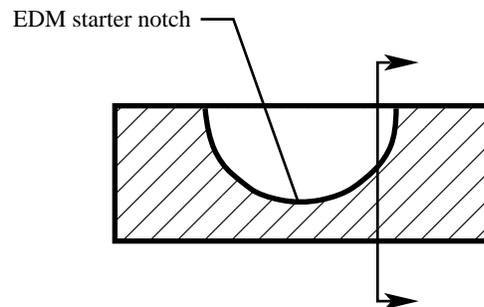
(a) T-S specimen tested at 25°C.

(e) Schematic of PS(T) fracture surface showing location of cross sections.

Figure 22. Through-thickness cross sections of 2090 PS(T) fracture specimens (anodized with Barker's reagent and viewed under cross-polarized light).

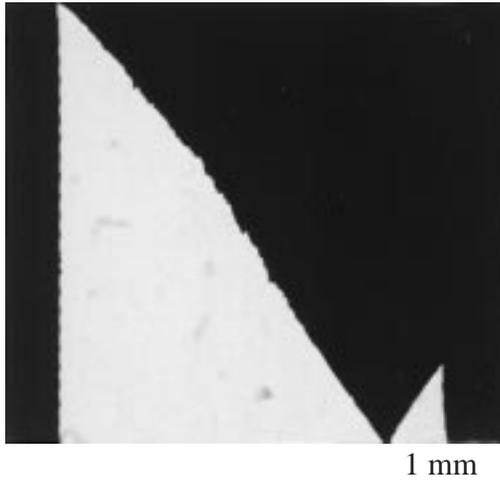
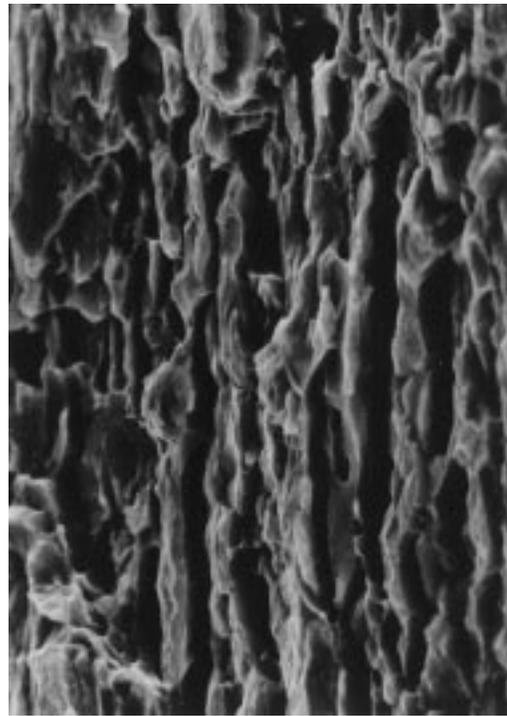
(a) Through-thickness cross section.

(c) Area in center of figure 23(b).

Figure 23. Fracture surface of PS(T) specimen in L-S orientation at 25°C.

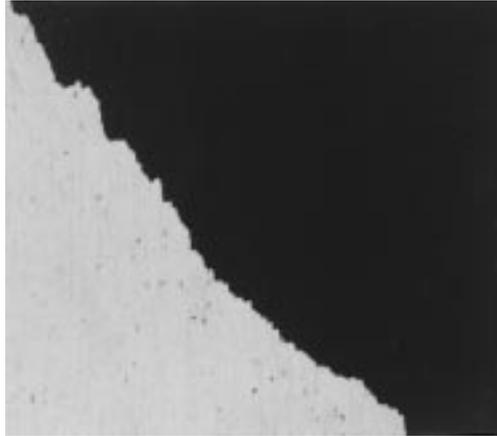
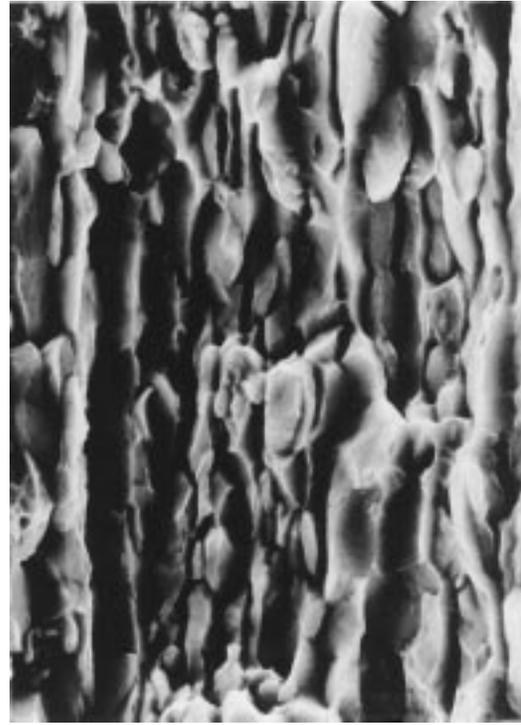
(a) Through-thickness cross section.

Figure 24. Fracture surface of PS(T) specimen in T-S orientation at 25°C.

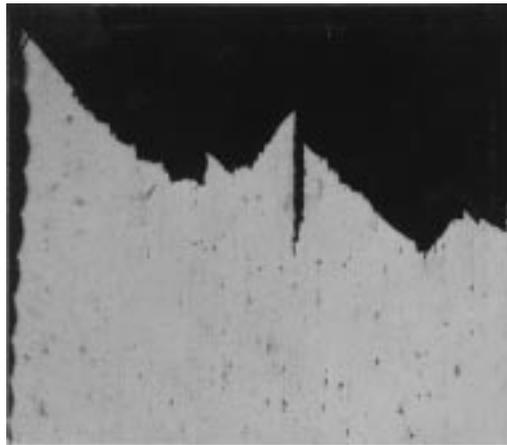
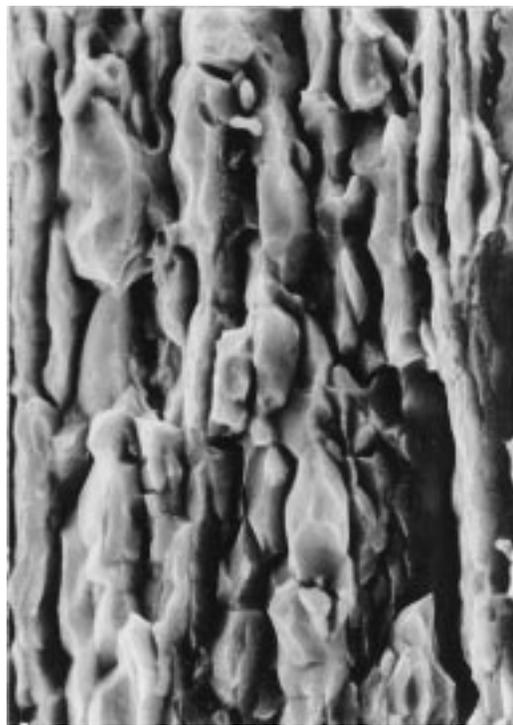
(b) Top view of cross section.

Figure 25. Fracture surface of PS(T) specimen in L-S orientation at  $-196^{\circ}\text{C}$ .

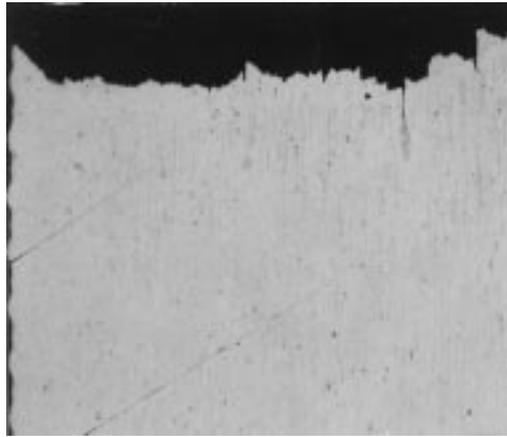
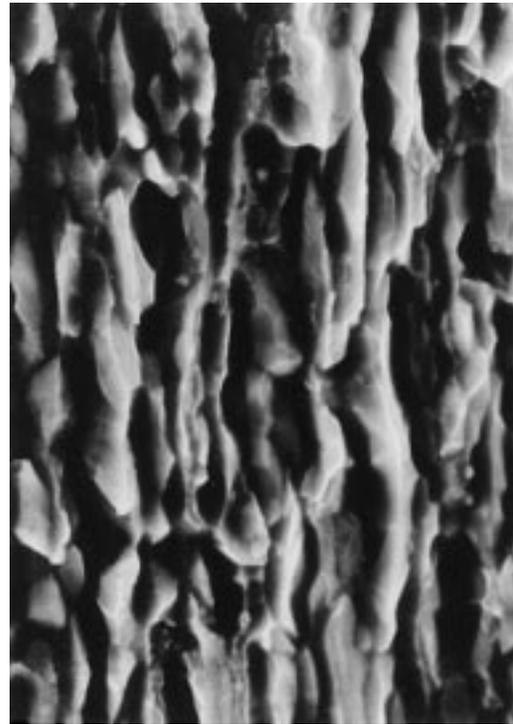
(b) Top view of cross section.

Figure 26. Fracture surface of PS(T) specimen in T-S orientation at  $-196^{\circ}\text{C}$ .

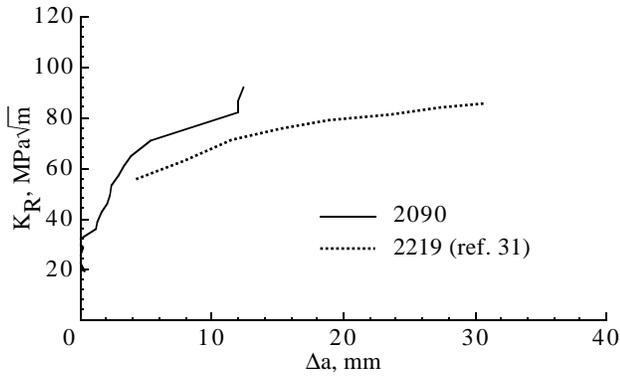
Figure 27. Comparison of the resistance to stable tearing of 2090-T86 extrusion with 2219-T87 plate in L-T orientation at 25°C. Data from M(T) specimens.

**4.3.2. Through-crack fracture tests.** Results from middle-cracked tension (M(T)) specimens machined from skin material panels 11 and 2 and tested at LaRC are presented in the form of R-curves in figures 27

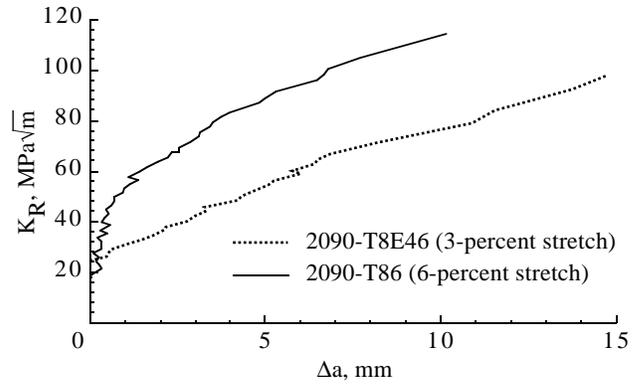
Figure 30. Effect of stretch on fracture behavior of 2090 extrusion in L-T orientation at 25°C. Data from M(T) specimens.

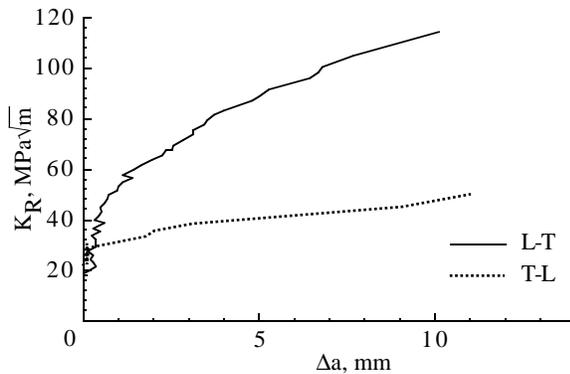
Figure 28. Effect of orientation on fracture behavior of 2090-T86 extrusion at 25°C. Data from M(T) specimens.

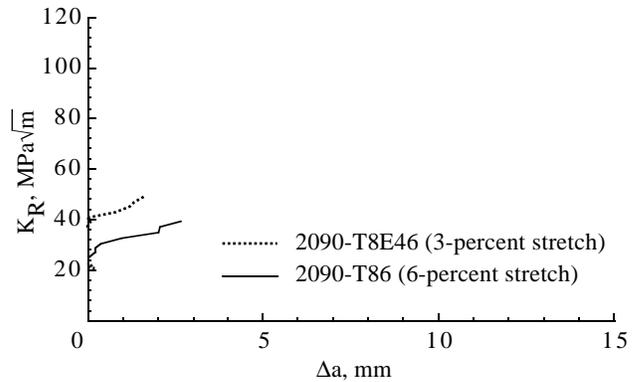
Figure 31. Effect of stretch on fracture behavior of 2090 extrusion in T-L orientation at 25°C. Data from M(T) specimens.

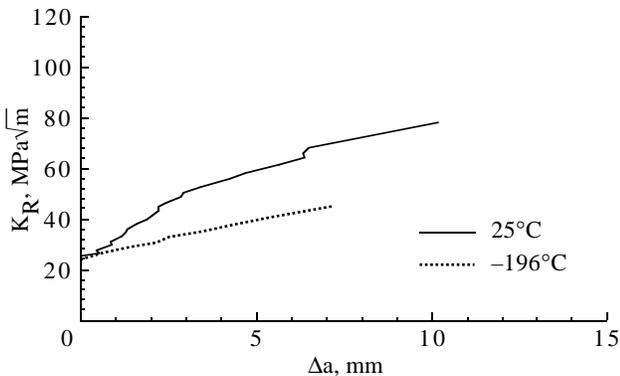
Figure 29. Effect of temperature on fracture behavior of 2090-T8E46 extrusion in L-T orientation. Data from M(T) specimens.

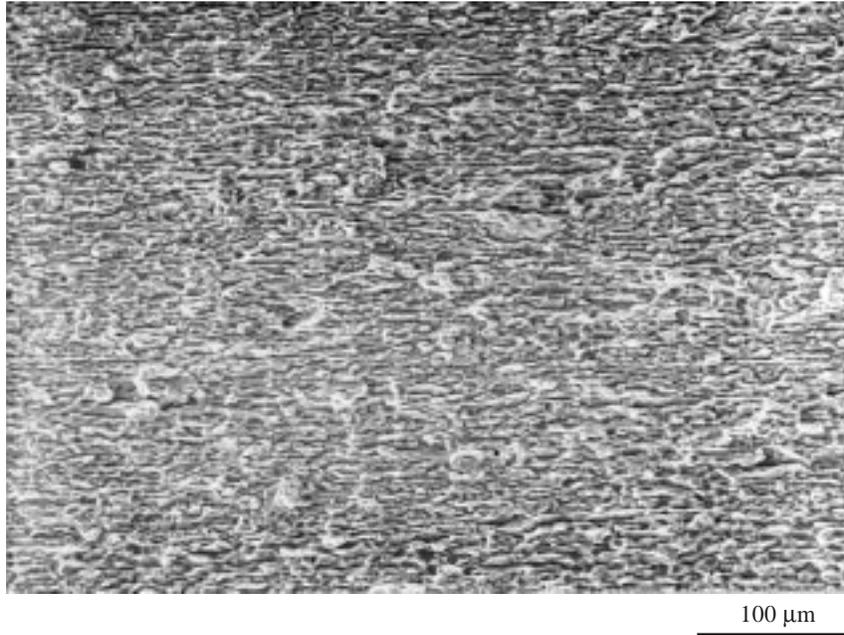
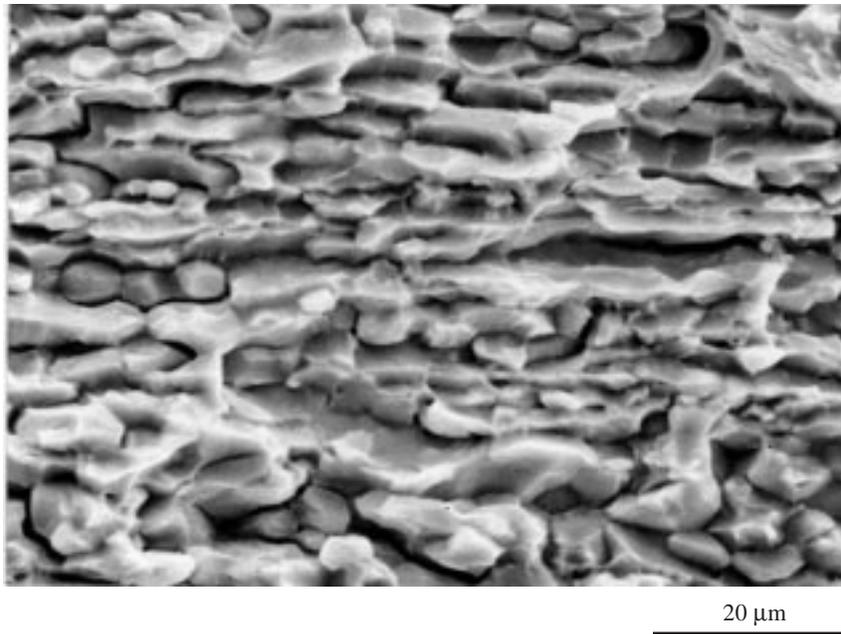
(a) Low-magnification micrograph of fracture surface.

(b) High-magnification micrograph showing intersubgranular separation.

Figure 32. SEM fractography of 2090-T8E46 extrusion M(T) specimens tested at 25°C in L-T orientation.

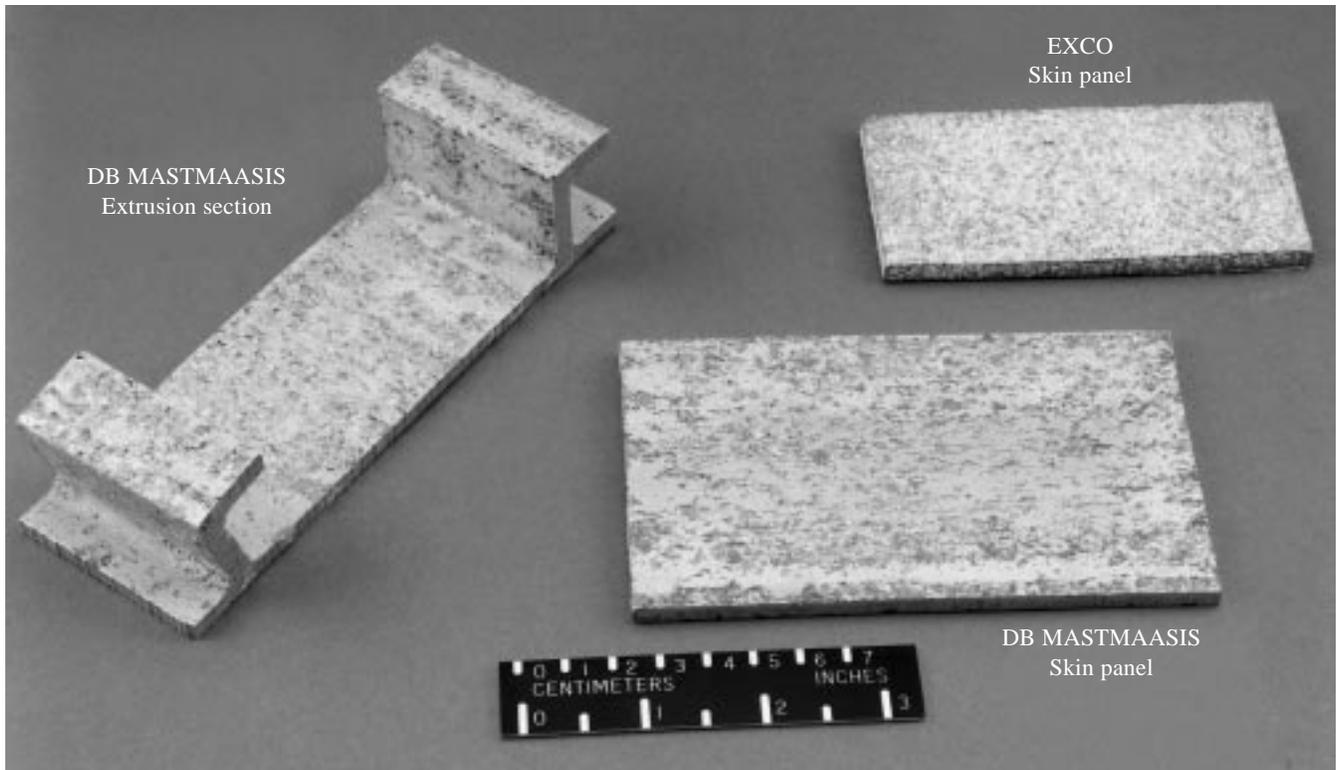
Figure 34. General appearance of 2090-T86 exfoliation specimens after EXCO and dry bottom MASTMAASIS exposures.

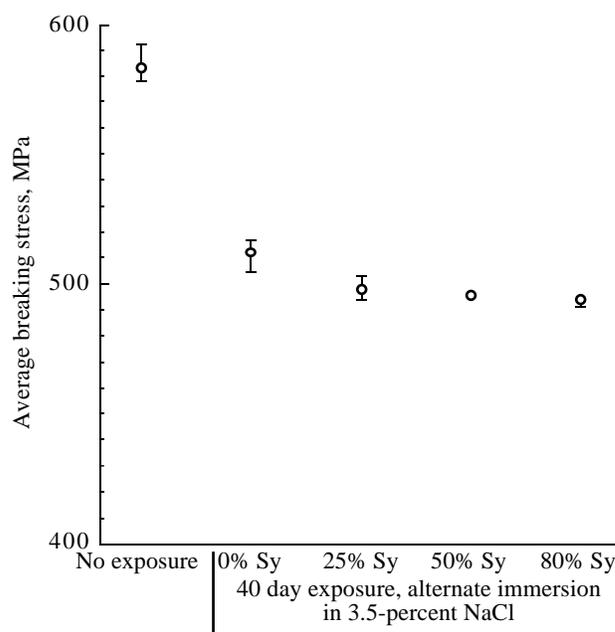
Figure 36. Variation in breaking stress with exposure stress for 2090-T86 long transverse direct-tension specimens. Bars represent range of data.
