NASA/TM-1998-207668

# Characterization of Al-Cu-Li Alloy 2090 Near Net Shape Extrusion

*Aluminum-lithium (Al-Li) alloy near net shape extrusions are being evaluated for potential application in launch vehicle structures. The objective of this study was to determine tensile and fracture properties, corrosion resistance, and weldability of integrally stiffened panels of Al-Cu-Li alloy 2090 in the T8 temper. The microstructure was predominantly unrecrystallized. Texture analyses revealed the presence of fiber components in the stiffeners and a combination of fiber and rolling components in the skin. Variations in grain morphology and texture through the extruded cross section were correlated with the tensile, fracture, and corrosion behavior. Tensile strengths at room and cryogenic temperatures of the 2090 extrusions were similar to other 2090 product forms and were higher than aluminum alloy 2219-T87, the primary structural material in the Space Shuttle external tank; however, ductilities were lower. The fracture resistance of the 2090 extrusion was lower than 2219-T87 plate at room temperature. At cryogenic temperatures, tensile ductility and fracture behavior of the 2090 extrusio

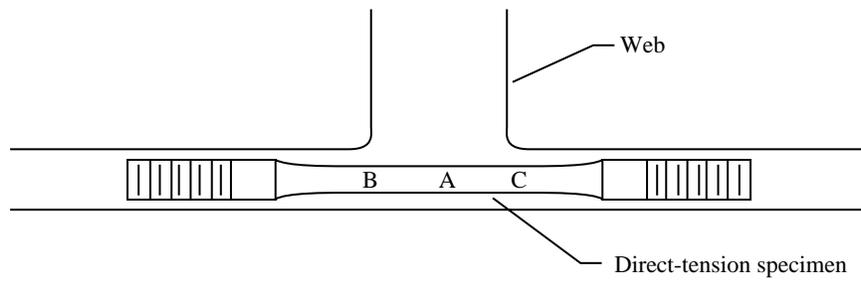
(a) Schematic of transverse direct-tension specimen position.

Metallographic sections from direct-tension specimens confirmed pitting attack, with pits undercutting the specimen surface along grain-subgrain boundaries. While there were no stress corrosion cracks observed in the stressed specimens, the pits were opened into broad, deep fissures. All direct-tension specimens failed away from the center of the reduced section during the breaking stress tests, with macroscopic fracture along boundaries of pancake-shaped grains aligned with the fillet, as was shown in figure 5(d). Additional specimens exposed at 0 percent and 75 percent  $S_y$  were used to further examine the corrosion morphology; therefore, the specimens were not failed in tension. One of these sections, shown

in figure 37, illustrates that the pits undercut along flow lines associated with the extrusion process. The pits were nearly equiaxed at the center of the reduced section and undercut parallel to the specimen surface. The microstructure at this position at the base of the stiffener exhibited mixed-pancake and fibrous grains, as shown in figure 5(e), with grain boundaries generally aligned parallel to the skin surface. To either side of the center of the reduced section, the pits were deep fissures and undercut at an angle following grain boundaries. The

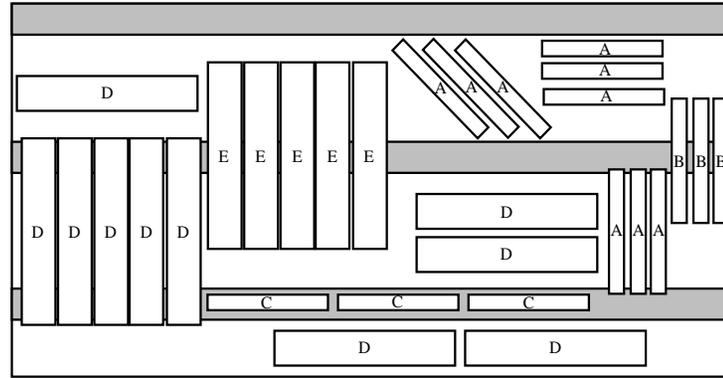
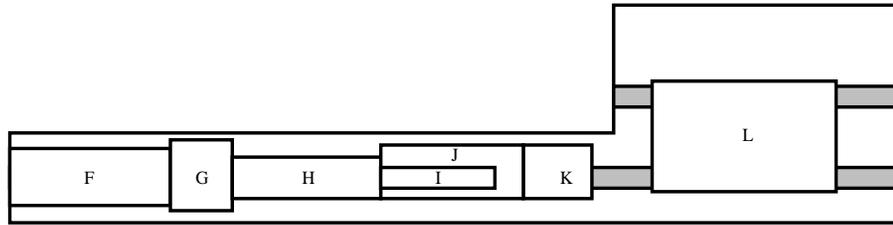
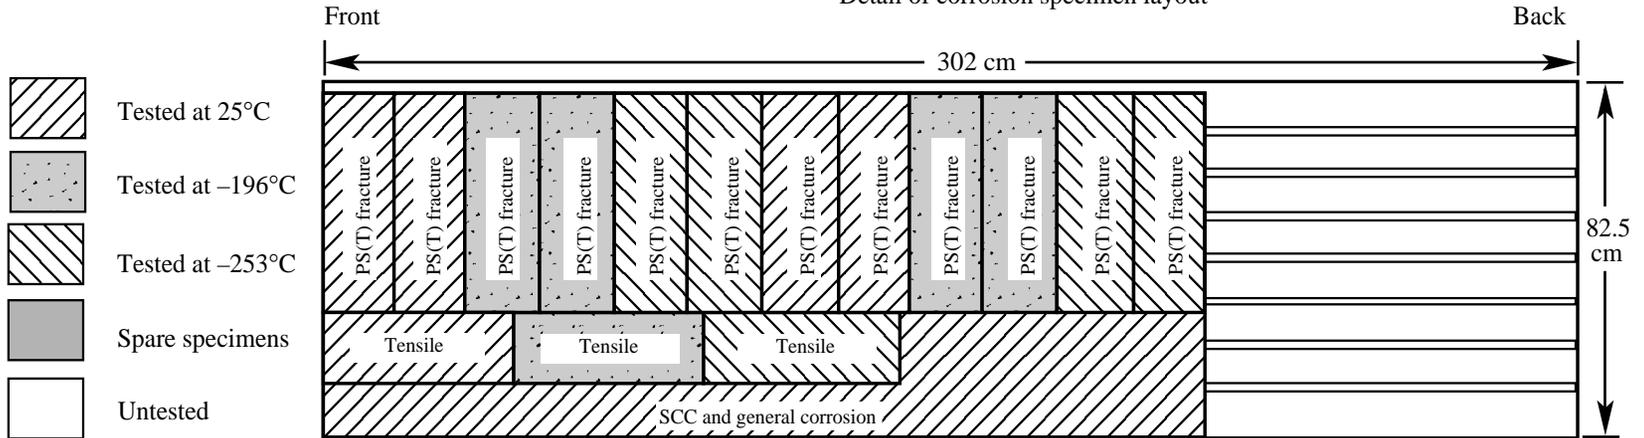
- F. Transverse bent beam (MSFC)
- G. Transverse direct tension (LaRC)
- H. Modified c-ring (LaRC)
- I. Bent beam (MSFC)
- J. Coating corrosion (MSFC)
- K. Transverse bent beam (MSFC)
- L. Exfoliation (Alcoa)

Figure A2. Specimen locations in panel 6.

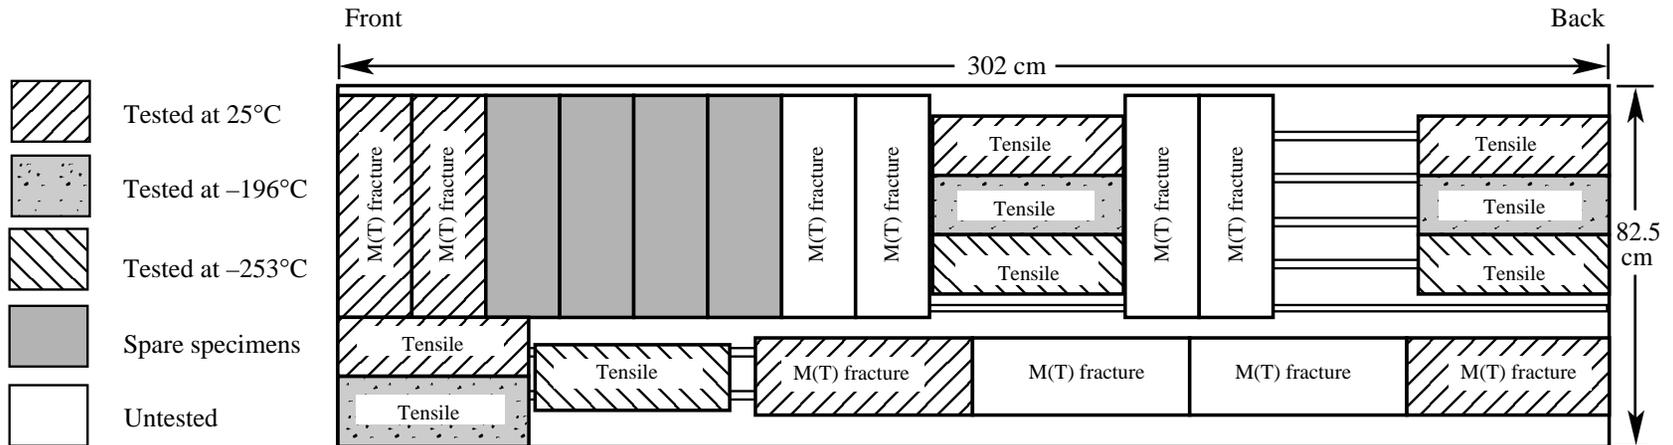
Figure A3. Specimen locations in panel 11.

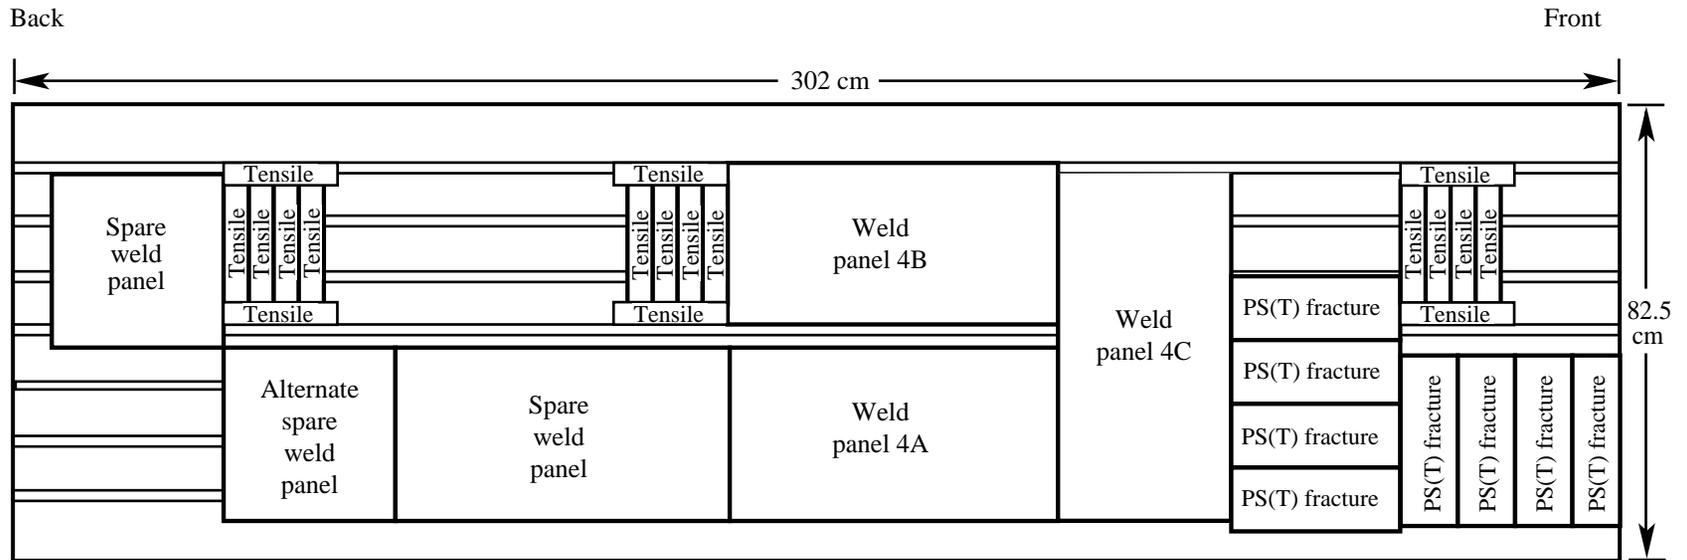
Figure A4. Specimen locations in panel 4.

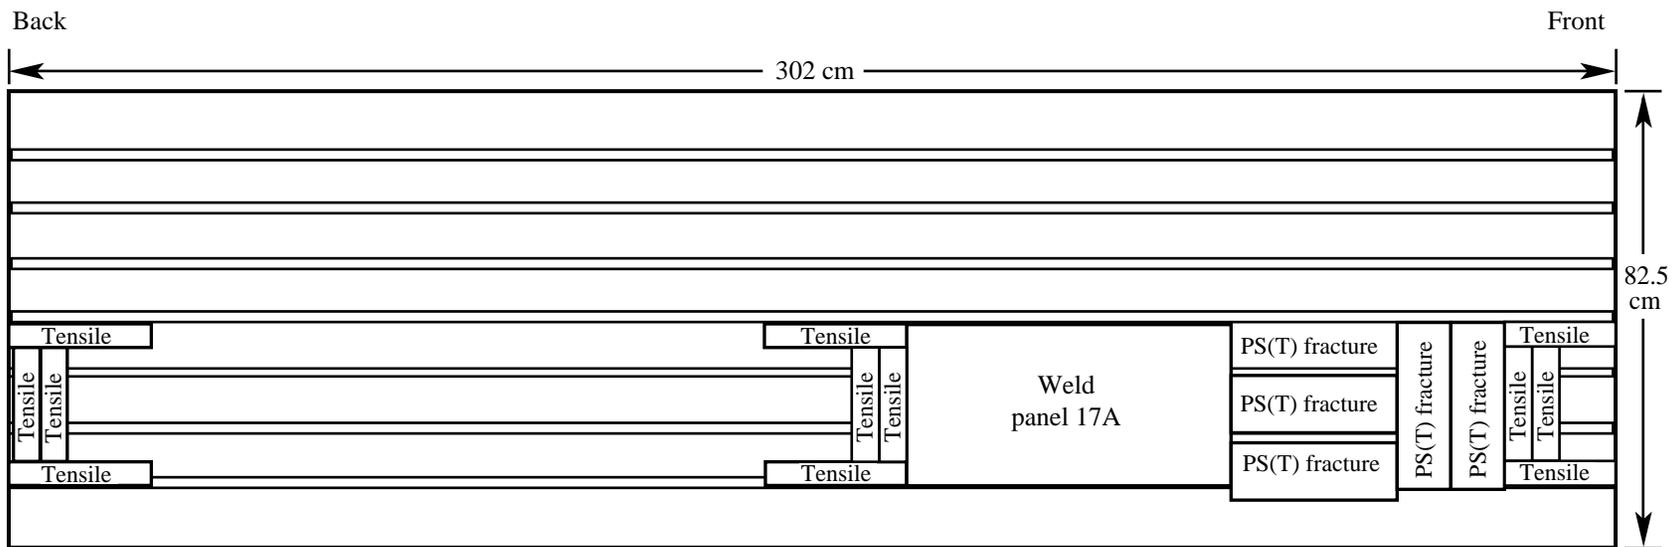
Figure A5. Specimen locations in panel 7.

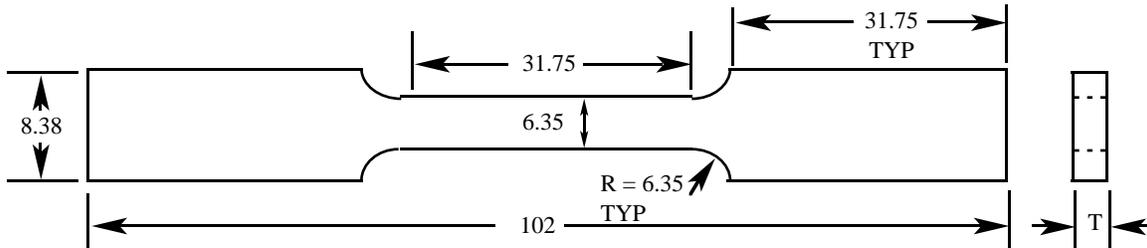
Figure B1. LaRC and Alcoa subsize tensile specimen (full-panel thickness). Dimensions are in mm.

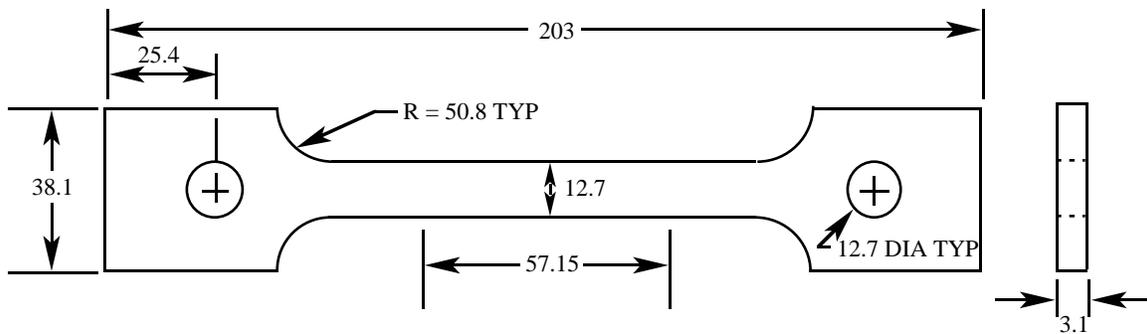
Figure B3. Boeing Aerospace base metal tensile specimen. Dimensions are in mm.

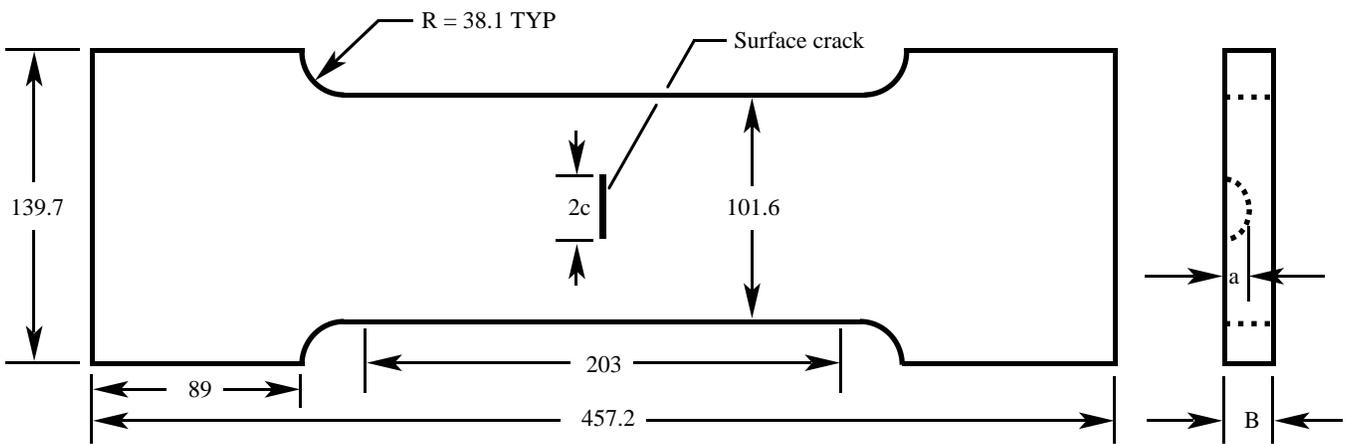
Figure B4. NIST large PS(T) specimen (full-panel thickness). Dimensions are in mm.

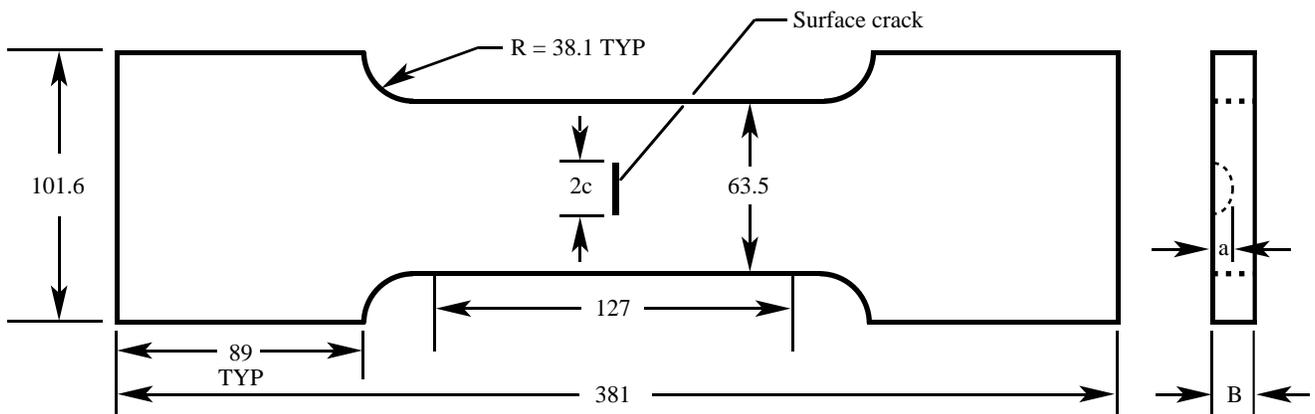
Figure B5. NIST small PS(T) specimen (full-panel thickness). Dimensions are in mm.

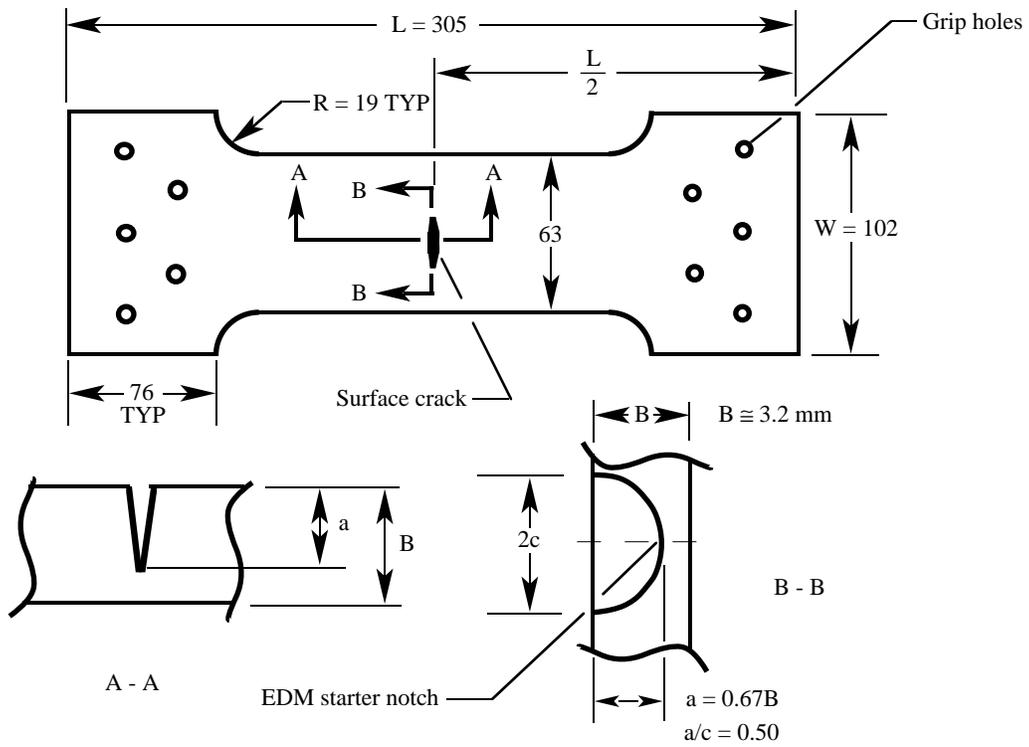
Figure B6. Boeing Aerospace PS(T) specimen. Dimensions are in mm.

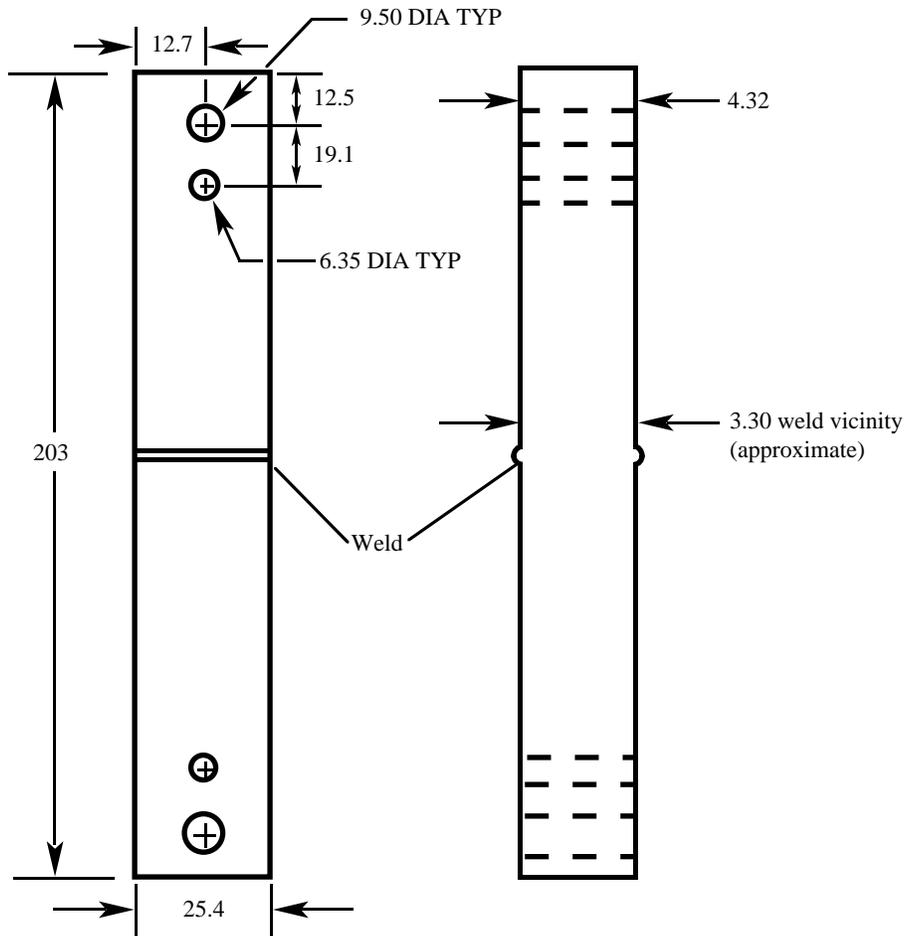
Figure B8. Boeing Aerospace weldment tensile specimen. Dimensions are in mm.

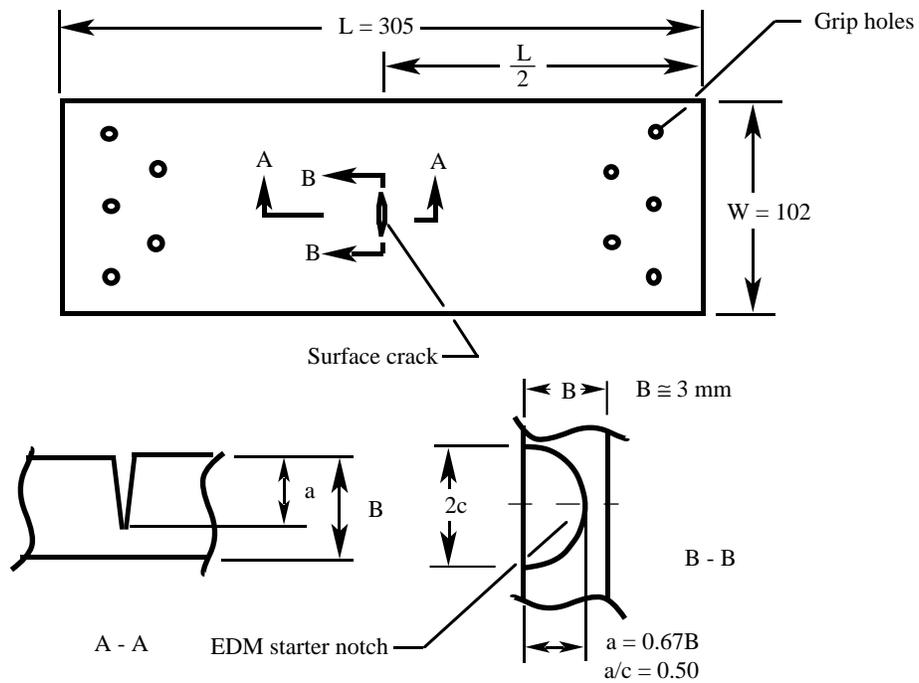
Figure B9. Boeing Aerospace weldment PS(T) specimen. Dimensions are in mm.

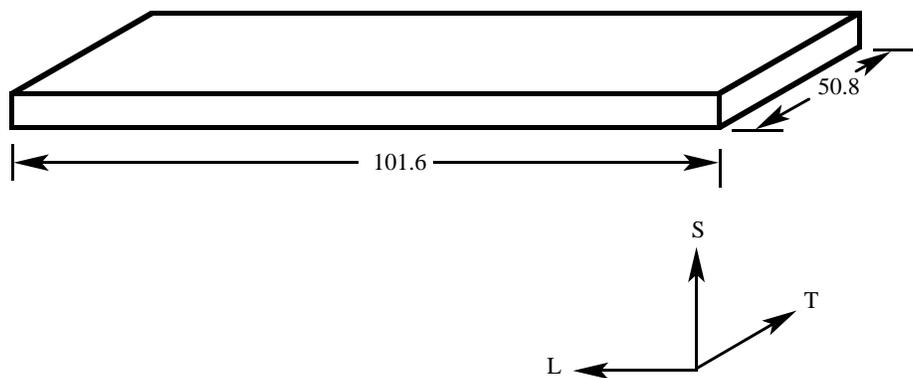
Figure B10. Alcoa exfoliation corrosion test specimen for EXCO test (full-panel thickness). Dimensions are in mm.

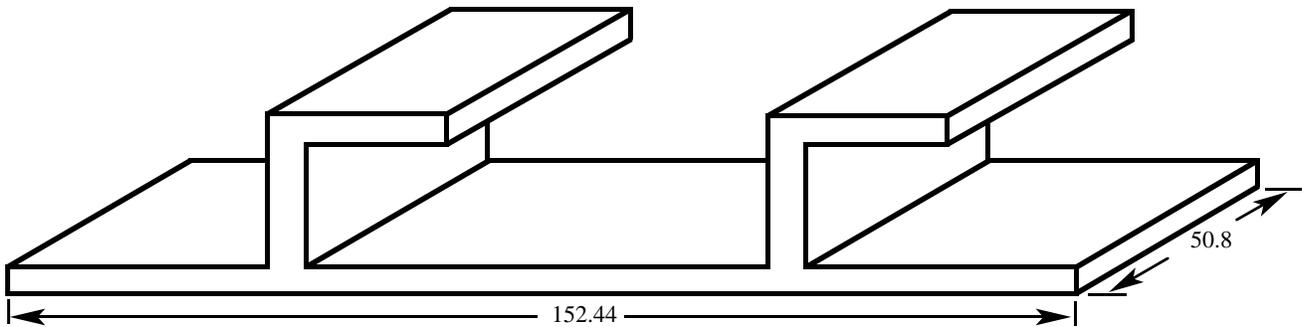
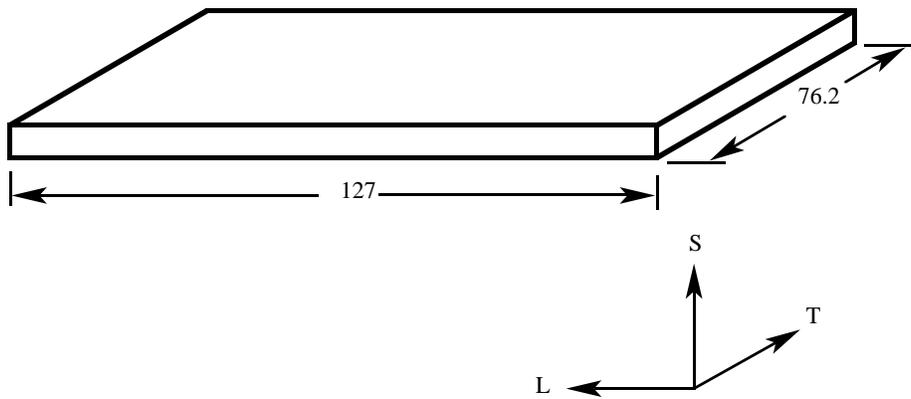
(a) Extrusion section with two stiffeners.

(b) Skin specimen.

Figure B11. Alcoa exfoliation corrosion test specimens for dry bottom MASTMAASIS test (full-panel thickness). Dimensions are in mm.

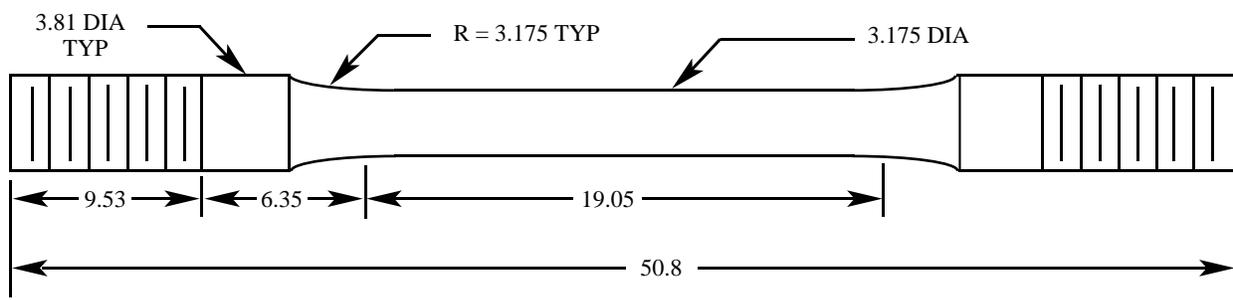
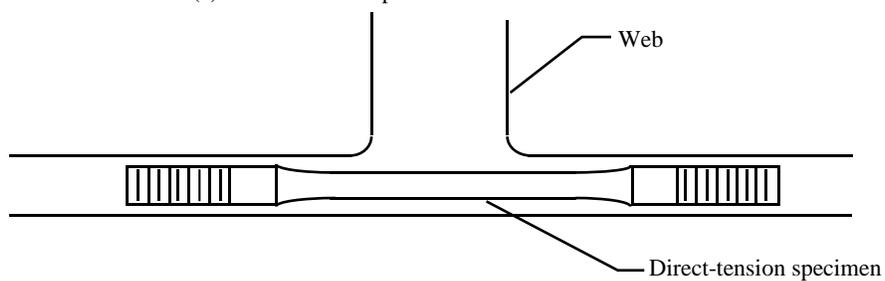
(a) Direct-tension specimen. Dimensions are in mm.

(b) Schematic of direct-tension specimen position.

Figure B12. LaRC direct-tension stress corrosion specimen.

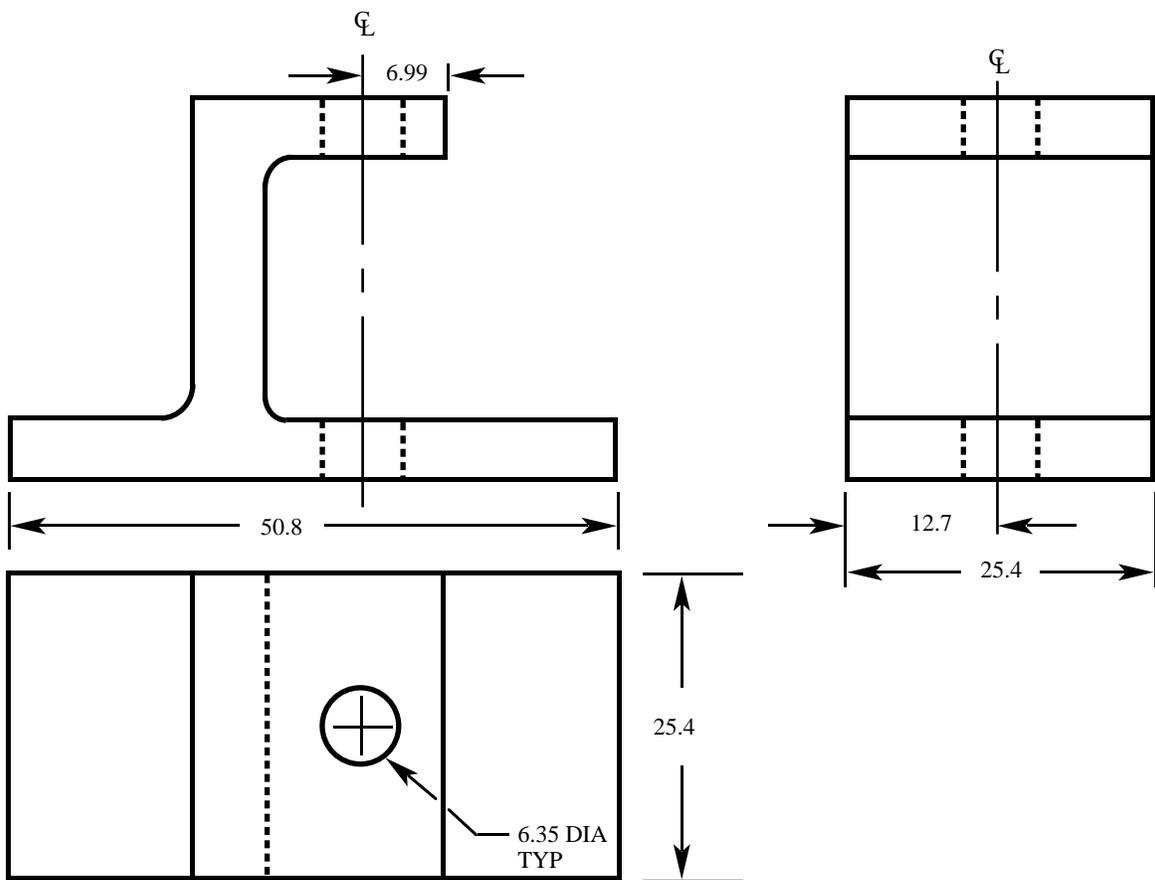
Figure B13. LaRC modified c-ring stress corrosion specimen. Dimensions are in mm.

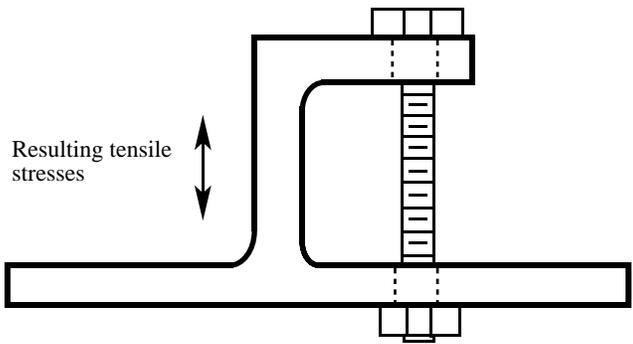
(a) Tensile stresses at outer web/fillet.

Figures B1 through B13 show specimen configurations used for tensile, fracture, and corrosion tests. Figure B14 shows schematically the loading methods used for the c-ring stress corrosion tests.
