MIR ENVIRONMENTAL EFFECTS PAYLOAD AND RETURNED MIR SOLAR PANEL CLEANLINESS

Gale A. Harvey, Donald H. Humes, and William H. Kinard
NASA Langley Research Center, Hampton, VA 23681-2199

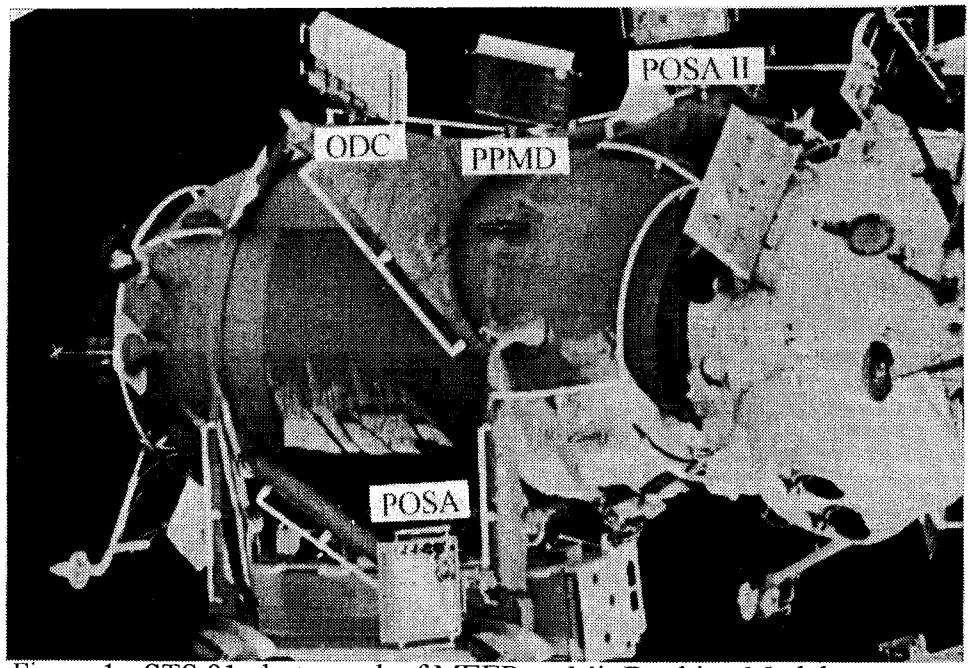
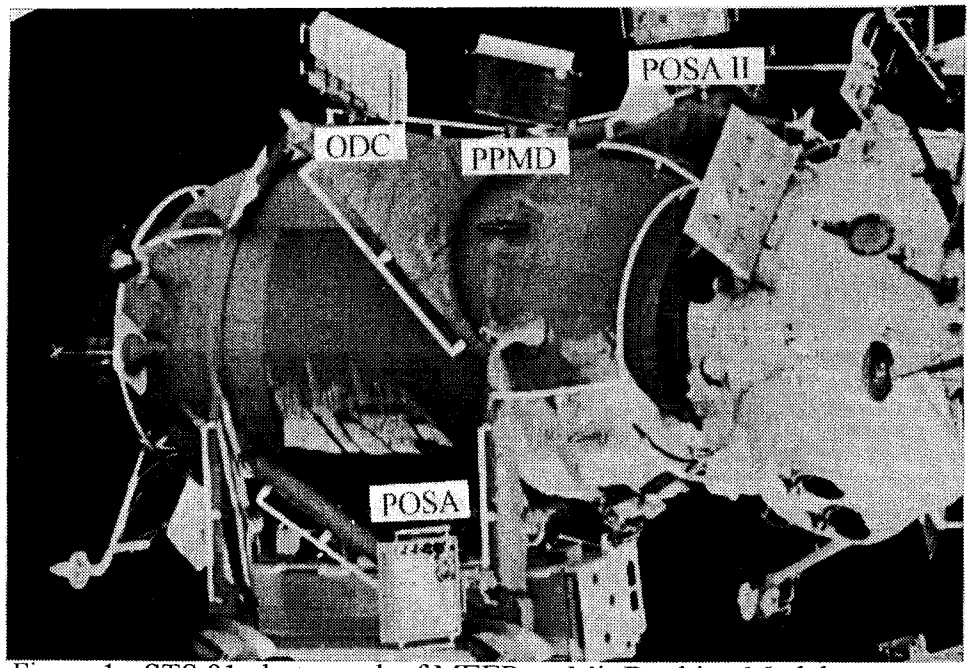
The PECs were bagged immediately after removal from the Orbiter upon return from space. The readily apparent spots and splashes on the PPMD experiment and on the PPMD PEC (Figure 2) were initially reported on at the ISS/MIR Space Environment Effects Workshop in Houston, TX in January 1998. The probable source of the water soluble residues on the PPMD was thought at that time to be Orbiter fluid waste dumps.

Figure 1.- STS 81 photograph of MEEP on Mir Docking Module.

Figure 2.- STS 86 photograph of brown spots on PPMD and handrail.

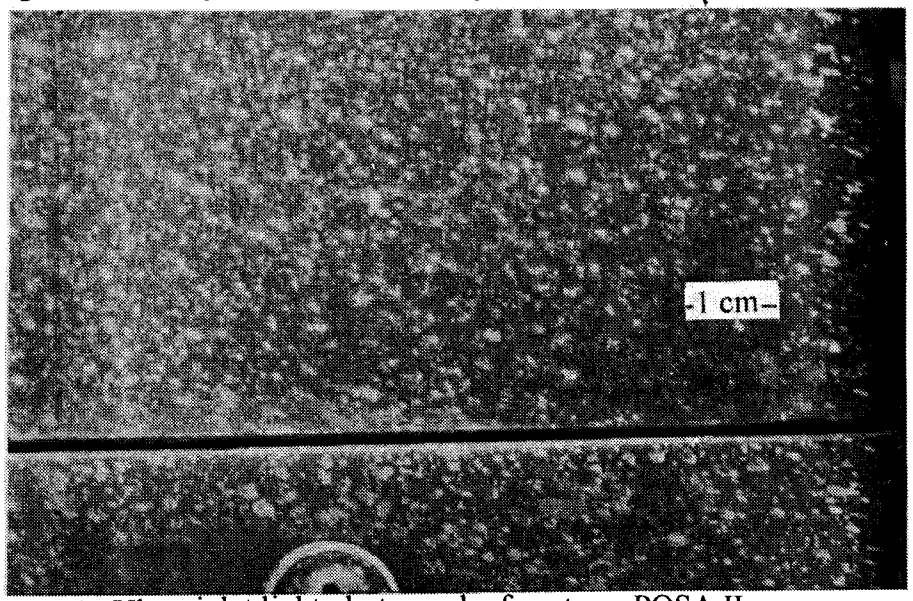
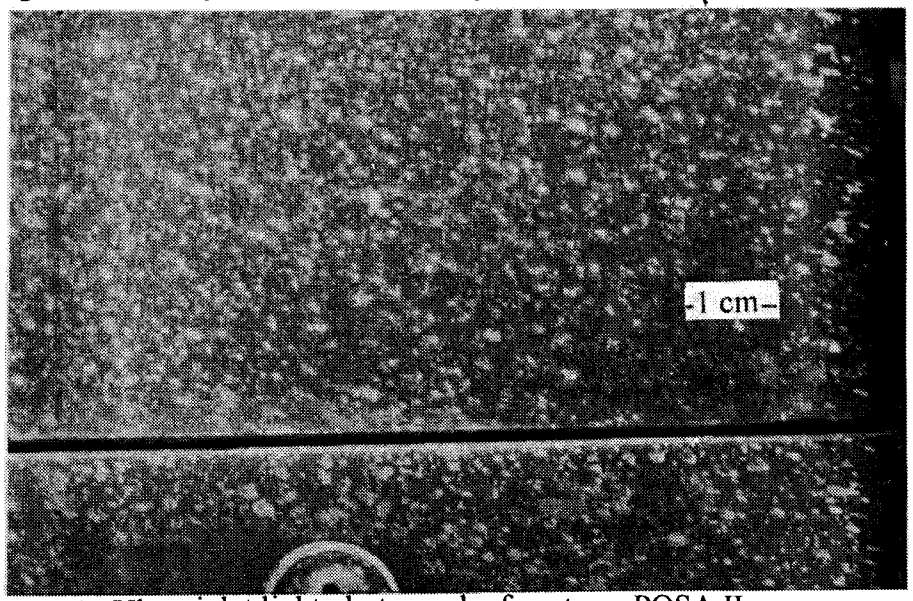
The residue deposits on the PPMD was in the form of circular spots, elongated spots, and streaks (Figure 3). Material scraped from spots on the front of the PPMD PEC dissolved in deionized water. The residue deposits on the POSA II PEC were in the form of circular spots on two sides of the PEC (Figure 4), and of streaks (Figure 5) on the bottom lips of the PEC.

Figure 4.- Ultraviolet light photograph of spots on POSA II.

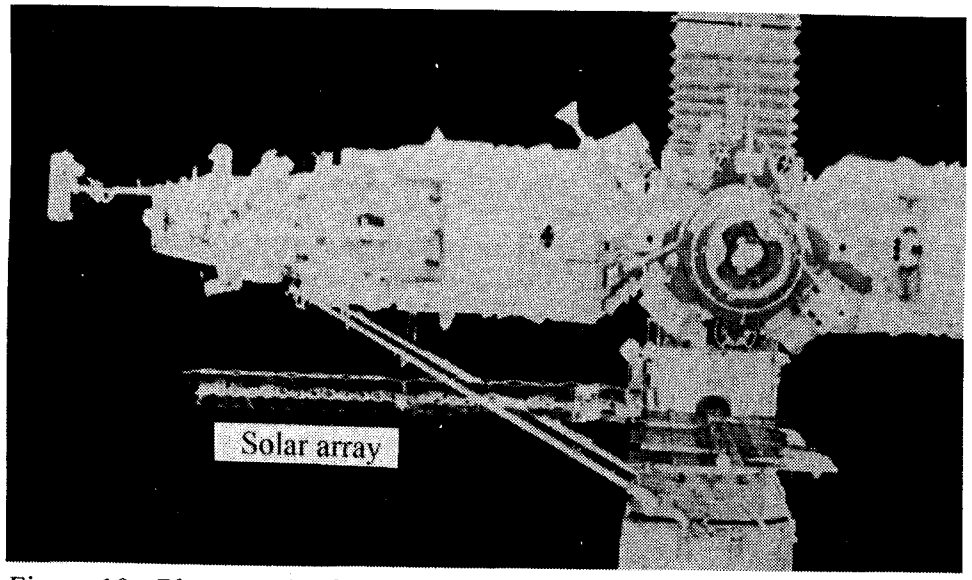
An on-orbit photograph of the solar array returned from MIR is shown in Figure 10. Figure 11 is a photograph of the returned solar array panel at the Spacehab facility in Florida. Each of the eight sections of the returned panel is 70 cm by 120 cm. Figure 12 is a head-on photograph of the lower half of section 1 of the returned panel. Most of the cells are 4.0 cm by 4.8 cm, however some of the solar cells along the edge of the end sections are 4.0 cm by 2.4 cm. Variability in hue or color of individual cells can be seen in this photograph. Most of the color differences seen in Figure 12 result from differences in reflected light from individual cover glasses, different hues of individual silicon wafer antireflection (AR)coatings, and creep of silicone polymer material from the edge of cells onto the cover glasses. This surface thin film of silicone polymer material was oxidized to silica by atomic oxygen. Figure 13 is a photograph taken with a flash illuminating the solar cells at a small angle of incidence. This photograph shows more backscatter of light along the edges of the cells than from the center of the cells, indicating that the backscatter is from the oxidized polymer that crept onto the cover glasses.

Figure 10.- Photograph of solar array on Mir.

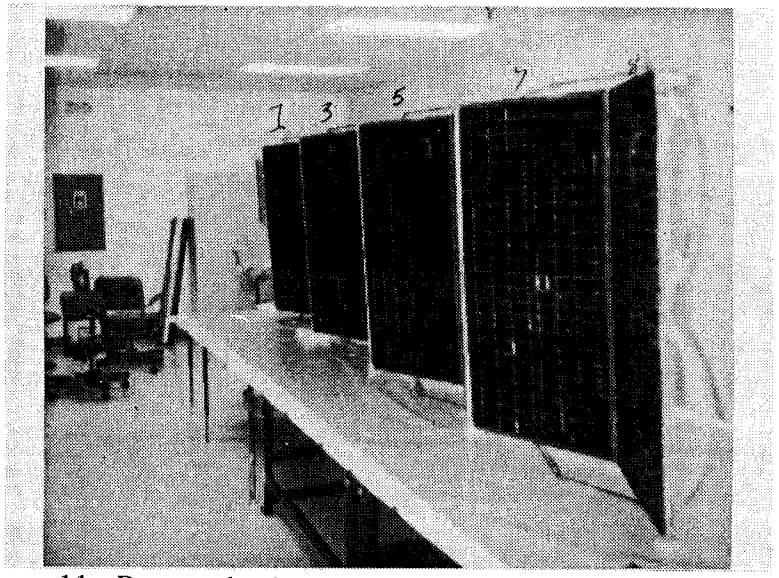
Large (greater than 1 cm diameter) and small (less than 1 mm diameter) thick brown spots were observed on the returned solar array. These water soluble residues consisted mostly of sulfur, sodium, and phosphorous, and could have originated from space craft module releases during the ten years of space exposure. Some of the residue films also contained fine particles. Many of the films are ring shaped, suggesting droplets or bubbles. This suggests venting of gases as a source of these residues. The cleanliness level of the returned array is about 2000 H, using Mil Standard 1246 C.

Figure 11.- Returned solar array in Spacehab facility.

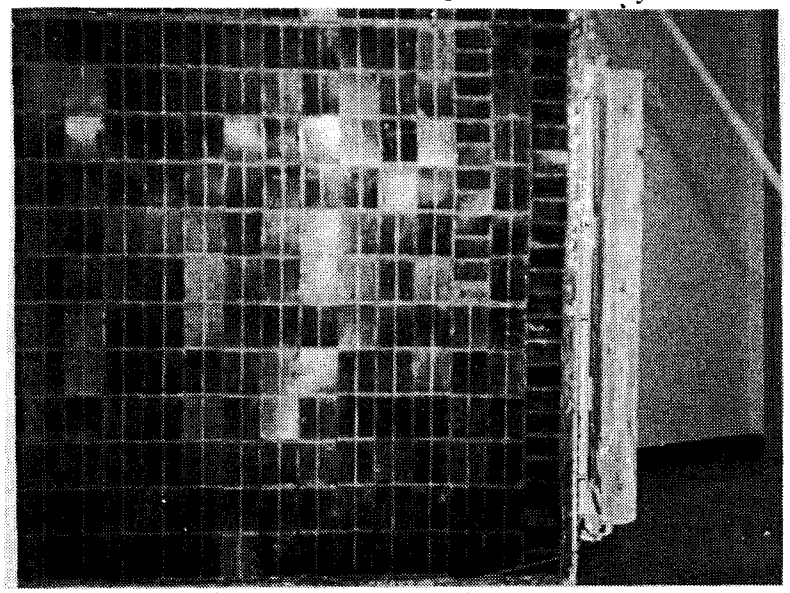
Figure 12.- Section 1 of returned solar panel.

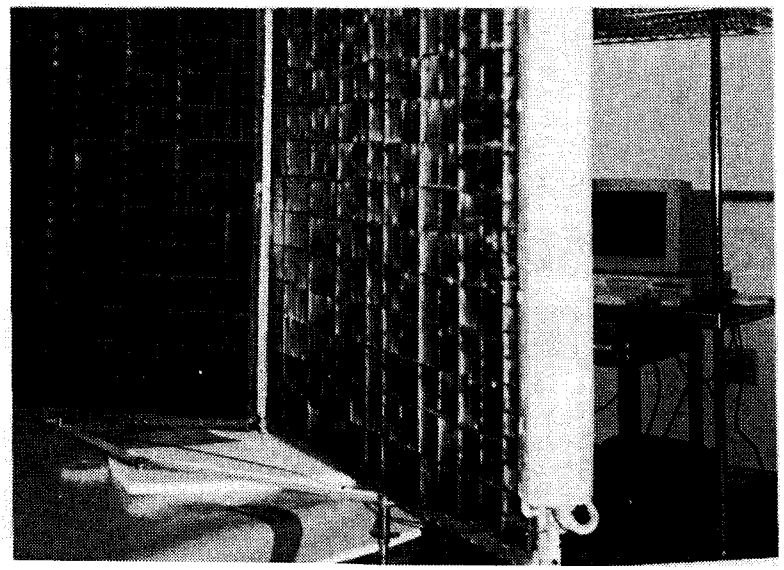
Figure 13.- Backscattered light from the edges of the solar cells.

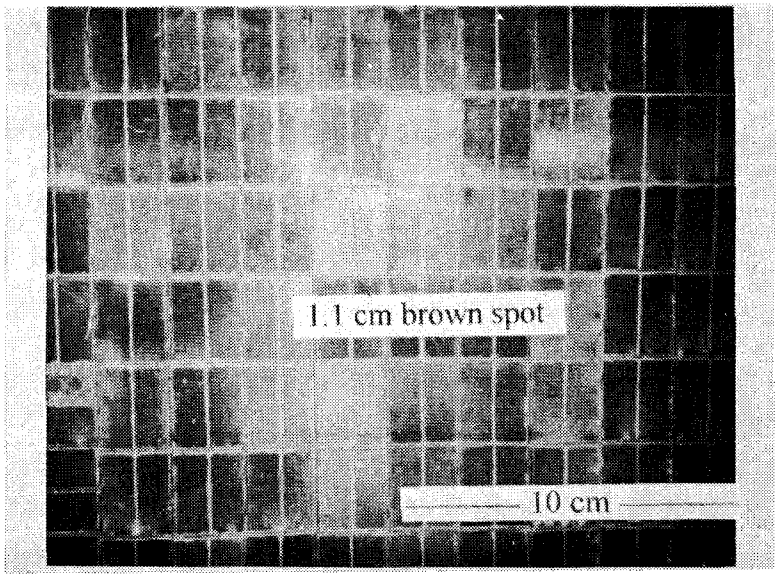
Four large (~ 1 cm diameter) thick brown spots were observed on sections 1, 2, 3, and 5 of the returned solar panel. Figure 14 shows the largest (1.1 cm diameter) of these spots (on section 1). Figure 15 is a SEM EDS of the spot residue. This residue (mostly sulfur, phosphorous, and sodium) chemically matches the water soluble residues on PPMD and POSA II.

Figure 14.- Photograph of 1.1 cm brown spot on panel 1.

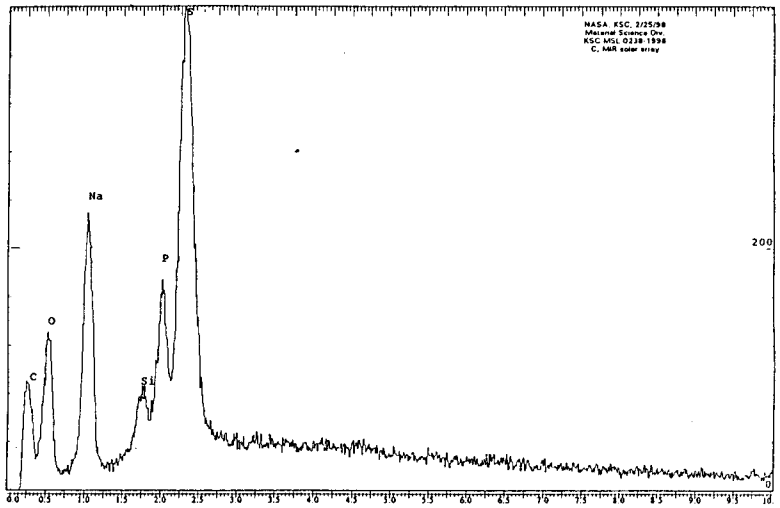
Figure 15.- EDS of 1.1 cm brown spot residue.

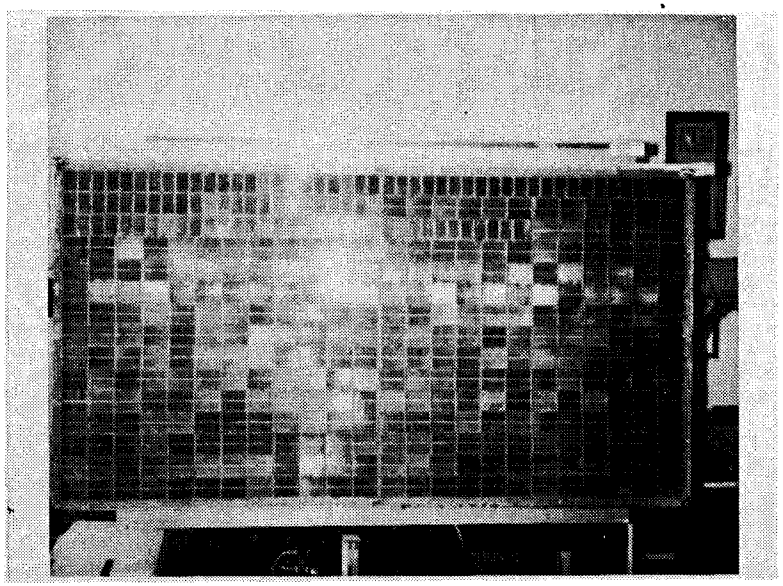
Section 8 (Figure 16) was removed from the solar panel and sent to Langley Research Center for microscopic examination and measurements of micrometeoroids and space debris impacts, and for cleanliness evaluation and contamination analyses. Section 8 was first examined visually with a six power comparitor (magnifying glass) and hand held illumination at oblique angles. About 95% of the solar cells have visible white backscatter on at least one edge of the cover glass. The white backscatter is mostly due to creep of the polymer potting between adjacent

solar cells onto the cover glasses, and from fine spray ejecta from discharges within the potting material. Amber and black particles are ejected from many of the discharge sites in addition to the fine spray (which is dark under normal [90°] illumination). However, many of the darker cells result from a darker silicon wafer within the cell rather than a coating or film on the cover glass. The brightness of the cells near the center of Figure 16 is an artifact of reflected light from the camera's flash.

Figure 16.- Photograph of section 8 of returned solar panel.

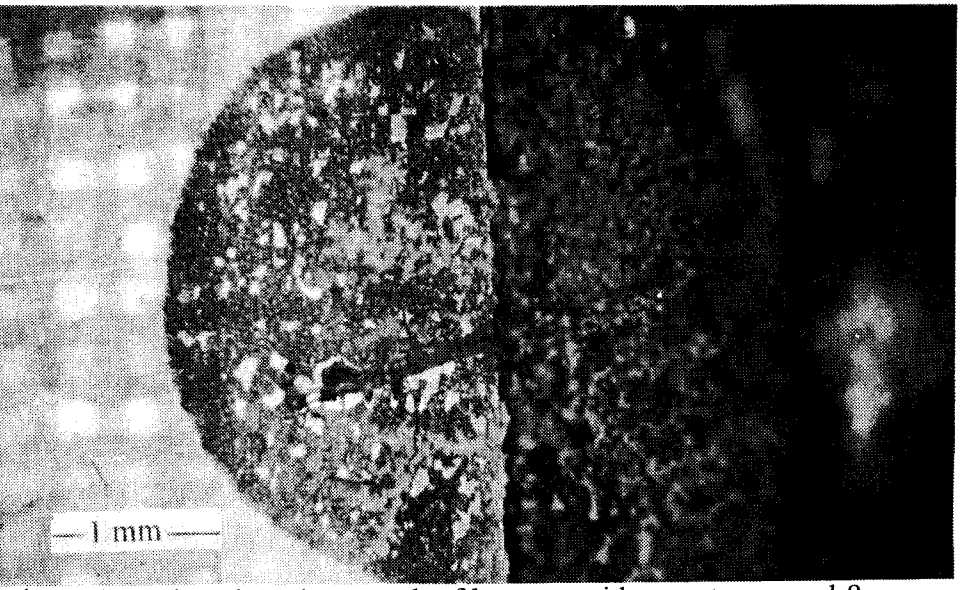
Forty-seven brown residue spots of 0.2 mm to 3.5 mm diameter were located on section 8. Two of these residue spots are shown in Figures 17 and 18. An EDS spectrum of the residue spot in Figure 17 is presented as Figure 19. This residue consists mostly of sodium, sulfur, and phosphorus.

The EDS (figure 20) of spot in Figure 18 shows only cadmium and potassium. The source of the cadmium and potassium is unknown.

Figure 17.- 50x microphotograph of largest residue spot on panel 8.

Figure 18.- 50x microphotograph of cadmium residue on cell 8-14-22.

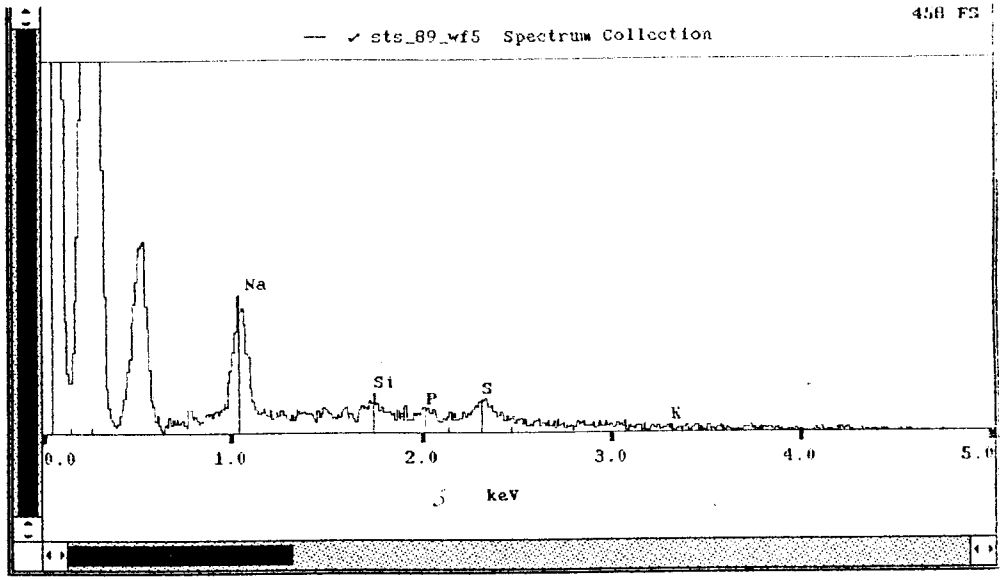
Figure 19.- EDS of largest residue spot on panel 8.

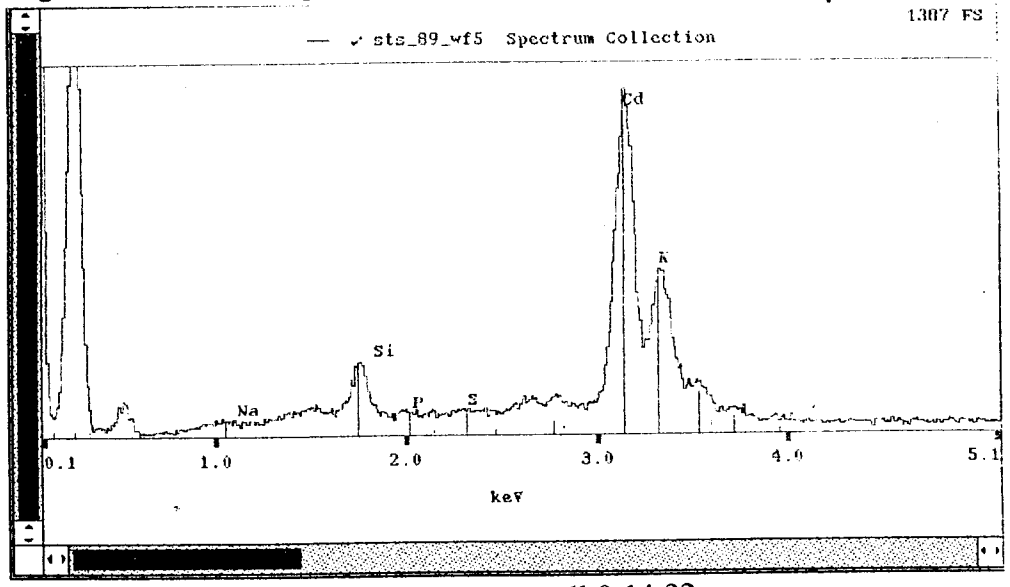
Figure 20.- EDS of cadmium residue on cell 8-14-22.

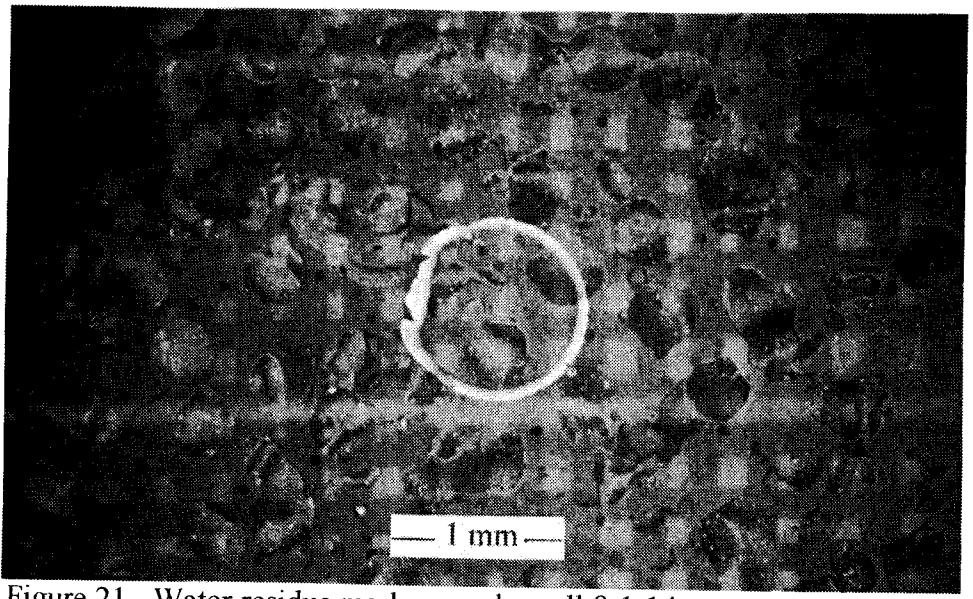
Figure 21.- Water residue marks on solar cell 8-1-14.

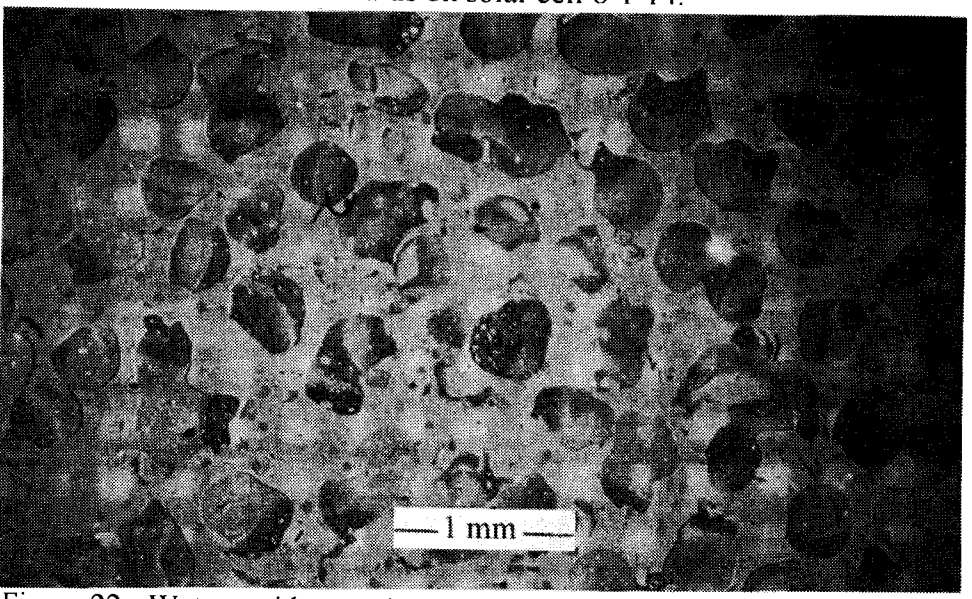
Figure 22.- Water residue marks on solar cell 8-1-14.

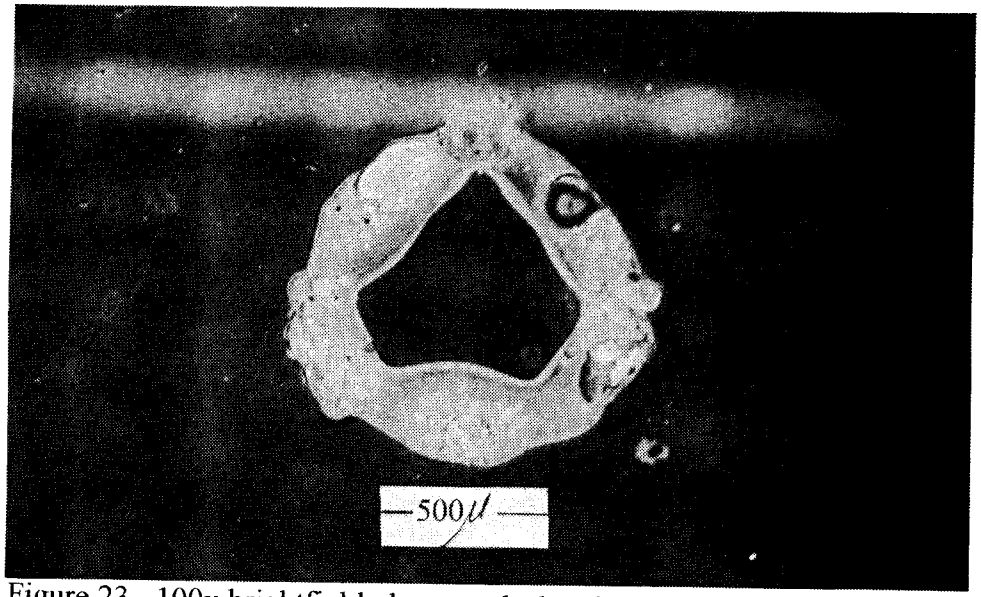
Additional thin transparent films of several types are shown in Figures 23 and 24. Some of these thin films or water marks have lots of very fine particles (similar to airborne dust) which are visible with darkfield illumination, intrapped in the thin molecular film and some of the films have little or no trapped dust. Many of the thin films are circular or ring shaped, suggesting droplets or bubbles. Most of the thin films are irregular in shape, possibly indicating pronounced wetting by an incident droplet. The thin film color shifts or enhancements due to deposition of molecular material on the cover glasses is similar to the color shifts due to erosion of optical-coated thin-films reported in reference 1.

Figure 23.- 100x brightfield photograph showing variable thickness residue.

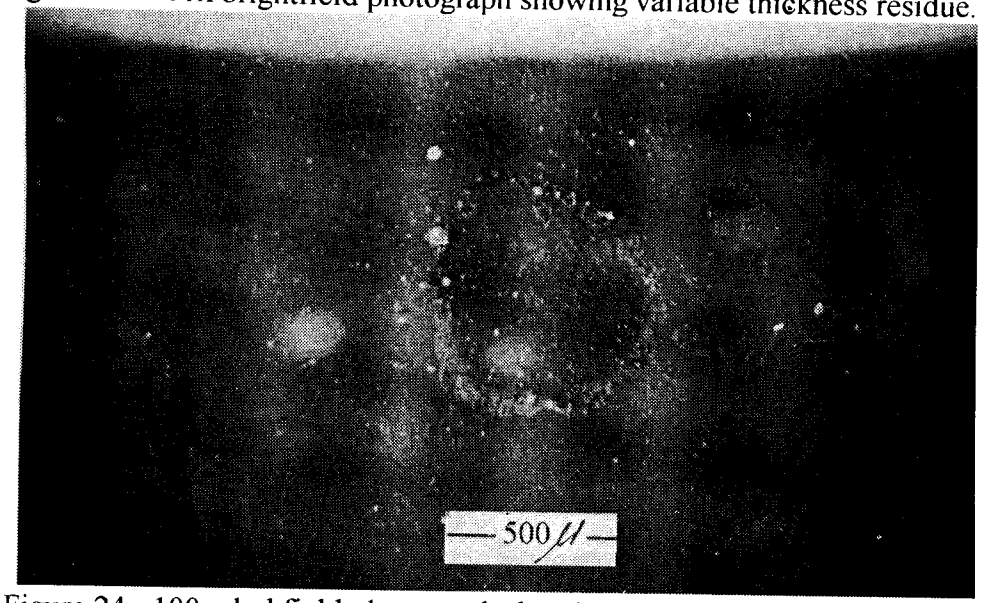
Figure 24.- 100x darkfield photograph showing many fine particles.
