# FAILURE ANALYSIS OF A HELICOPTER EXTERNAL FUEL-TANK PYLON

**Abstract:** An eight-inch-long (0.2 m) crack was found in an external helicopter fuel-tank pylon. The damaged pylon was removed from service and analyzed at NASA Langley Research Center to determine the cause of the crack. Results of the analysis revealed that crack initiation occurred at corrosion pits in a fastener hole and crack propagation was a result of fatigue loading.

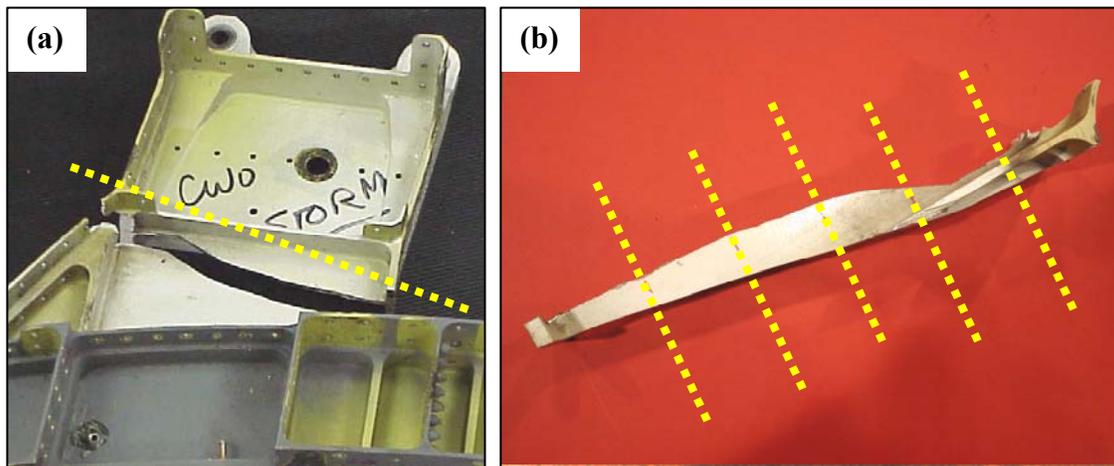
factor ( $K_I$ ) is at its maximum value and the mode II stress intensity factor ( $K_{II}$ ) is zero.<sup>17</sup> This stiffener likely diverted the crack from principal stress directions, resulting in mixed-mode crack-tip loading (*i.e.* both  $K_I$  and  $K_{II}$  are non-zero) and a reduction in  $K_I$ , the crack driving force. Crack arrest was likely a result of a reduction in crack driving force and crack-face contact due to mode II (sliding-mode) displacements further reducing the fatigue crack driving force.<sup>18, 19</sup> The crack surface corrosion product in Figure 5 were likely produced by sliding-mode contact of rough crack surfaces.

**Figure 5** – A photograph of the crack surface as the crack propagated into the vertical stiffener is shown.
