# TECHNICAL NOTE

D-535

DAMAGE INCURRED ON A TILT-WING MULTIPROPELLER  
VTOL/STOL AIRCRAFT OPERATING OVER A  
LEVEL, GRAVEL-COVERED SURFACE

By Robert J. Pegg

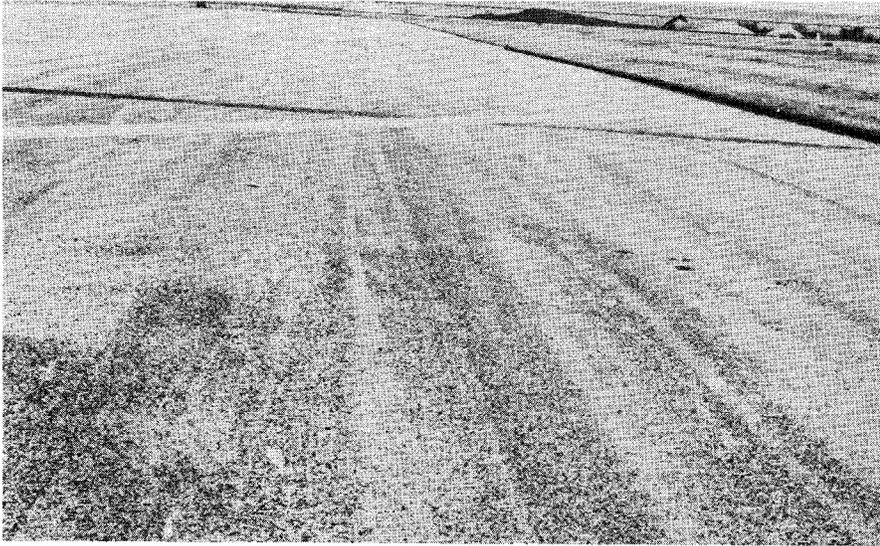
Figure 3 shows a general view of the 900-foot eastern overrun of a runway at Langley Air Force Base. Figure 4 shows the area over which the aircraft rolled and where the gravel concentration was the highest. This surface, as is shown in the closeup of figure 5, is macadam covered with a variety of loose and embedded crushed stone. This area of loose stone was approximately 600 square feet and  $1/2$  inch deep. Approximately 70 percent of the stones were  $1/8$  inch to  $1/2$  inch in diameter, and approximately 30 percent were  $1/2$  inch in diameter or larger.

Figure 3.- General view of overrun area. L-59-8143
