NASA Technical Memorandum 110331  
U. S. Army Research Laboratory Technical Report 1342

# Fatigue Debonding Characterization in Composite Skin/Stringer Configurations

**ABSTRACT:** The objective of this work was to investigate the fatigue damage mechanisms and to identify the influence of skin stacking sequence in carbon epoxy composite bonded skin/stringer constructions. A simple 4-point-bending test fixture originally designed for previously performed monotonic tests was used to evaluate the fatigue debonding mechanisms between the skin and the bonded frame when the dominant loading in the skin is flexure along the edge of the frame. The specimens consisted of a tapered flange, representing the stringer, bonded onto a skin. Based on the results of previous monotonic tests two different skin lay-ups in combination with one flange lay-up were investigated. The tests were performed at load levels corresponding to 40%, 50%, 60%, 70% and 80% of the monotonic fracture loads. Microscopic investigations of the specimen edges were used to document the onset of matrix cracking and delamination, and subsequent fatigue delamination growth. Typical damage patterns for both specimen configur

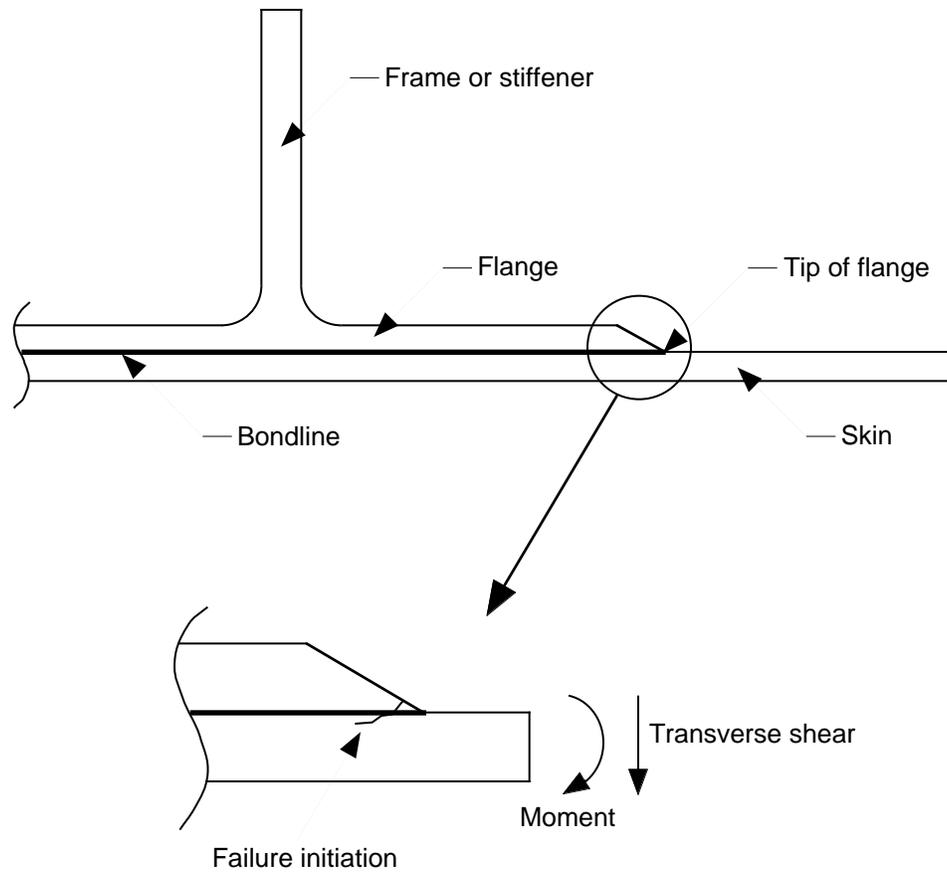
Fig. 1—Illustration of frame/skin interface.

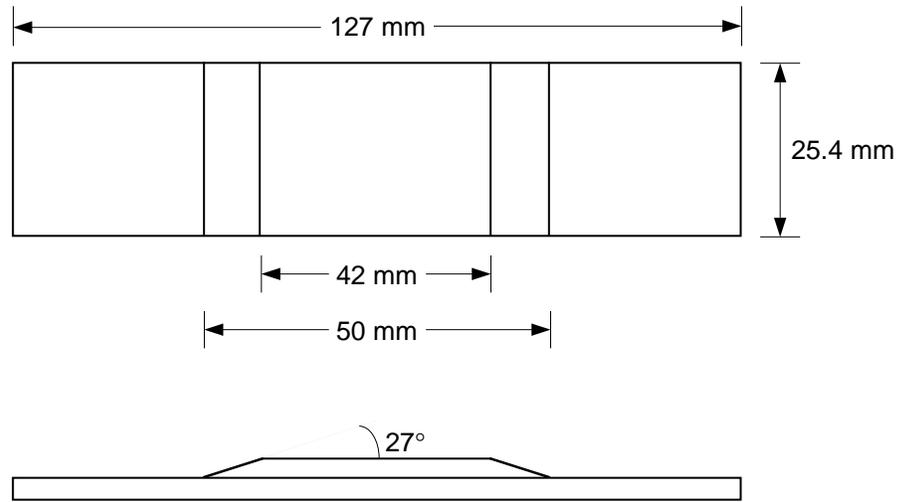
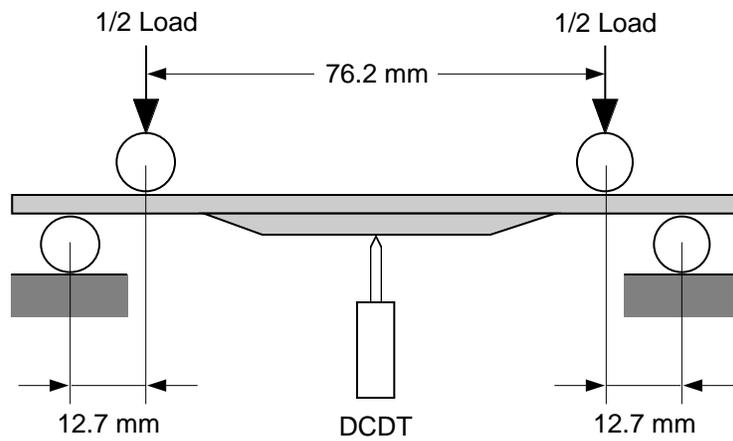
a) Specimen configuration

b) Test set-up

Fig. 2—Four-point bending specimen configuration and test set-up.

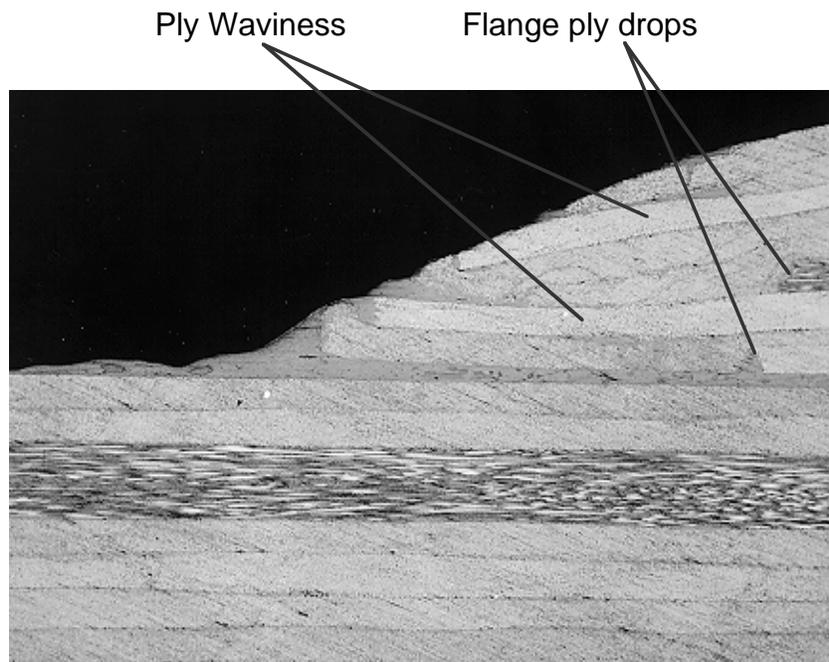
Fig. 3—Side view of a specimen of configuration D showing ply waviness and flange ply drops.

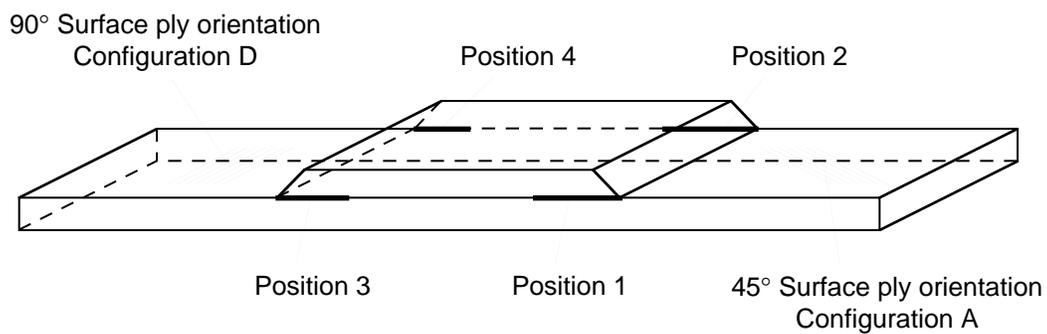
Fig. 4—Four-point bending specimen with crack locations and surface ply orientations.

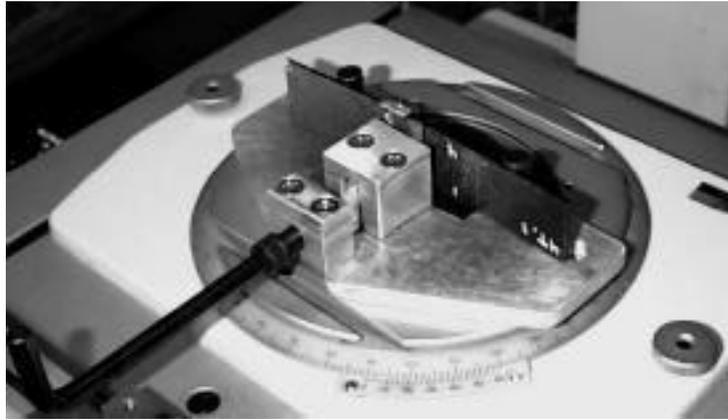
Fig. 5—Three-point bend rig with specimen in place.

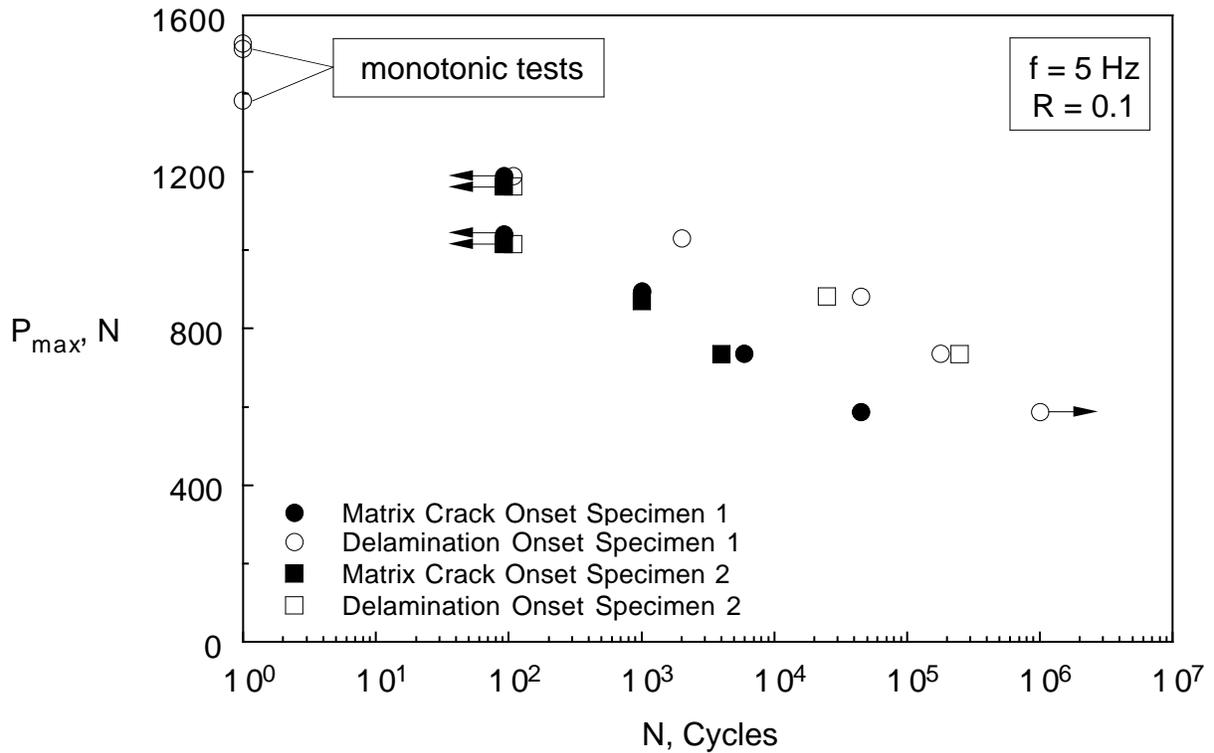
Fig. 6—Maximum cyclic load as a function of the number of cycles to matrix cracking and subsequent delamination onset for configuration A.

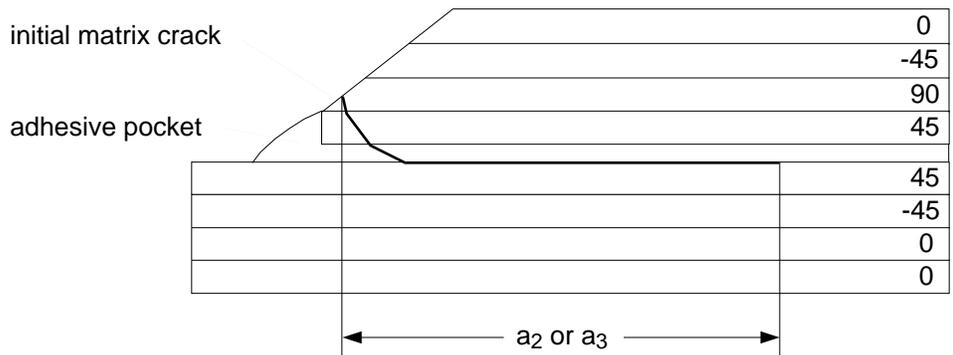
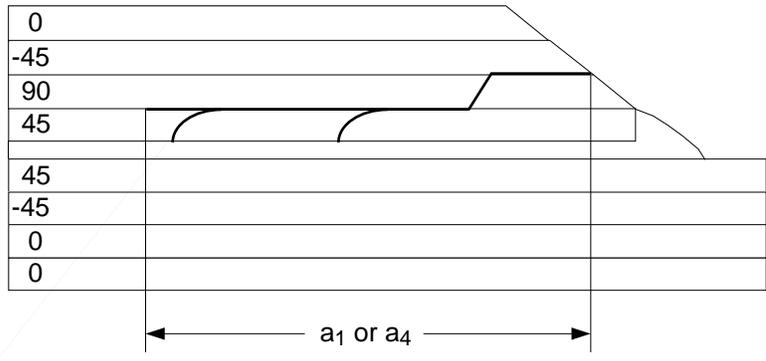
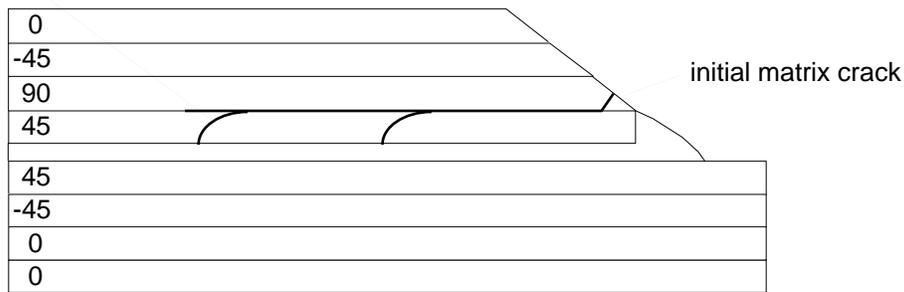
a) "B"-delaminations: positions 2 and 3

matrix crack branch

b) "P"-delaminations: positions 1 and 4

Fig. 7—Typical damage patterns in specimens of configuration A.

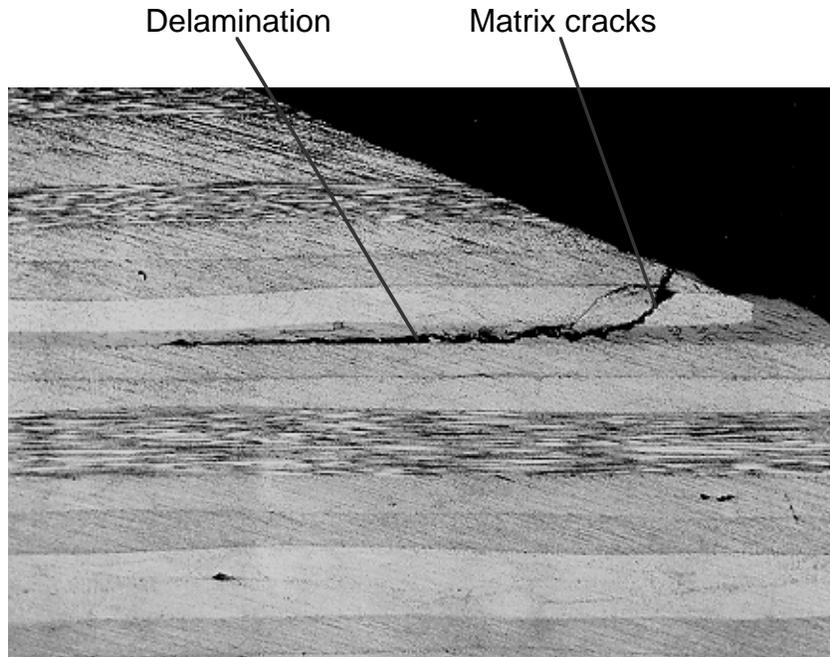
Fig. 8—Side view of a failed specimen of configuration A at a load level of 80% of  $P_{nl}$  showing a type "B" delamination between skin and flange at the bondline at corner 2.

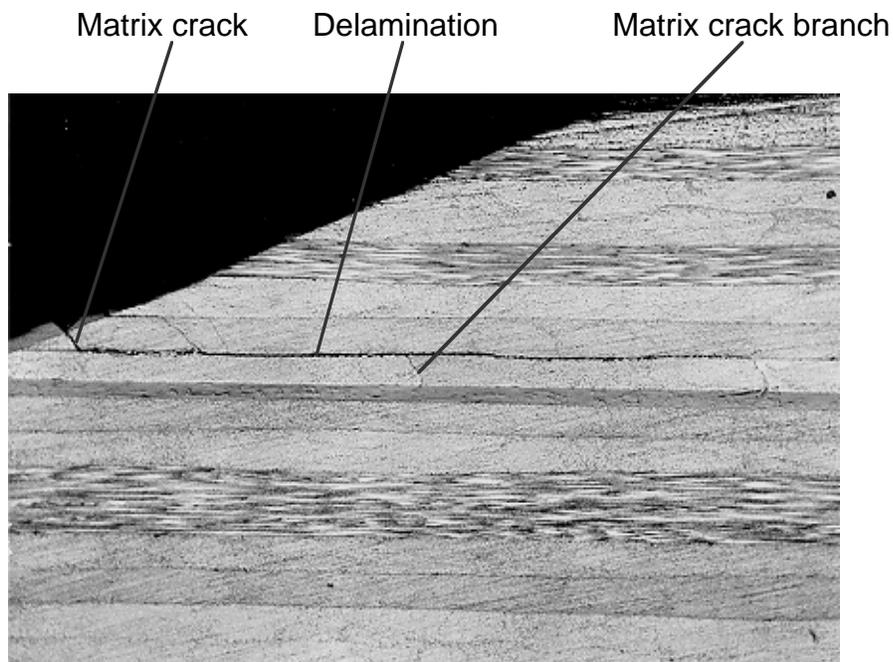
Fig. 9—Side view of a failed specimen of configuration A at a load level of 80% of  $P_{nl}$  showing a type "P" delamination in the 90°/45° flange interface at corner 4.

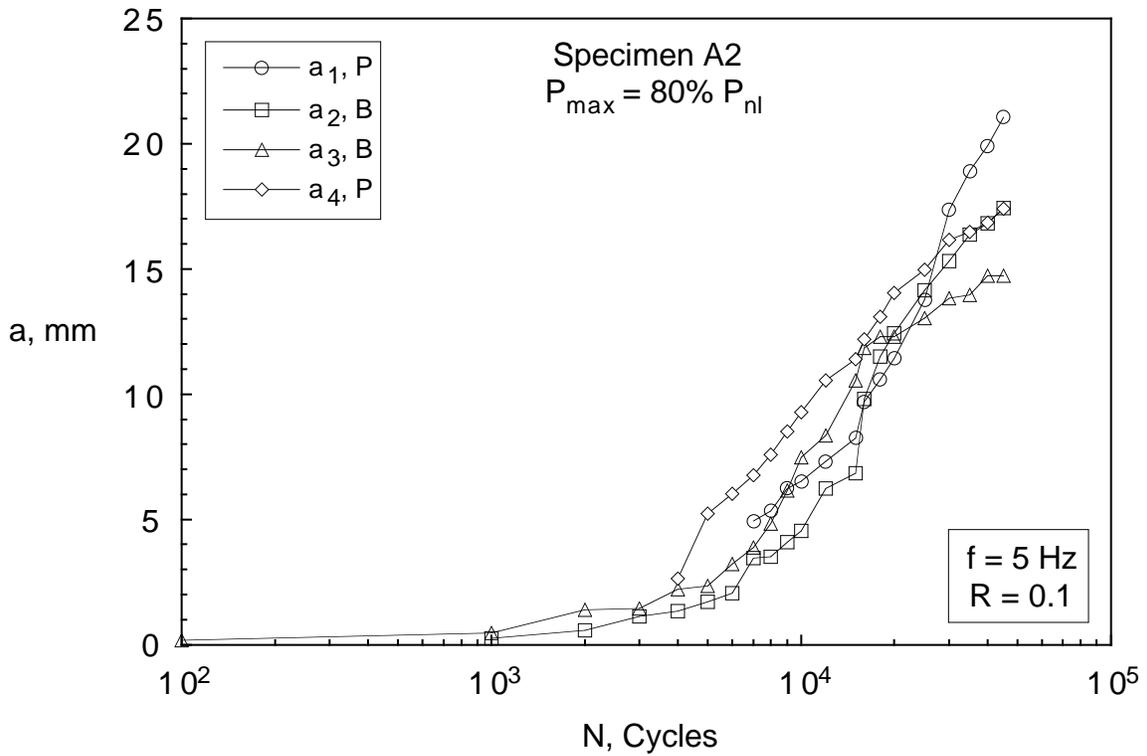
Fig. 10—Delamination length versus number of cycles for specimen A2 at 80% of  $P_{nl}$ .

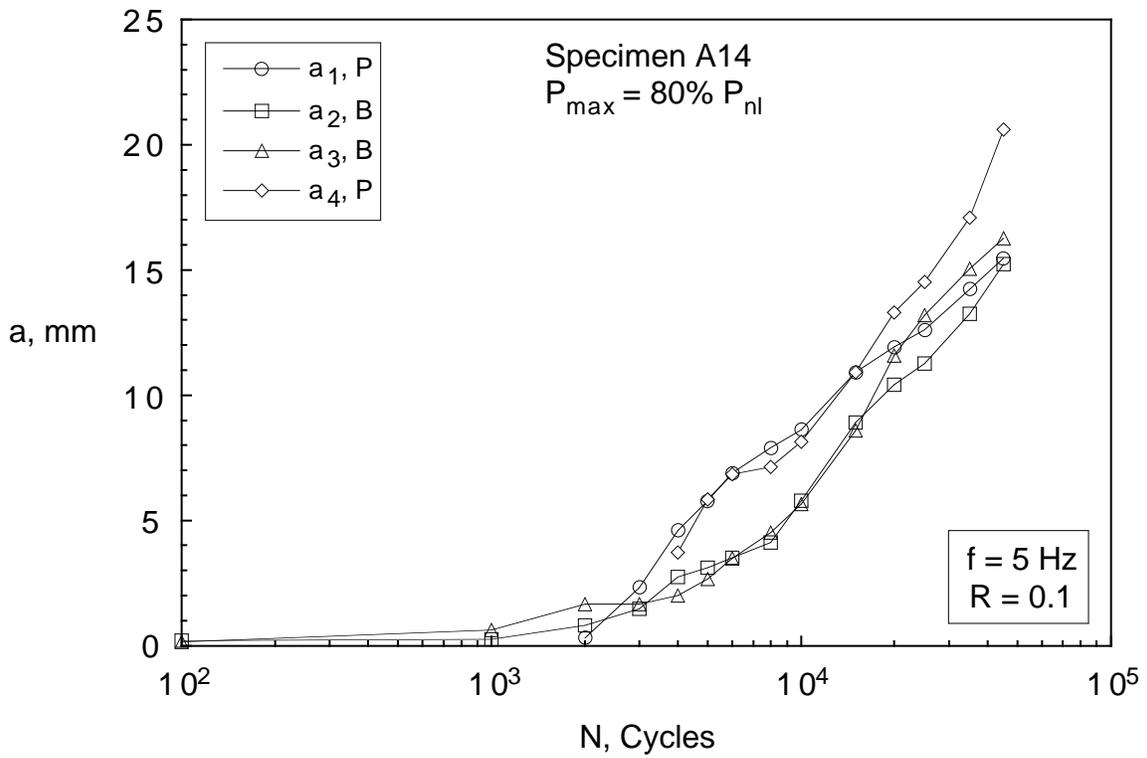
Fig. 11—Delamination length versus number of cycles for specimen A14 at 80% of  $P_{nl}$ .

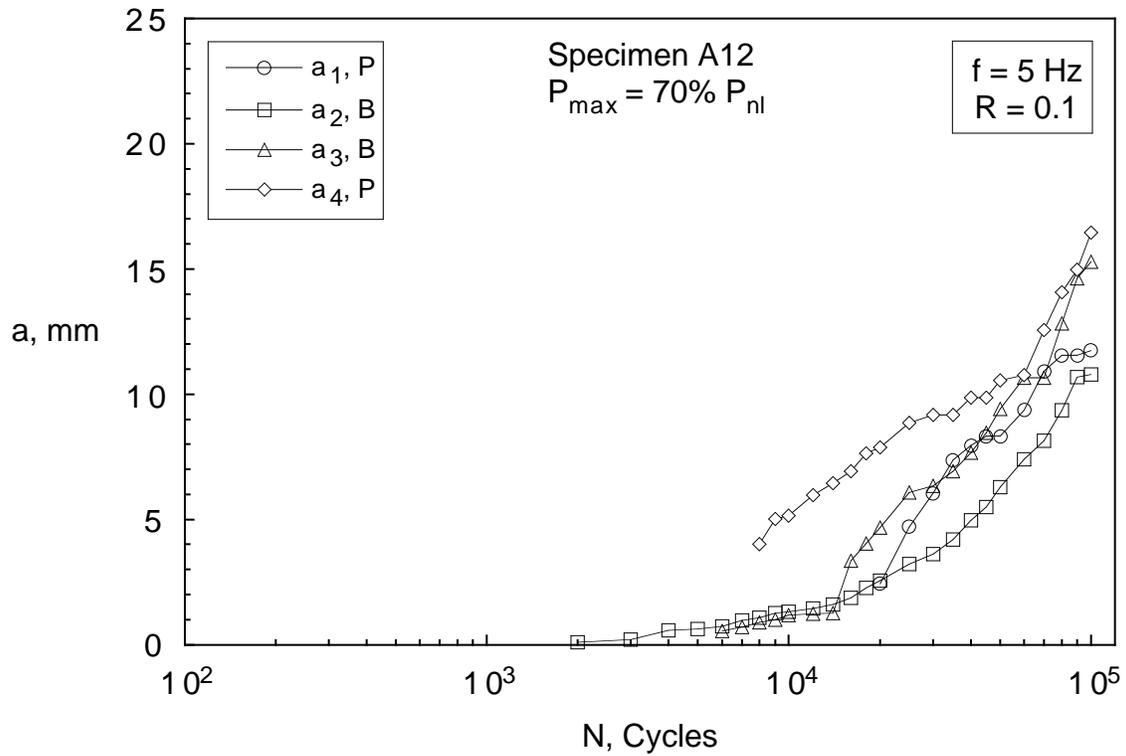
Fig. 12—Delamination length versus number of cycles for specimen A12 at 70% of  $P_{nl}$ .

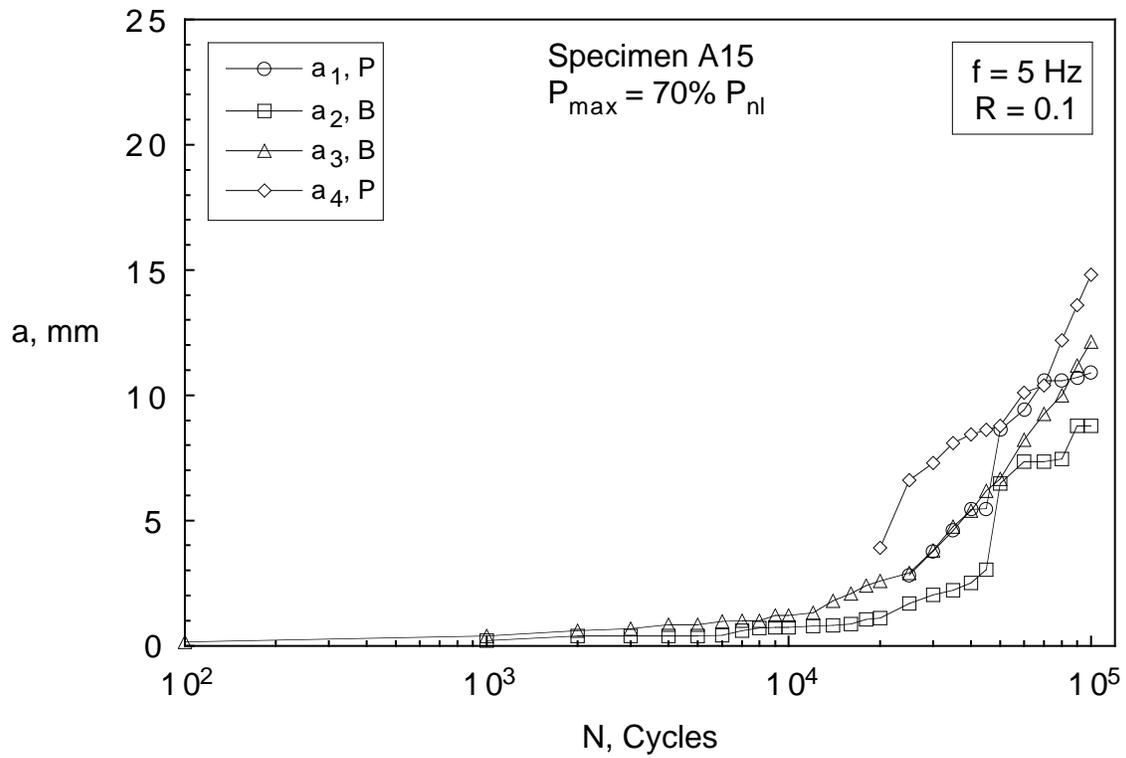
Fig. 13—Delamination length versus number of cycles for specimen A15 at 70% of  $P_{nl}$ .

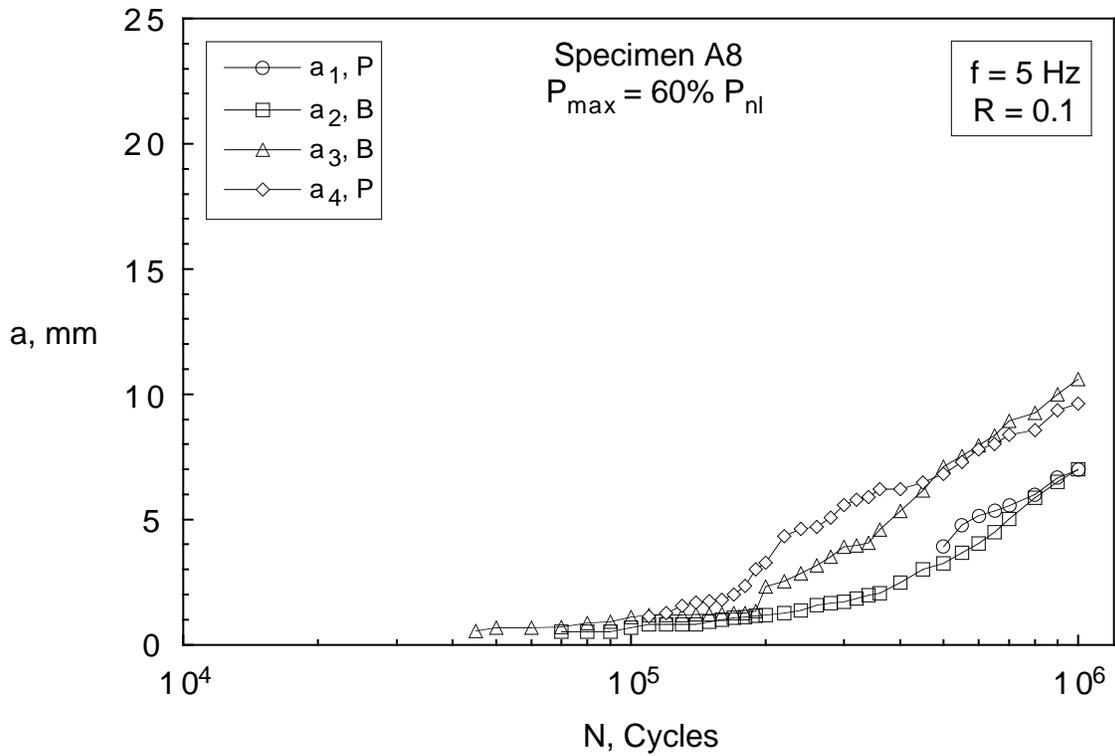
Fig. 14—Delamination length versus number of cycles for specimen A8 at 60% of  $P_{nl}$ .

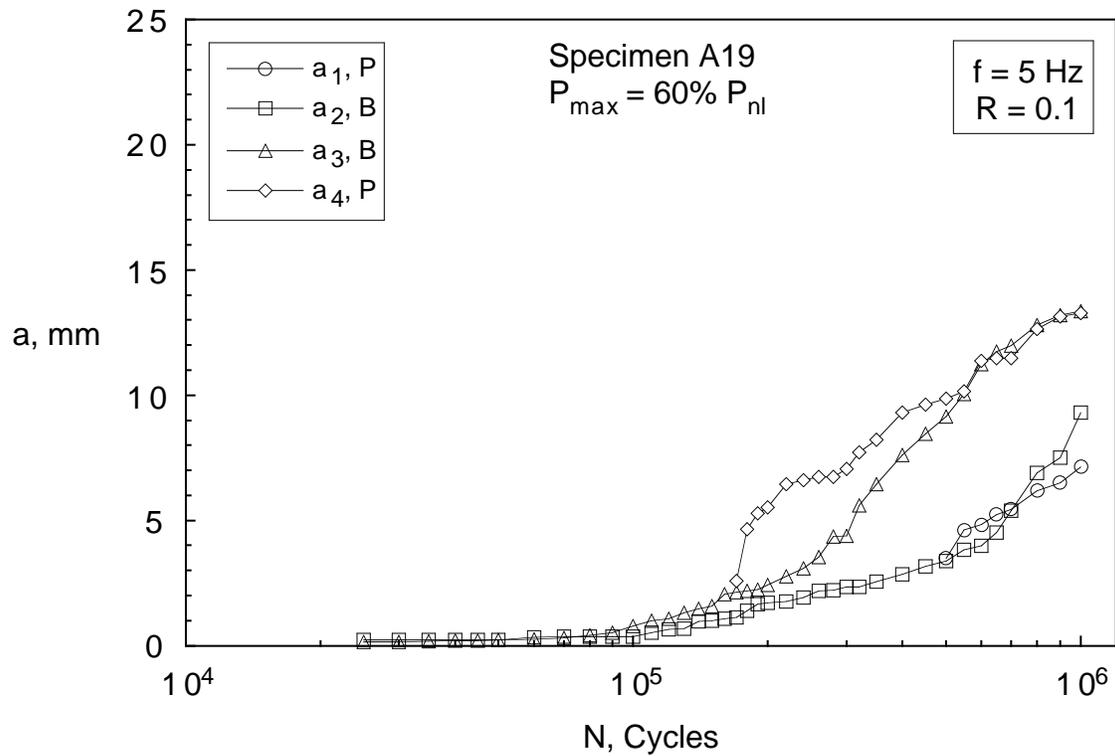
Fig. 15—Delamination length versus number of cycles for specimen A19 at 60% of  $P_{nl}$ .

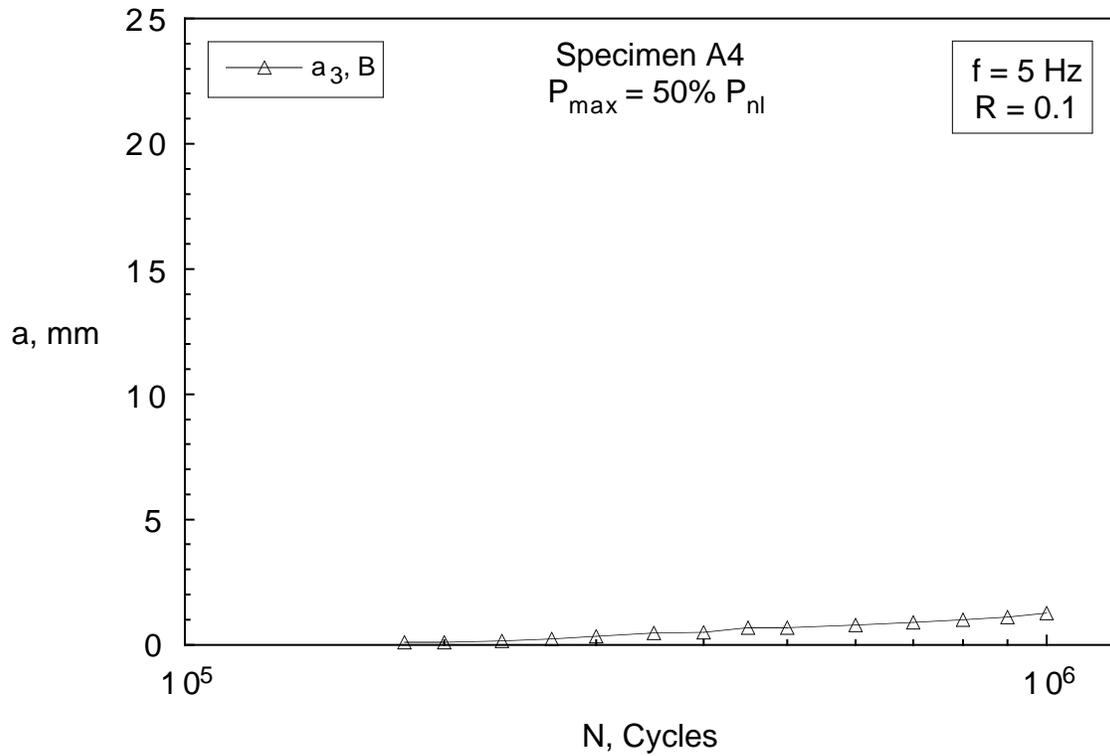
Fig. 16—Delamination length versus number of cycles for specimen A4 at 50% of  $P_{nl}$ .

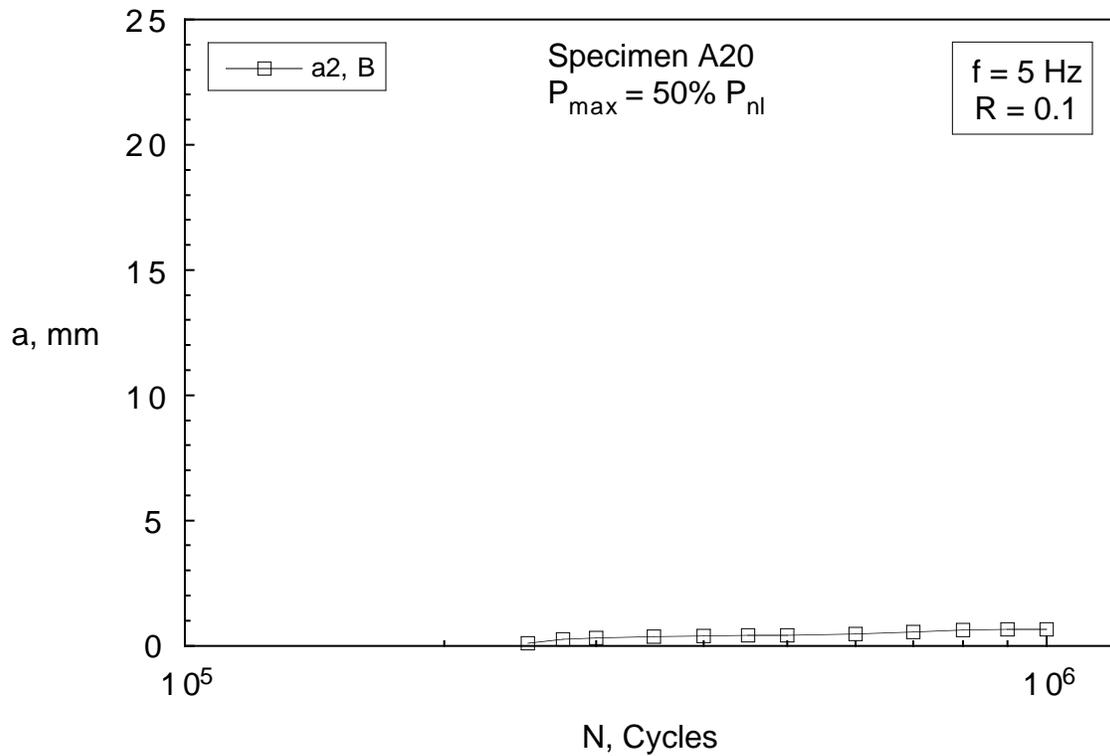
Fig. 17—Delamination length versus number of cycles for specimen A20 at 50% of  $P_{nl}$ .

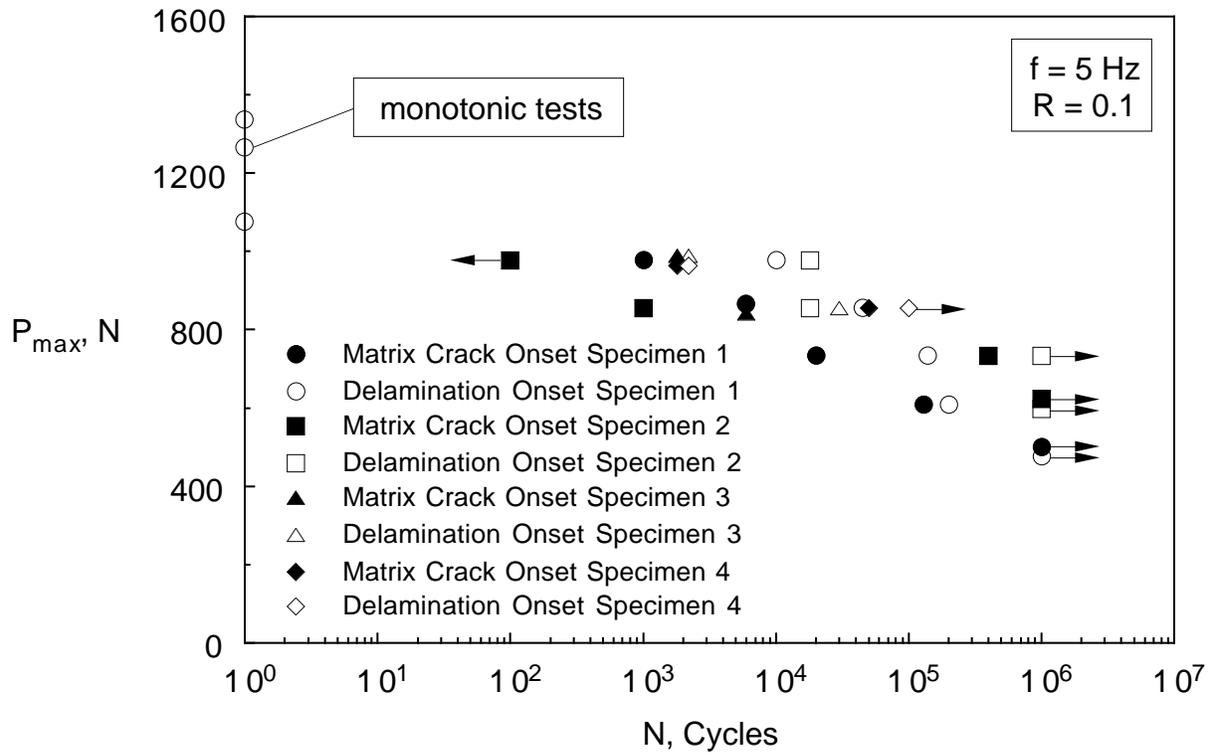
Fig. 18—Maximum cyclic load as a function of the number of cycles to matrix cracking and subsequent delamination onset for configuration D.

In Fig. 18, results of configuration D are summarized as a plot of the number of cycles to the onset of matrix cracking and subsequent delamination. At a load level of 80%, a left hand arrow indicates matrix cracking within the first 100 cycles. At other load levels, a right hand arrow shows that no delaminations or matrix cracks occurred within the test period of either 100 000 or 1 000 000 cycles. The loads at onset of damage obtained from the monotonic tests are shown at the ordinate. These data points represent a load level of 100% of  $P_{nl}$ . In contrast to configuration A, no clear differentiation between matrix cracking and delamination onset is seen as the scatter for each event is significantly higher. Hence, the data overlap and no delay between those two events is apparent. The data scatter and the random manner of delamination growth also reflects the higher scatter compared to configuration A observed in monotonic tests. At the investigated load levels, the presence of an imperfection in the form of a flange ply drop does not seem to have any influence on either event. This is shown in Fig. 19, where the data from Fig. 18 are replotted for onset to matrix cracking only to discriminate between ideal specimens and specimens with flange ply drop. In one of the two specimens tested at 50% and at 40%, both matrix cracking and delamination formation could not be observed within the test duration.

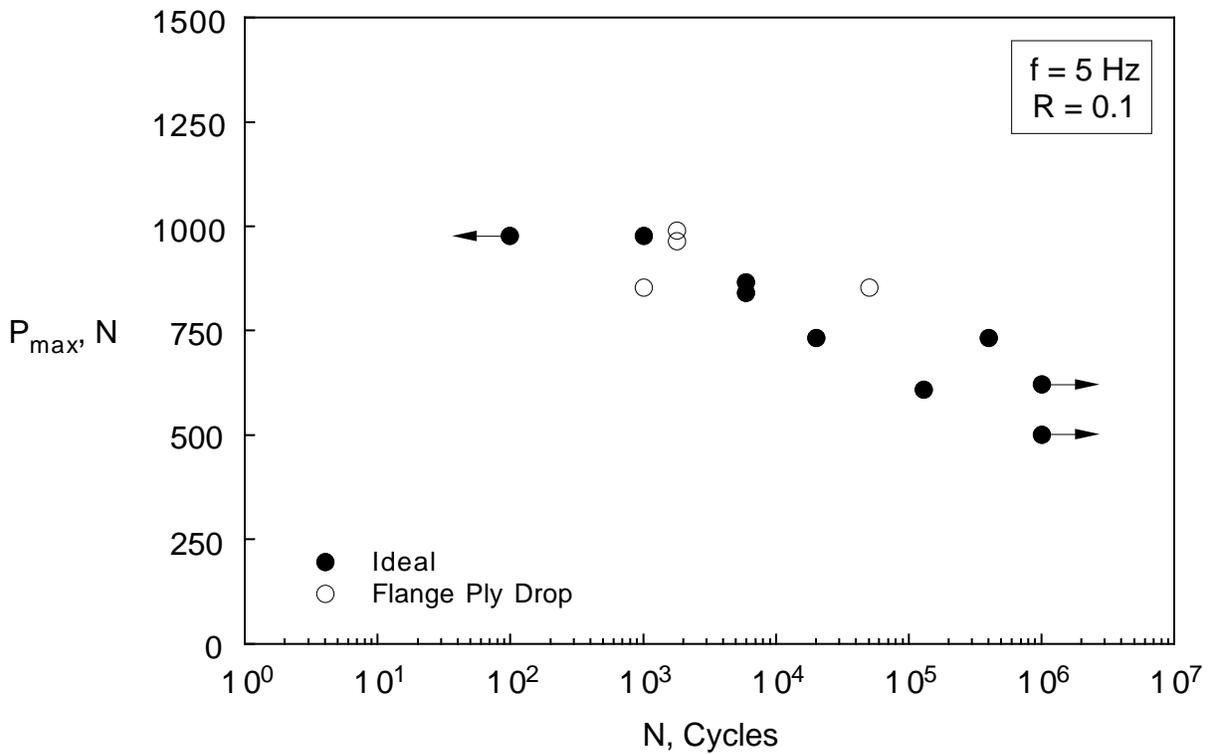
Fig. 19—Maximum cyclic load as a function of the number of cycles to matrix cracking onset for configuration D.

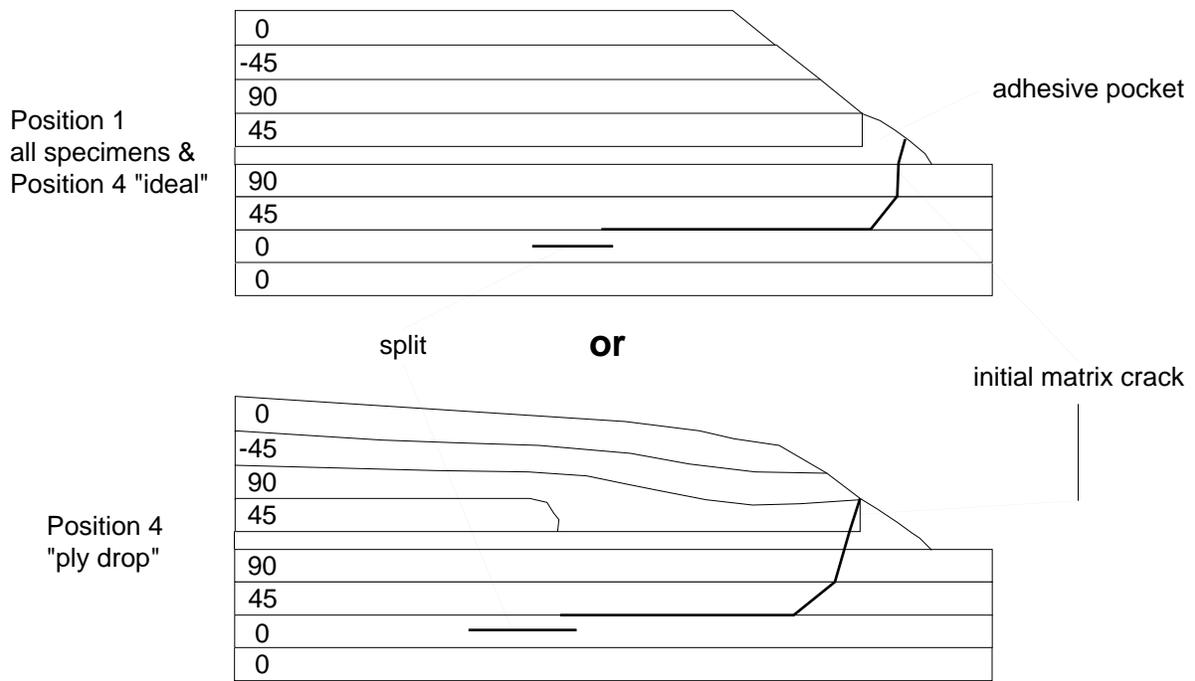
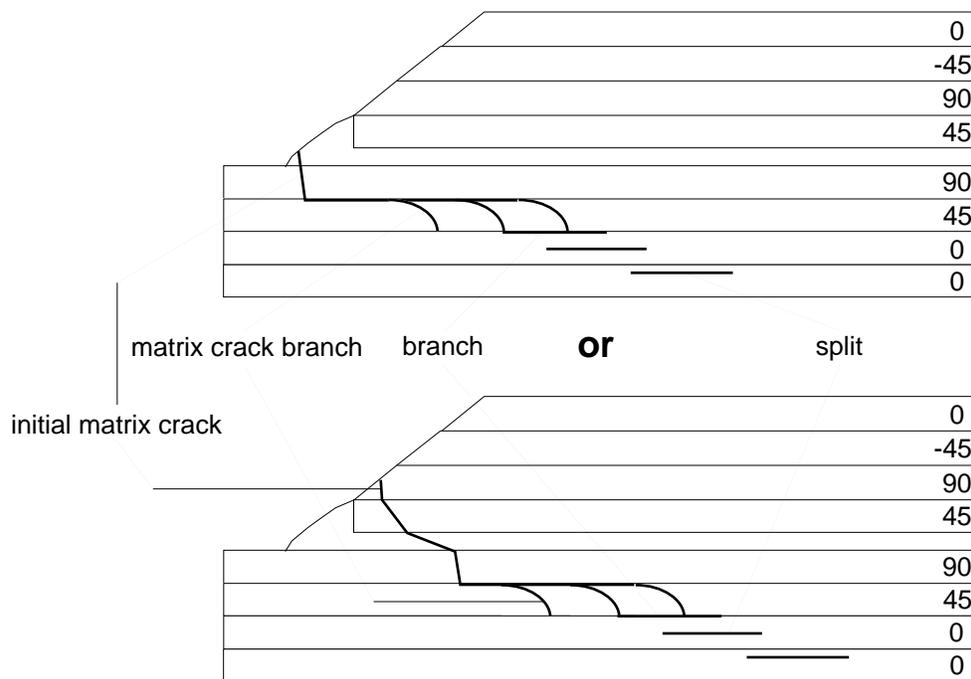
a) Positions 1 and 4

b) Positions 2 and 3

Fig. 20—Typical damage patterns in specimens of configuration D.

Unlike the previous specimen configuration A that was tested, delaminations in specimens of configuration D propagated in a more random manner. The only consistency found in the damage patterns is related to the four flange corners (see drawings in Fig. 20).

Transverse matrix cracks typically formed in the 90° skin ply closest to the flange at corner 1 in all specimens and at corner 4 in specimens with no flange ply drop ("ideal") (see top section of Fig. 20a)). Subsequently, these 90° skin ply cracks initiated matrix cracks in the 45° ply below, which in turn initiated delaminations in the 45°/0° interface. Once the delamination started to grow, the adhesive pocket also cracked. However, in the specimens with internal ply drops on one flange side (see Fig. 3 and bottom section of Fig. 20a)), matrix cracks at corner 4 formed first in the ply drop region of the bottom 45° or 90° flange ply and in the bondline and then initiated further matrix cracks and delaminations as described above. The majority of these delaminations stayed in the 45°/0° interface. In some specimens, however, those delaminations started to split into the two 0° plies at longer crack lengths. These events are labeled "split" in Fig. 20.

At corners 2 and 3, no consistent correlation between the flange imperfections and the damage patterns was observed. Typically, some transverse matrix cracks formed in the 90° skin ply closest to the flange, initiating a delamination in the 90°/45° interface as depicted in the top section of Fig. 20b). The other matrix cracks formed either in the flange ply drop region (not shown) or in the 90° flange ply closest to the skin, initiating further matrix cracks in the bottom 45° flange ply shown in the bottom section of Fig. 20b). Subsequently, a short delamination formed in the bondline, creating another matrix crack in the 90° top skin ply. At the end of this transverse crack a delamination formed in the 90°/45° interface. At this point, all delaminations started to grow in a similar manner. As they propagated, they would tend to arrest and form new matrix cracks branching into the top 45° skin ply. These matrix cracks always stopped at the 45°/0° interface. After the matrix crack had formed the delamination would start to grow again. However, delamination arrest was not related to any position within the laminate. As the delaminations grew further, they started to branch into the lower 45°/0° interface (labeled "branch" in Fig. 20), along with subsequent crack splitting into the two 0° plies. Branching and splitting were either detected within the same observation cycle or occurred within a few thousand cycles of each other. As an example, micrographs of a specimen tested at 80% of  $P_{nl}$  display typical damage patterns in

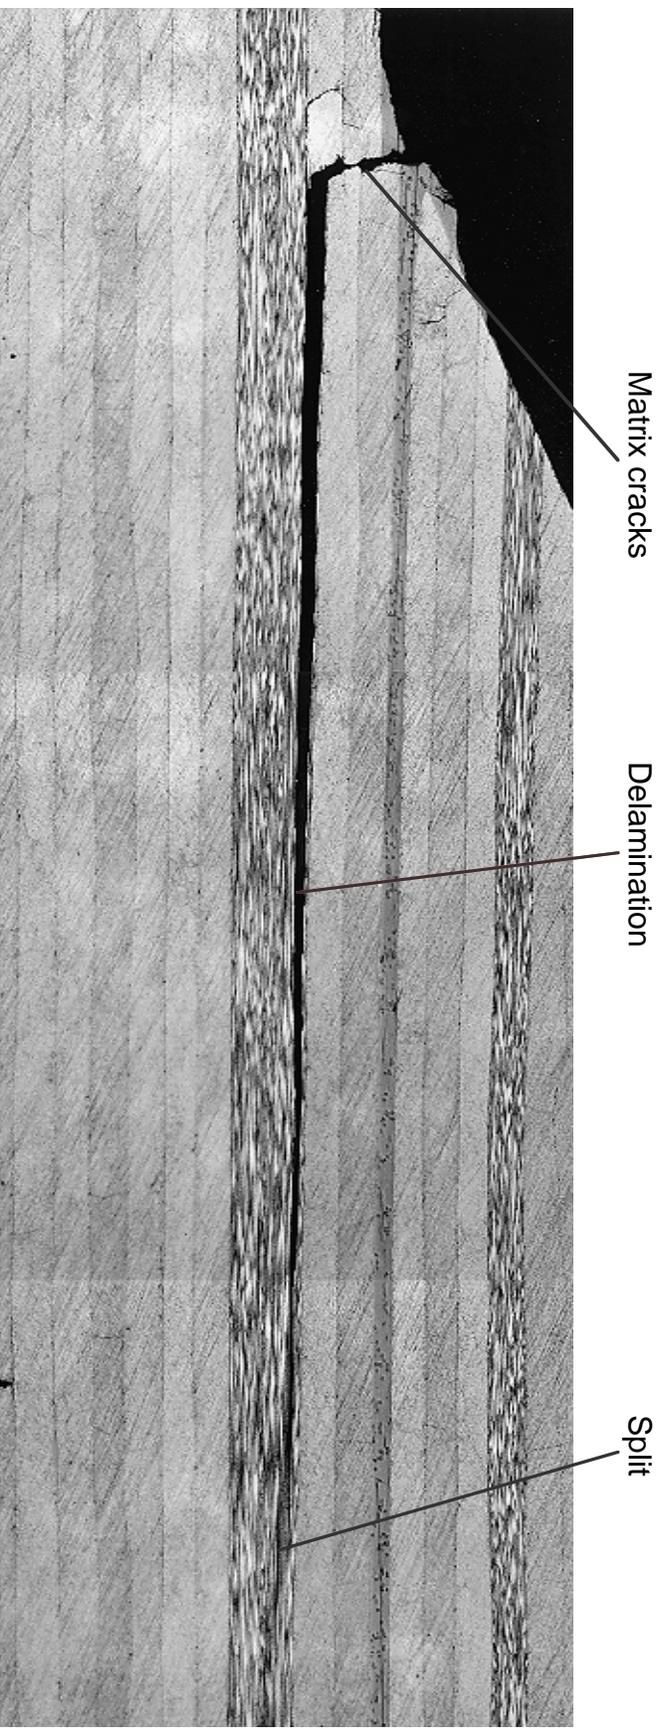
Fig. 21—Side view of a failed specimen of configuration D at a load level of 80% of  $P_{m1}$  showing a delamination in the 45°/0° skin interface at corner 1.

Figures 21 and 22. In Figures 23 to 31, the results are shown as plots of delamination length versus the number of cycles for each load level for the specimens with delaminations.

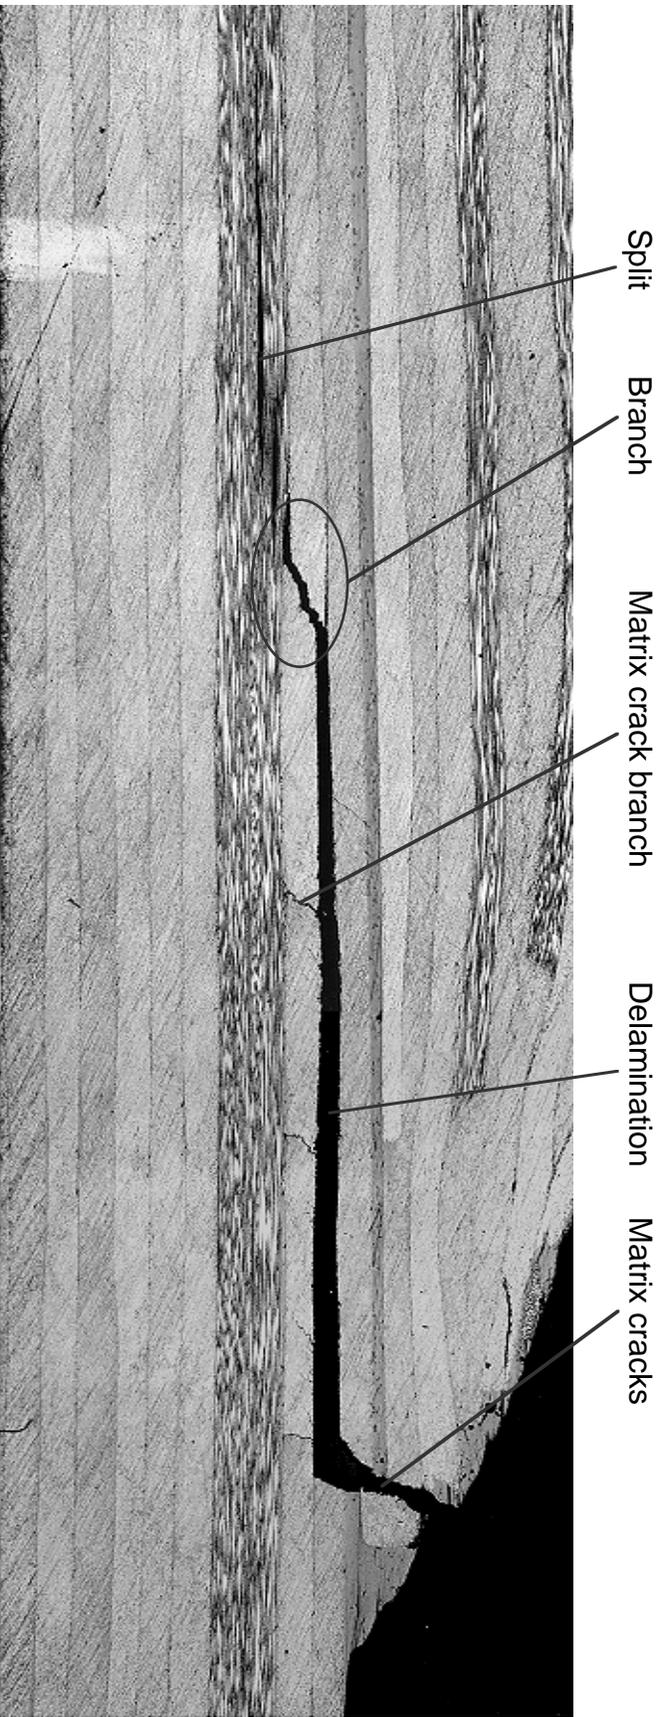
Fig. 22—Side view of a failed specimen of configuration D at a load level of 80% of  $P_{m1}$  showing a delamination in the  $90^\circ/45^\circ$  skin interface branching into the  $45^\circ/0^\circ$  interface at corner 3.

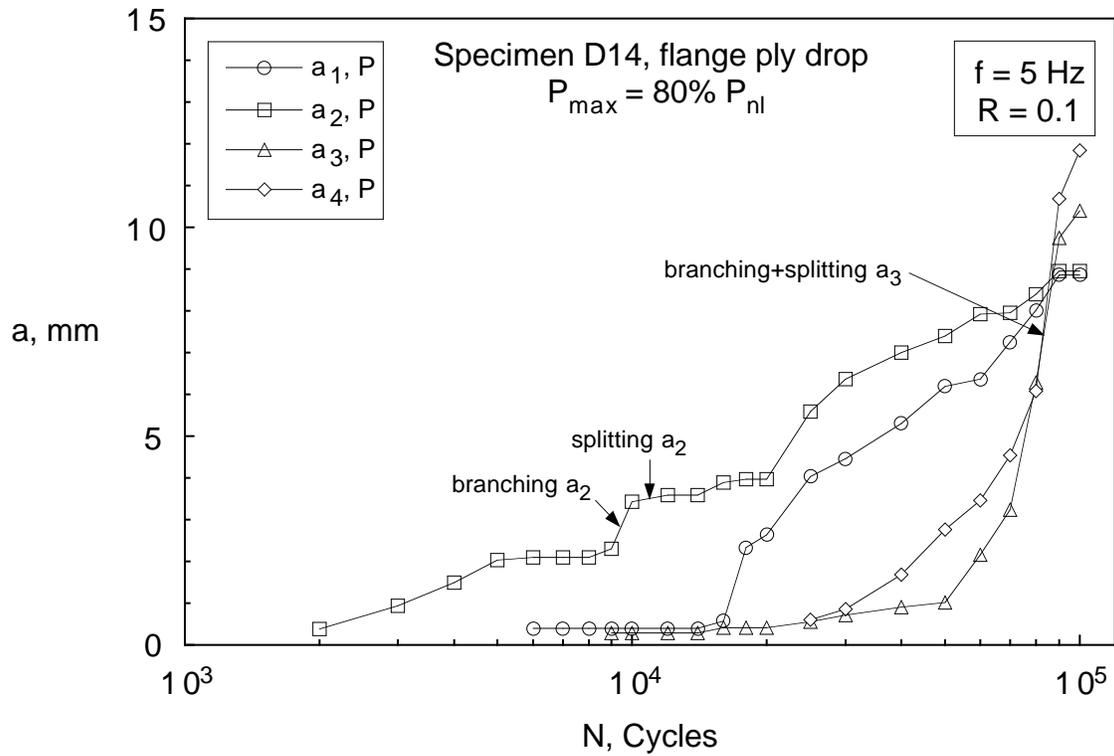
Fig. 23—Delamination length versus number of cycles for specimen D14 at 80% of  $P_{nl}$ .

At  $P_{max}$  of 80% of  $P_{nl}$  (see Figures 23 to 26), matrix cracks formed first between 100 and 2000 cycles. Subsequently, delaminations formed from these matrix cracks. The first delamination always corresponded to the first matrix crack that formed. Only in one specimen (D16) were no branching and splitting found, which is most likely due to the comparatively very short crack lengths at test termination.

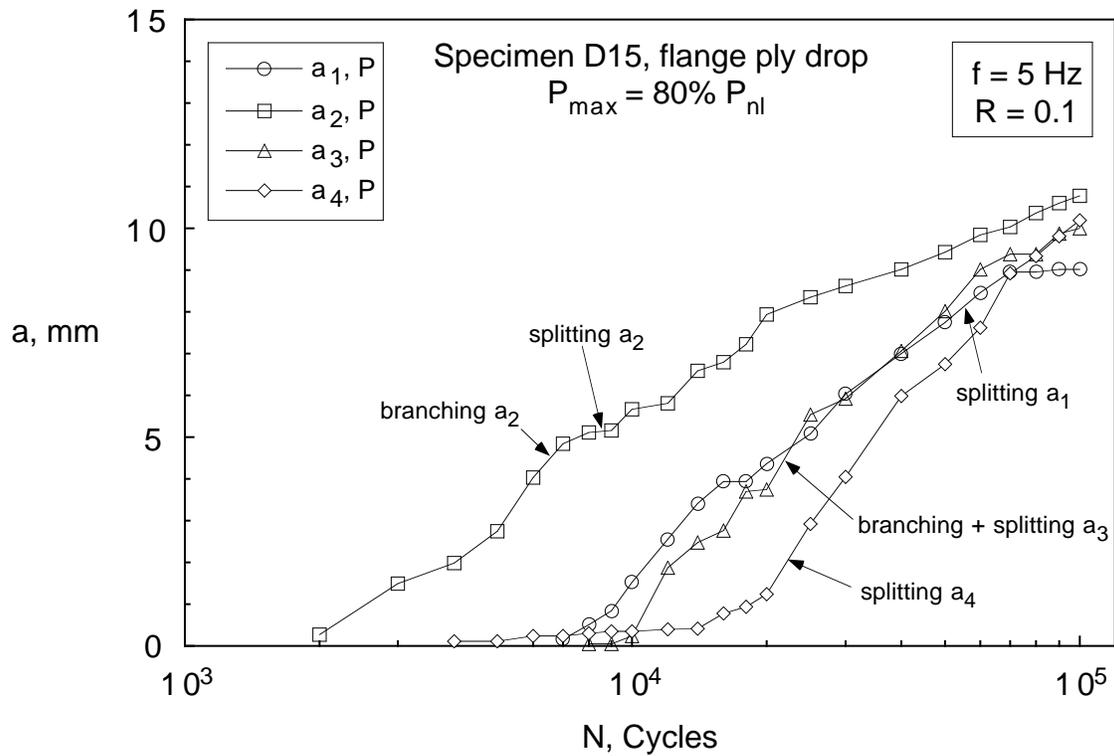
Fig. 24—Delamination length versus number of cycles for specimen D15 at 80% of  $P_{nl}$ .
