NASA Technical Memorandum 110331  
U. S. Army Research Laboratory Technical Report 1342

# Fatigue Debonding Characterization in Composite Skin/Stringer Configurations

**ABSTRACT:** The objective of this work was to investigate the fatigue damage mechanisms and to identify the influence of skin stacking sequence in carbon epoxy composite bonded skin/stringer constructions. A simple 4-point-bending test fixture originally designed for previously performed monotonic tests was used to evaluate the fatigue debonding mechanisms between the skin and the bonded frame when the dominant loading in the skin is flexure along the edge of the frame. The specimens consisted of a tapered flange, representing the stringer, bonded onto a skin. Based on the results of previous monotonic tests two different skin lay-ups in combination with one flange lay-up were investigated. The tests were performed at load levels corresponding to 40%, 50%, 60%, 70% and 80% of the monotonic fracture loads. Microscopic investigations of the specimen edges were used to document the onset of matrix cracking and delamination, and subsequent fatigue delamination growth. Typical damage patterns for both specimen configur

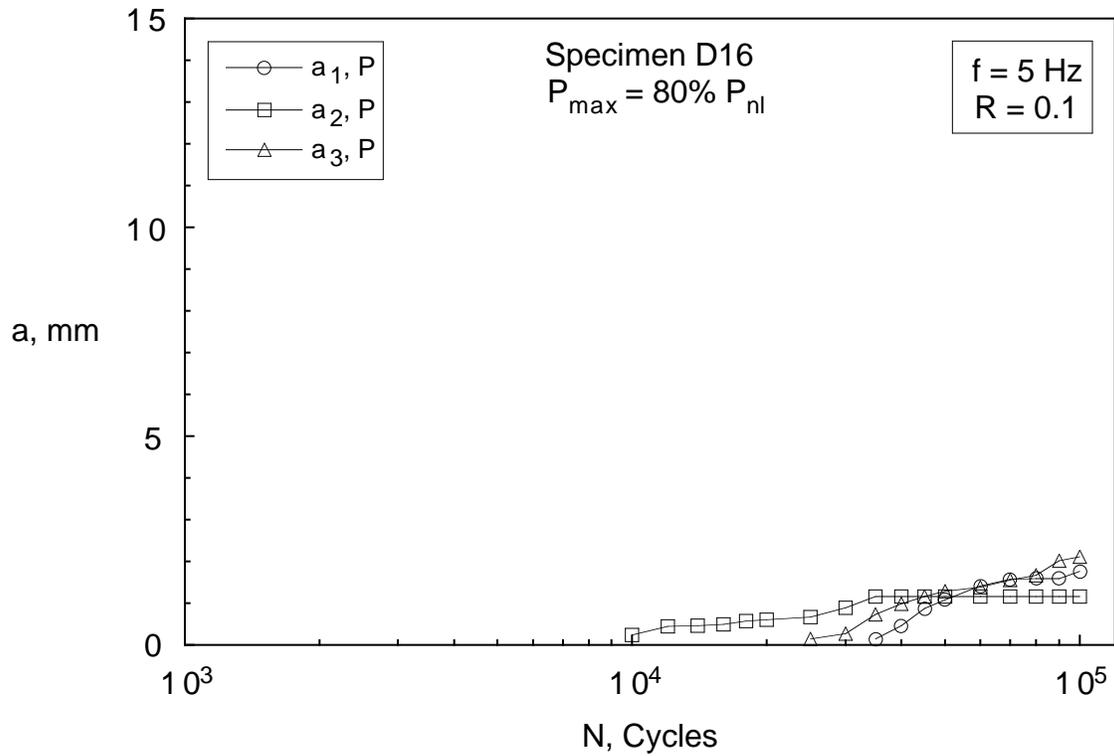
Fig. 25—Delamination length versus number of cycles for specimen D16 at 80% of  $P_{nl}$ .

At  $P_{max}$  of 80% of  $P_{nl}$  (see Figures 23 to 26), matrix cracks formed first between 100 and 2000 cycles. Subsequently, delaminations formed from these matrix cracks. The first delamination always corresponded to the first matrix crack that formed. Only in one specimen (D16) were no branching and splitting found, which is most likely due to the comparatively very short crack lengths at test termination.

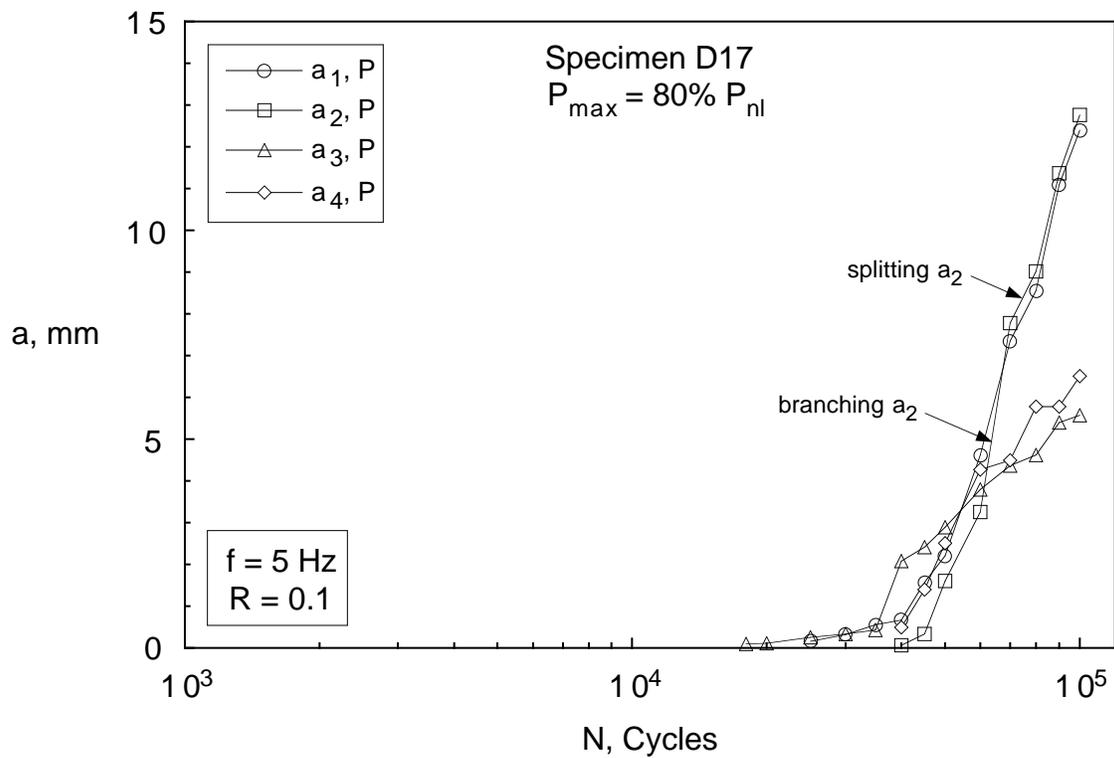
Fig. 26—Delamination length versus number of cycles for specimen D17 at 80% of  $P_{nl}$ .

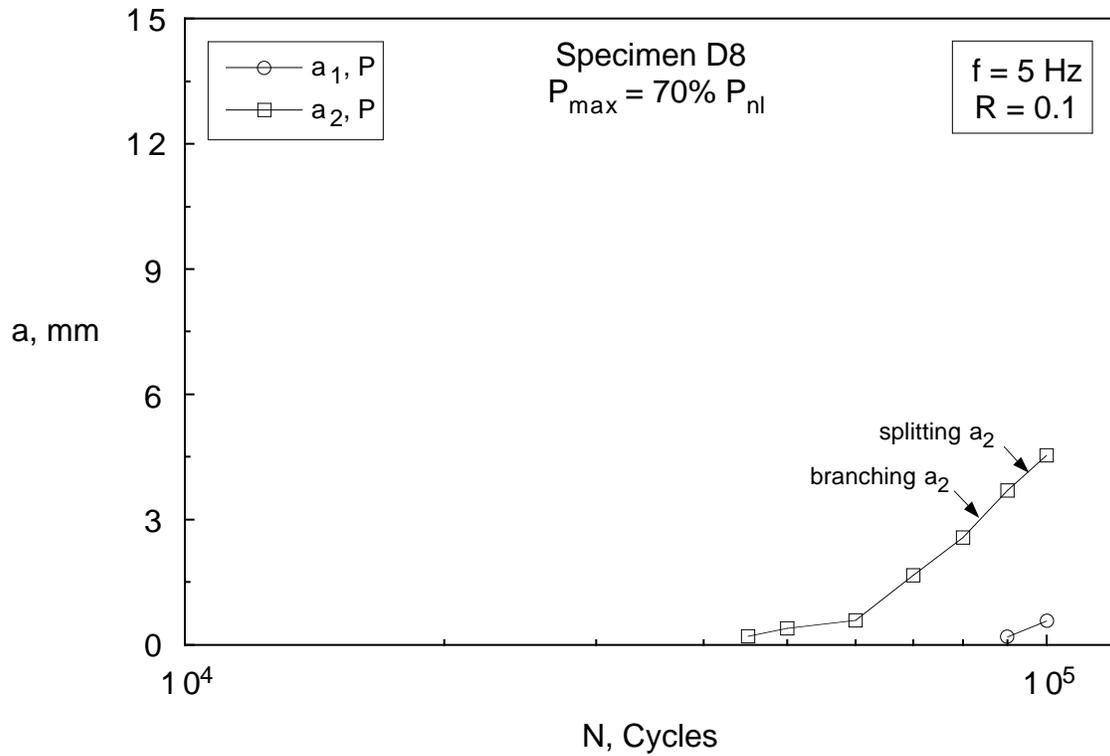
Fig. 27—Delamination length versus number of cycles for specimen D8 at 70% of  $P_{nl}$ .

At  $P_{max}$  of 70% of  $P_{nl}$  (see Figures 27 to 29), matrix cracks formed first between 1 000 and 50 000 cycles. In some cases, delaminations formed from these matrix cracks. For the "ideal" specimens without a flange ply drop, the first delamination always corresponded to the first matrix crack that formed. In one specimen with a flange ply drop, a matrix crack occurred at 1 000 cycles but did not result in a delamination for the time span investigated. Instead, at 18 000 cycles a matrix crack and a delamination formed at a different corner. In the second specimen with a flange ply drop, a single matrix crack occurred at 50 000 cycles. No other matrix cracks and no delamination formed in this specimen before the test was terminated.

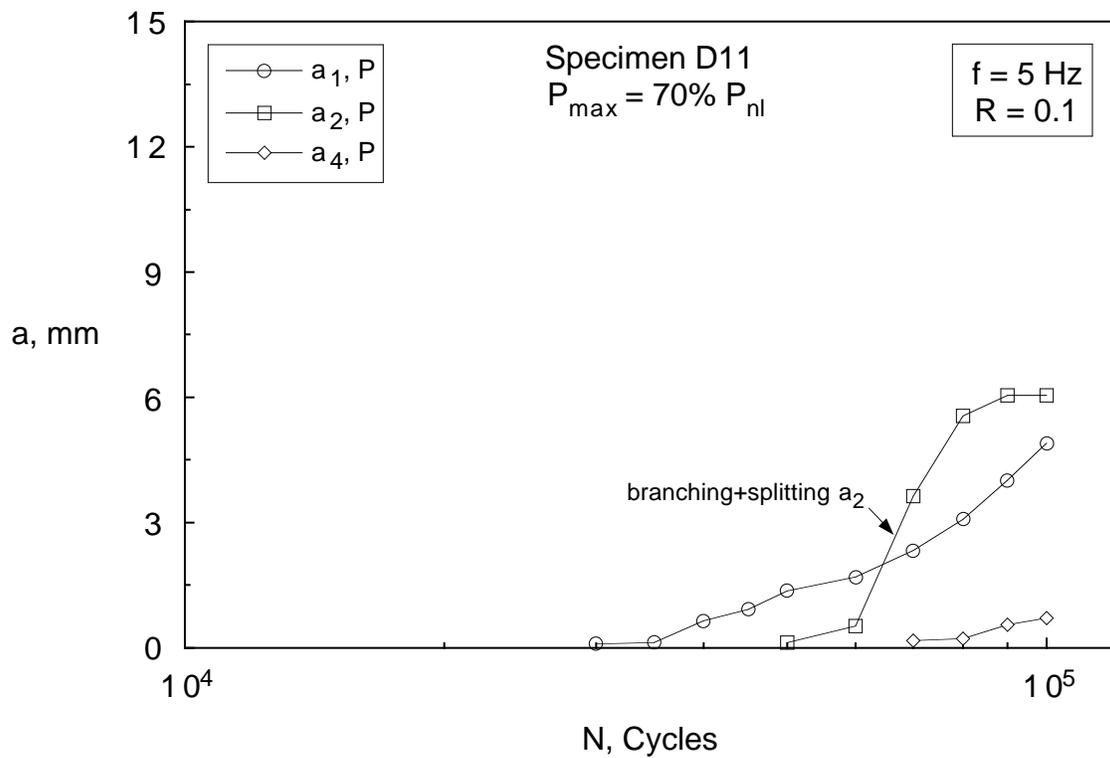
Fig. 28—Delamination length versus number of cycles for specimen D11 at 70% of  $P_{nl}$ .

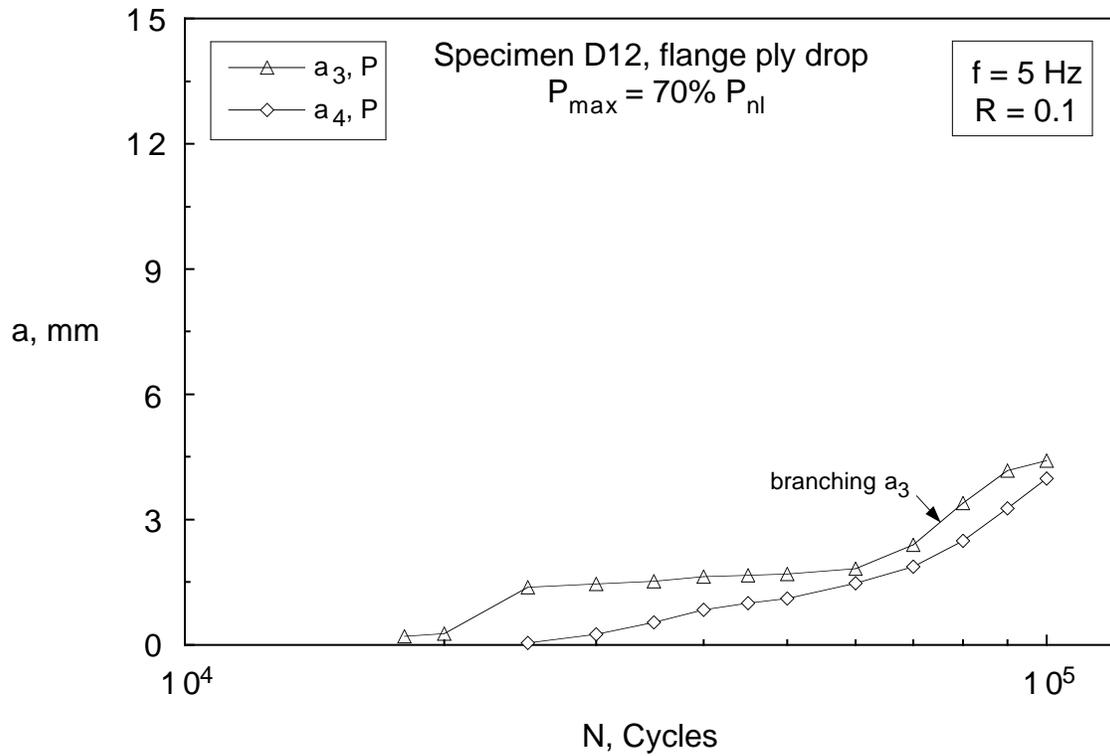
Fig. 29—Delamination length versus number of cycles for specimen D12 at 70% of  $P_{nl}$ .

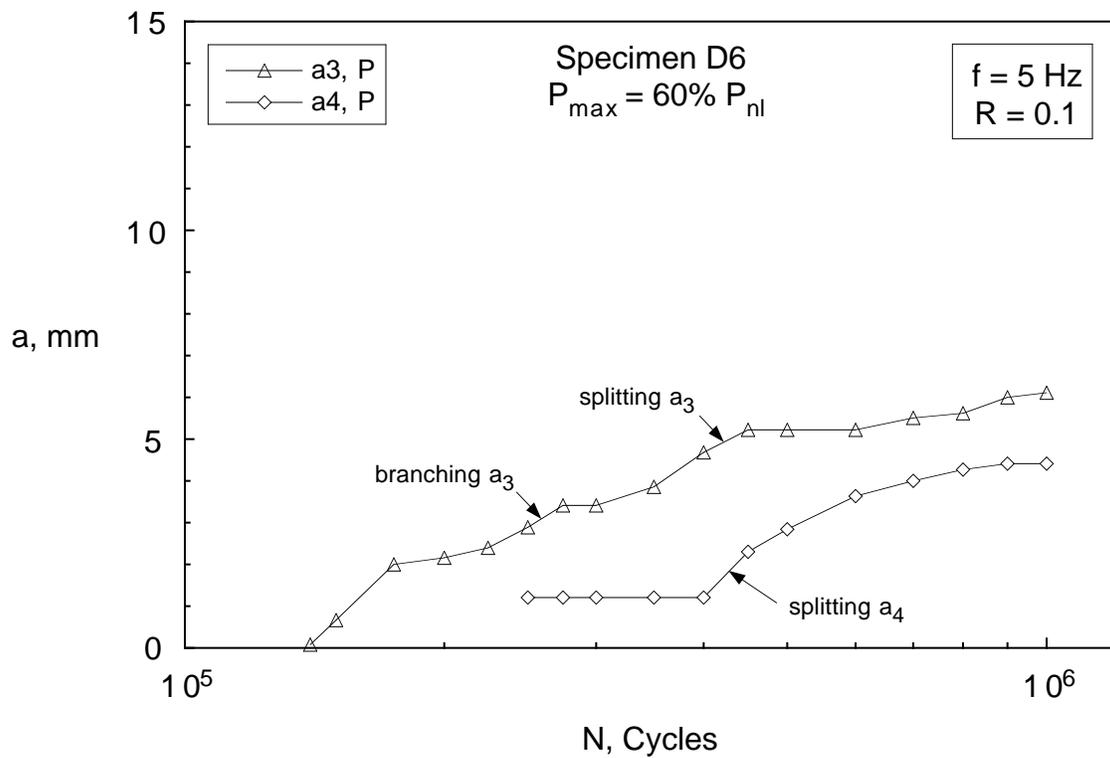
Fig. 30—Delamination length versus number of cycles for specimen D6 at 60% of  $P_{nl}$ .

At  $P_{max}$  of 60% of  $P_{nl}$  (see Fig. 30), matrix cracks formed first between 20 000 and 400 000 cycles. In one of the two specimens tested at this load level, delaminations formed from these matrix cracks. The first transverse matrix crack formed at corner 4. Subsequently, a matrix crack formed at corner 3 and initiated a delamination in the  $90^\circ/45^\circ$  interface at 140 000 cycles. At 250 000 cycles another matrix crack formed at corner 4 in the  $45^\circ$  ply below the top  $90^\circ$  skin ply. It instantly initiated a delamination in the  $45^\circ/0^\circ$  interface. In the other specimen, a matrix crack formed at 400 000 cycles but did not result in a delamination.

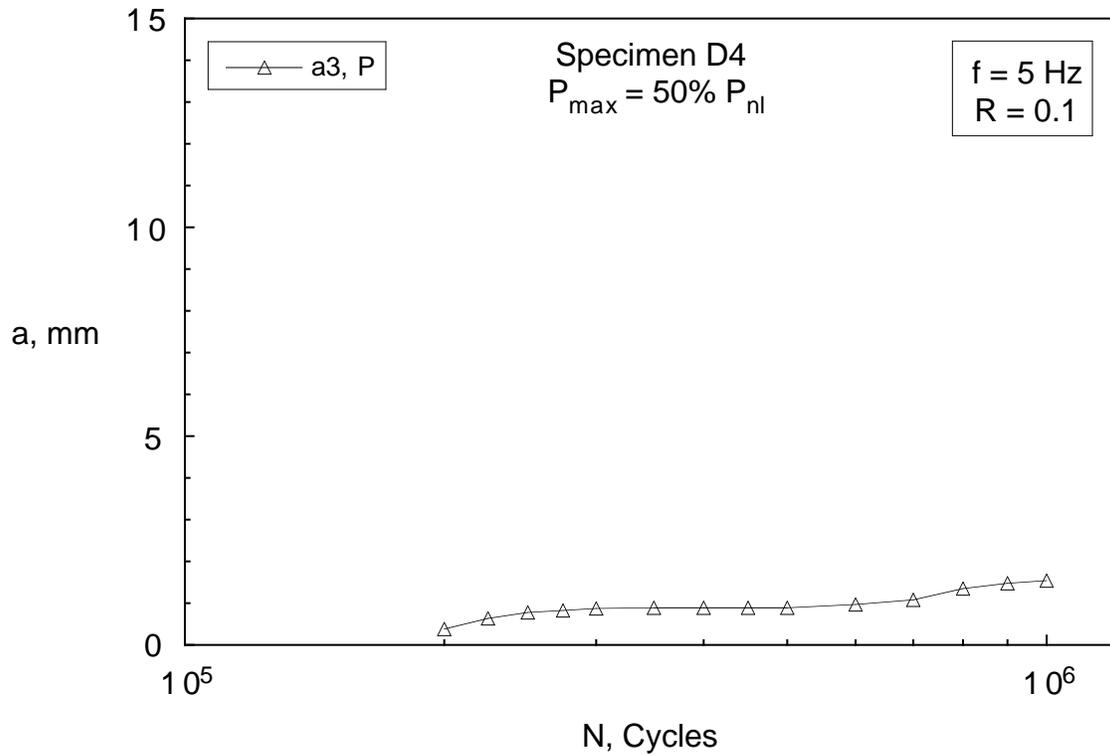
Fig. 31—Delamination length versus number of cycles for specimen D4 at 50% of  $P_{nl}$ .

At  $P_{max}$  of 50% of  $P_{nl}$  (see Fig. 31), a single matrix crack and a delamination formed only in one of the two specimens within the period investigated. In this specimen, the only matrix crack occurred at 130 000 cycles at corner 3 in the  $90^\circ$  skin ply closest to the flange. It resulted in a delamination in the  $90^\circ/45^\circ$  interface, forming at 200 000 cycles. No matrix cracks and

delaminations were detected in the second specimen. At  $P_{max}$  of 40% of  $P_{nl}$ , no matrix cracks and delaminations formed within one million cycles.

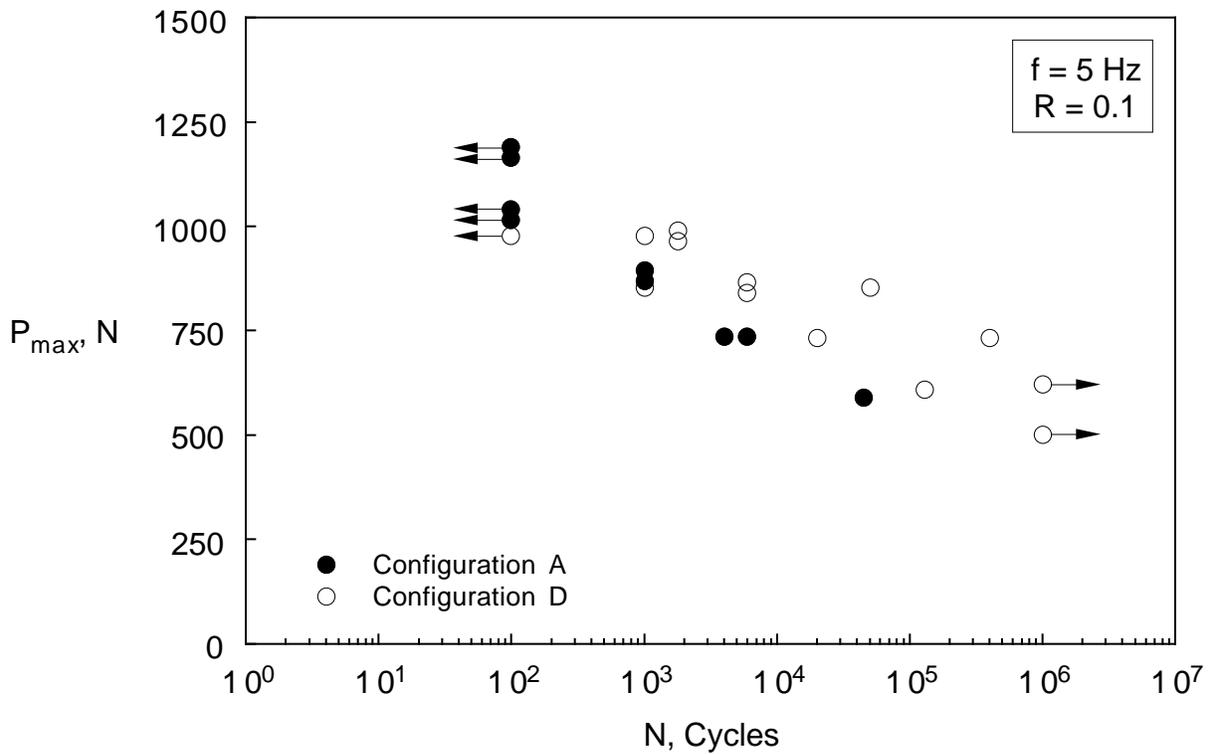
Fig. 32—Comparison of the maximum cyclic load as a function of the number of cycles to matrix crack onset.

In Fig. 32, the two specimen configurations are compared with respect to the onset of matrix cracking. Matrix cracking typically occurred earlier in configuration A where  $90^\circ$  plies in the flange were close to the bondline as in configuration D but  $90^\circ$  plies in the skin were not. Again, left hand arrows indicate damage within the first 100 cycles, while right hand arrows show that no matrix cracks were observed within the test period of one million cycles. While specimens of configuration A show very little scatter, the data for configuration D displays significant variability at each load level. It is believed that this scatter is related to the transverse tension strength of the surface  $90^\circ$  skin ply. This large variability has also been found in  $90^\circ$  flexural fatigue tests performed in Reference 4.

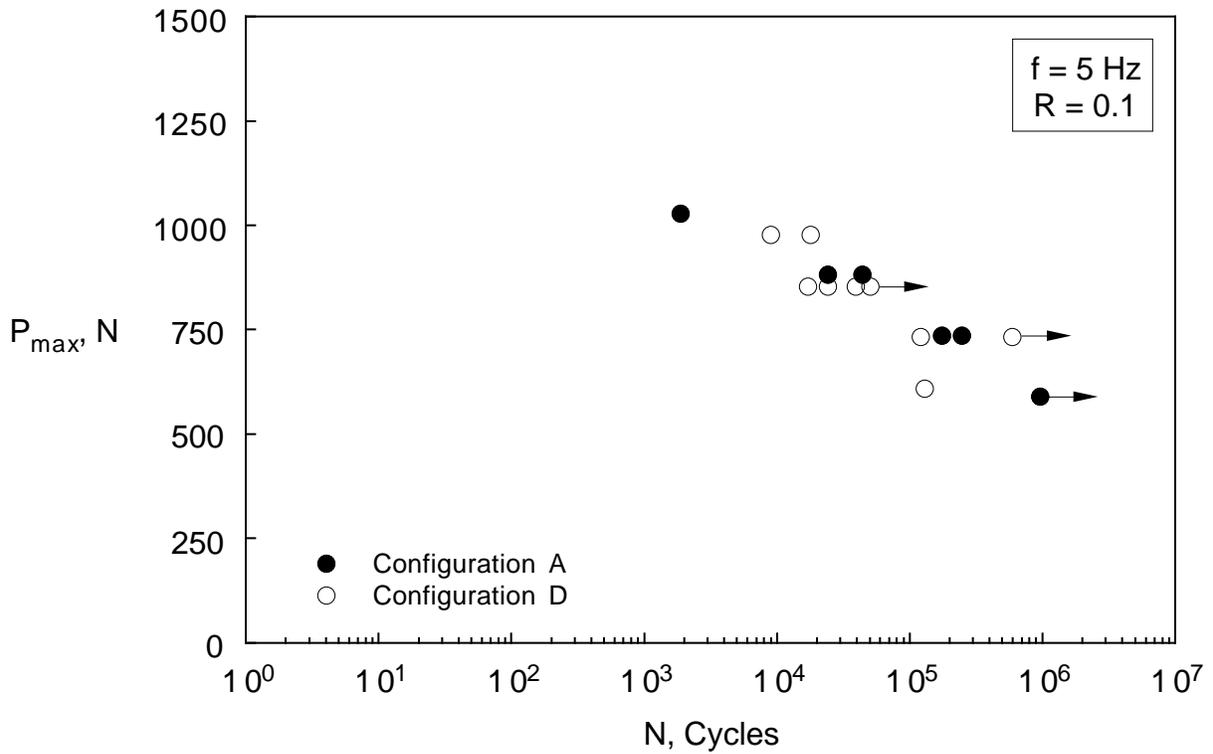
Fig. 33—Comparison of the maximum cyclic load as a function of the number of cycles to delamination onset once a matrix crack is present.

Another way of comparing the results is to show the number of cycles to delamination onset once a matrix crack has already formed. This can be established by simply subtracting the number of cycles to onset of matrix cracking from the number of cycles to delamination onset. The combined data for configurations A and D are shown in Fig. 33. As pointed out before, in some cases both events occurred within the first 100 cycles or could not be detected until the tests were terminated. Hence, as no complete information of these damage stages was obtained these data points have been excluded from the graph. Right hand arrows indicate that matrix cracking occurred within one million cycles whereas delaminations did not occur. Although both configurations have been tested at different absolute load levels, there is little difference in the fatigue response for delamination onset between the two configurations once matrix cracks are formed. As noted before, with decreasing load levels the number of cycles to delamination onset is shifted towards higher values. The scatter for the onset of delamination once a matrix crack has formed in specimens of configuration D is smaller than observed for matrix cracking alone, indicating that delamination onset is not so sensitive to the skin lay-up.
