TESTING AND ANALYSIS OF COMPOSITE SKIN/STRINGER DEBONDING UNDER MULTI-AXIAL LOADING

A consistent step-wise approach is presented to investigate the damage mechanism in composite bonded skin/stringer constructions under uniaxial and biaxial (in-plane/out-of-plane) loading conditions. The approach uses experiments to detect the failure mechanism, computational stress analysis to determine the location of first matrix cracking and computational fracture mechanics to investigate the potential for delamination growth. In a first step, tests were performed on specimens, which consisted of a tapered composite flange, representing a stringer or frame, bonded onto a composite skin. Tests were performed under monotonic loading conditions in tension, three-point bending, and combined tension/bending to evaluate the debonding mechanisms between the skin and the bonded stringer. For combined tension/bending testing, a unique servohydraulic load frame was used that was capable of applying both in-plane tension and out-of-plane bending loads simultaneously. Specimen edges were examined on the microscope to document the damage occurrence and to identify typical damage patterns. For all three load

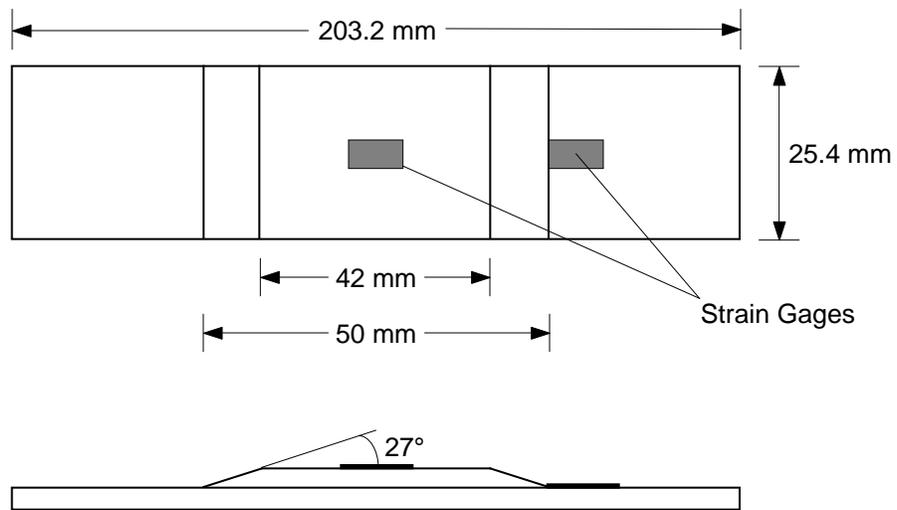
Figure 1. Specimen Configuration.

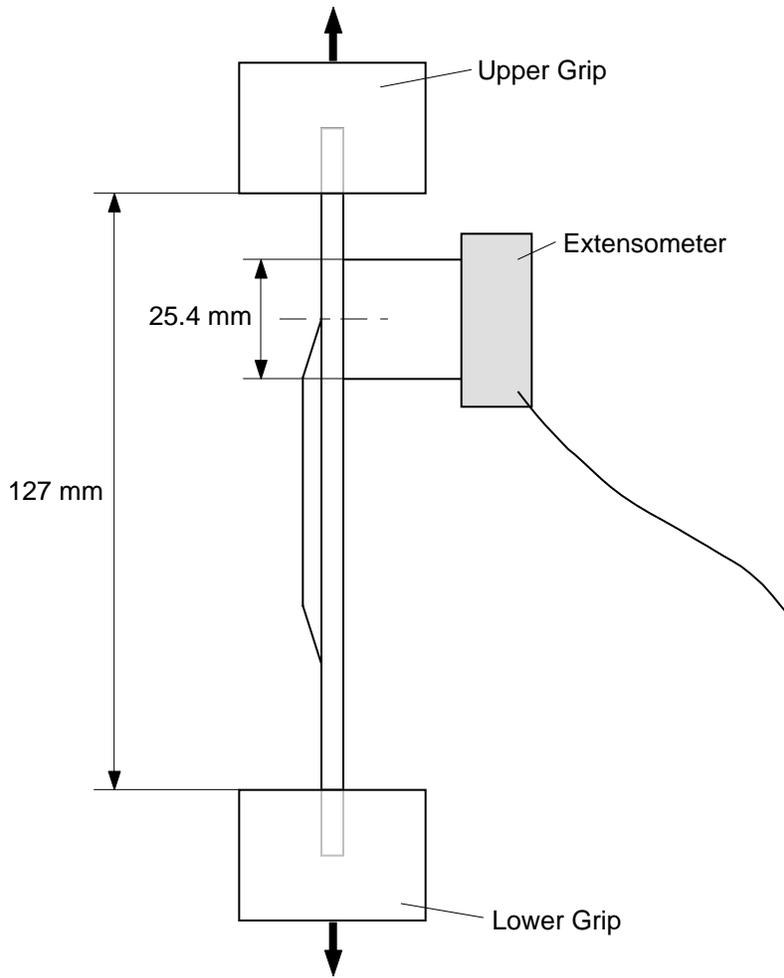
Figure 2. Tension Test Set-Up.

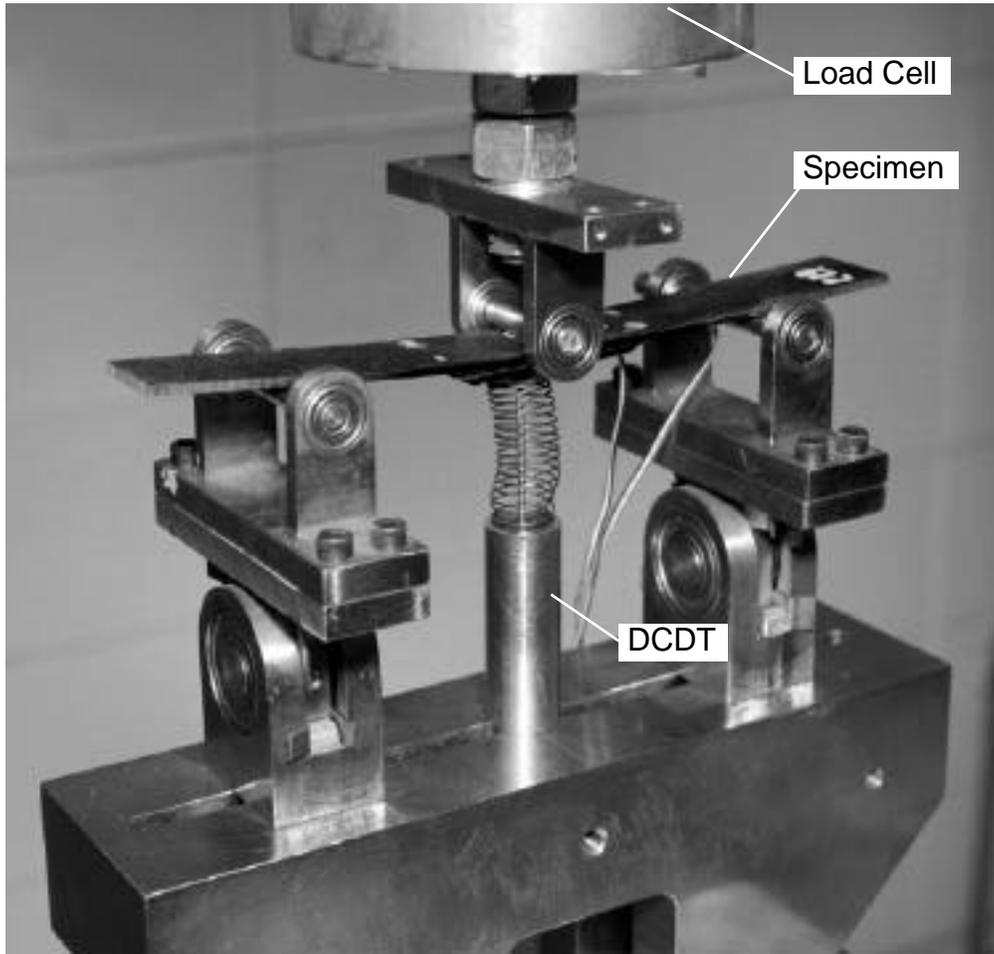
Figure 3. Three-Point Bending Test Set-Up.

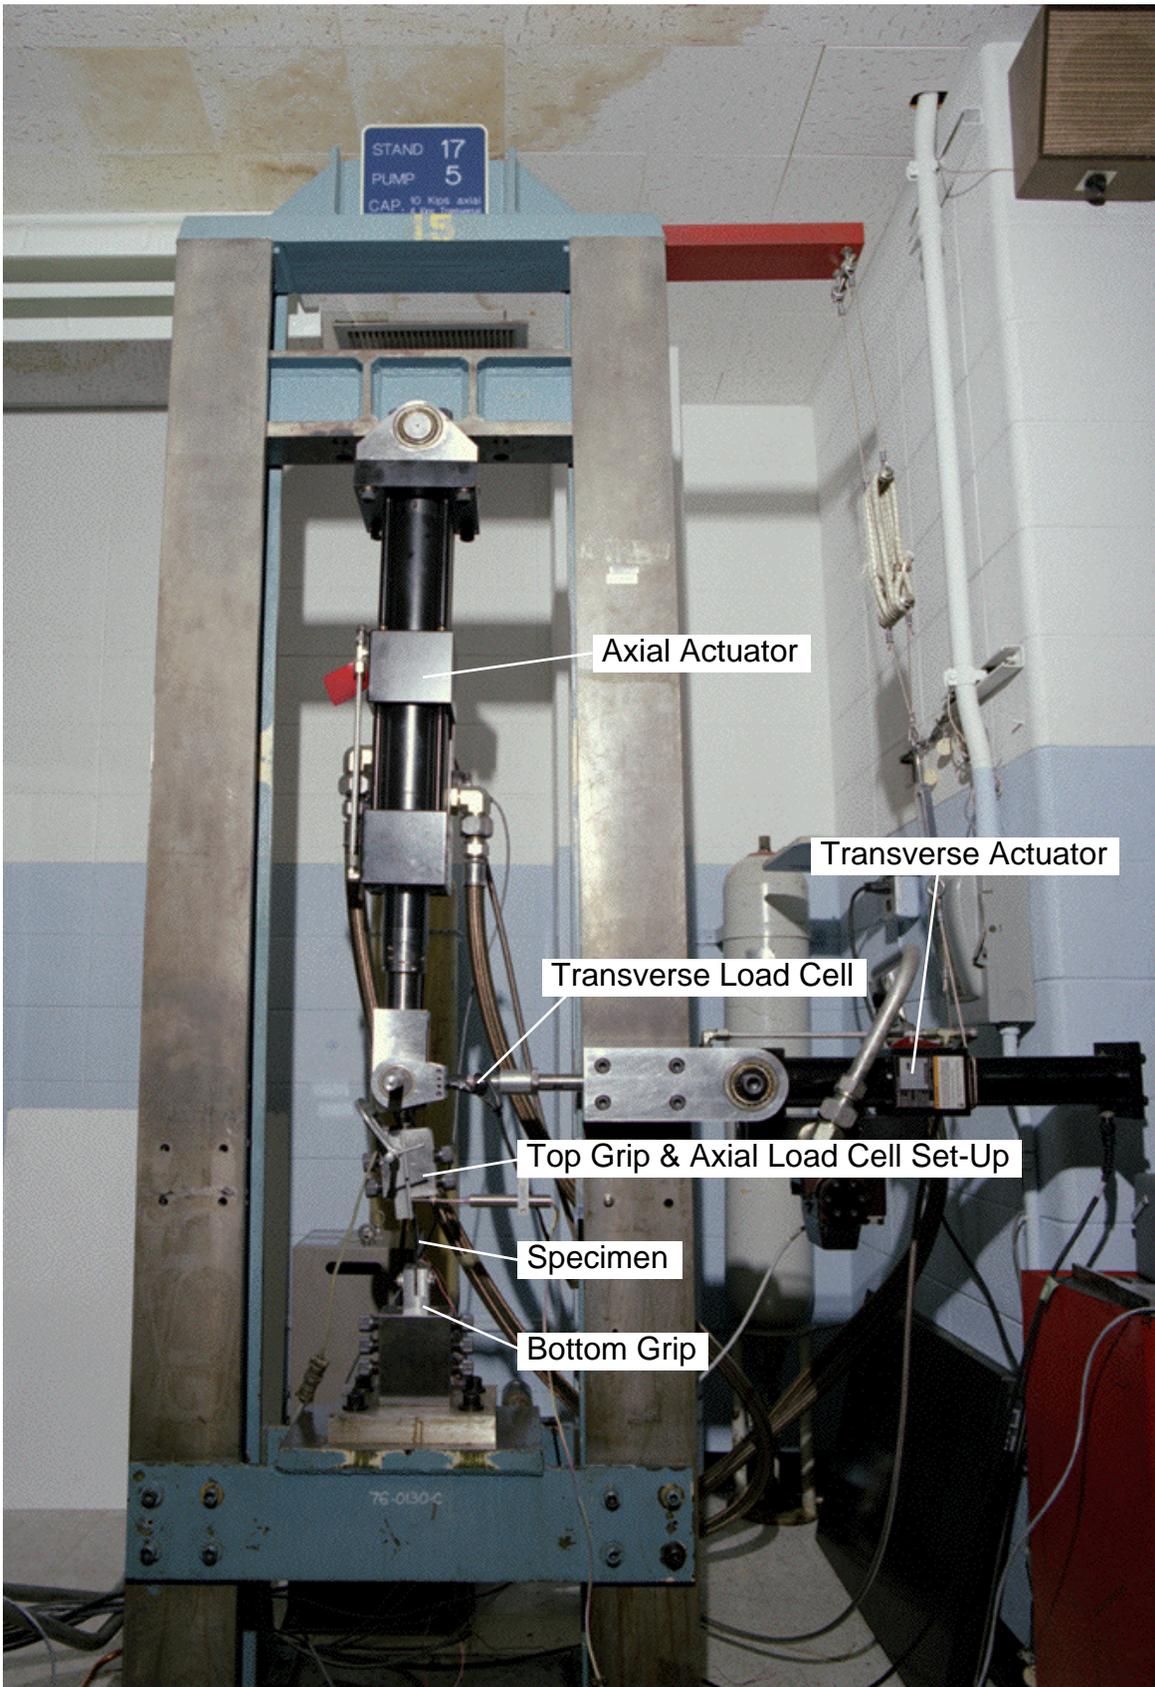
Figure 4. ATB Test Set-Up.

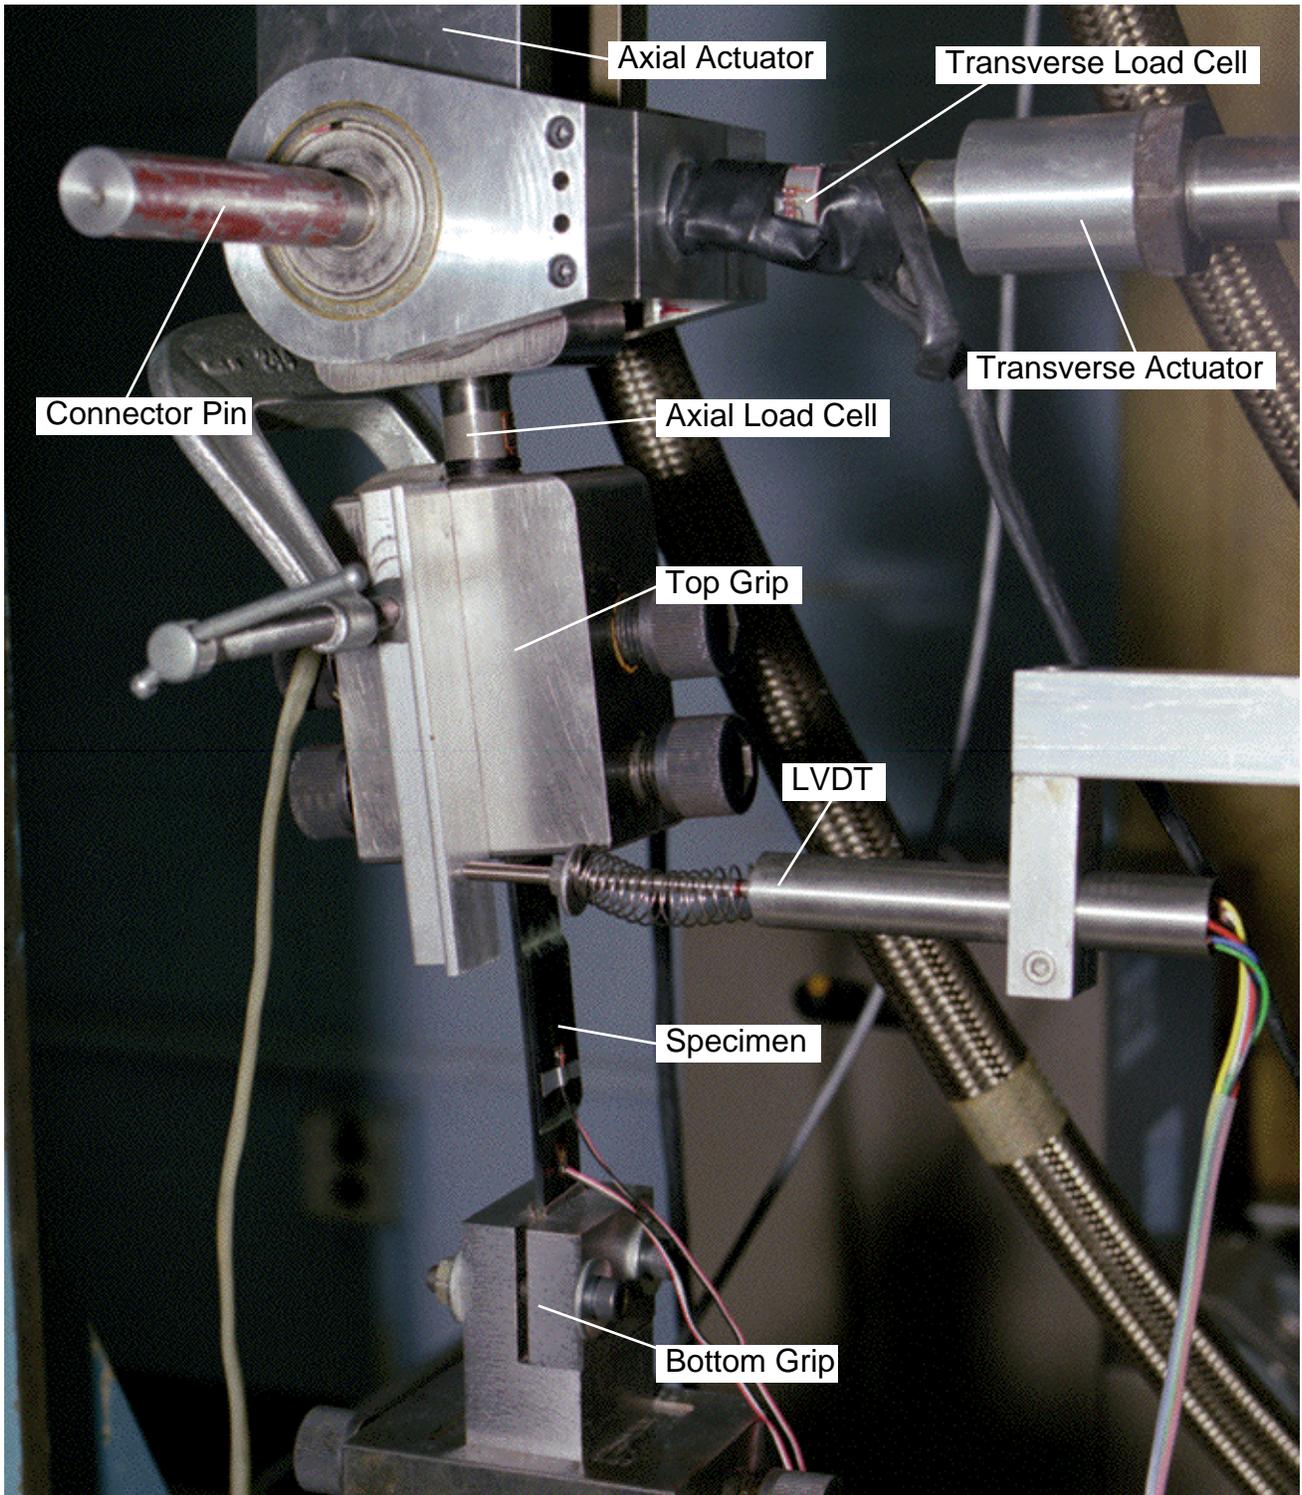
Figure 5. ATB Test Set-Up Close View.

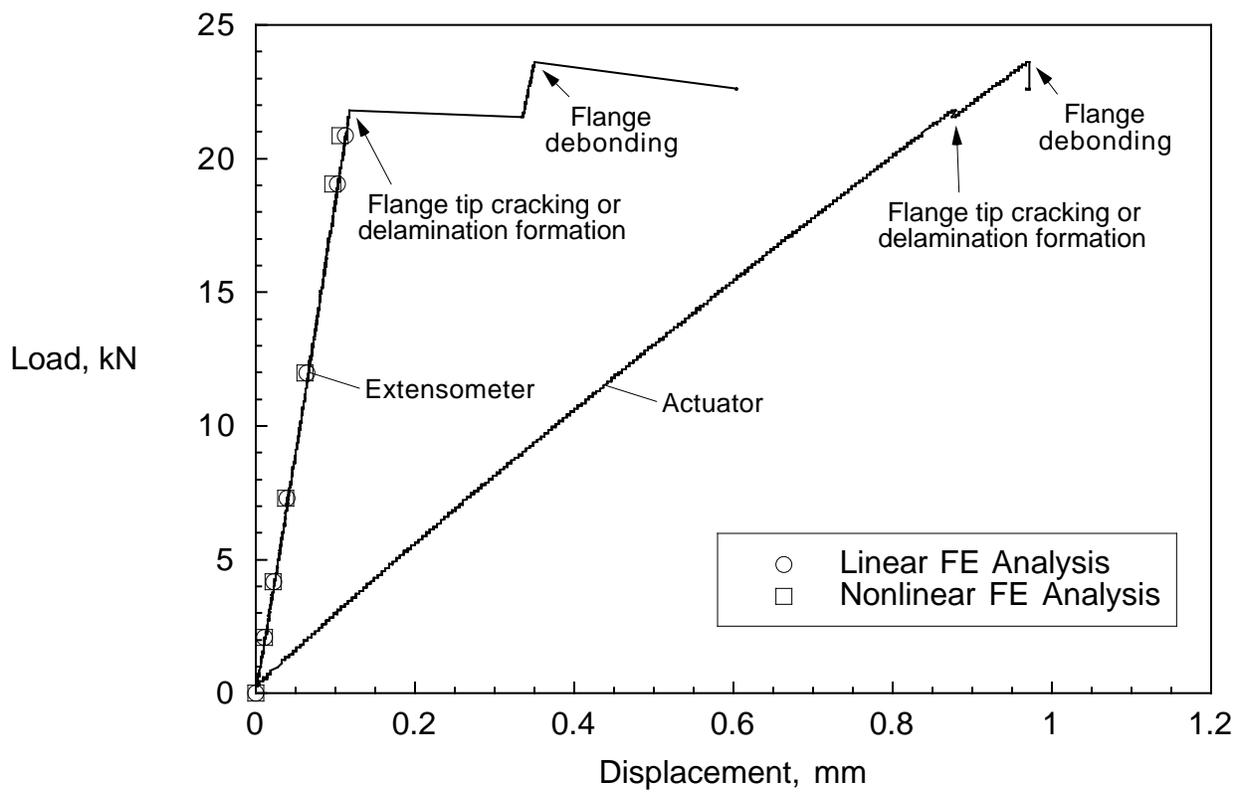
Figure 6. Typical Load-Displacement Plot for Tension Tests.

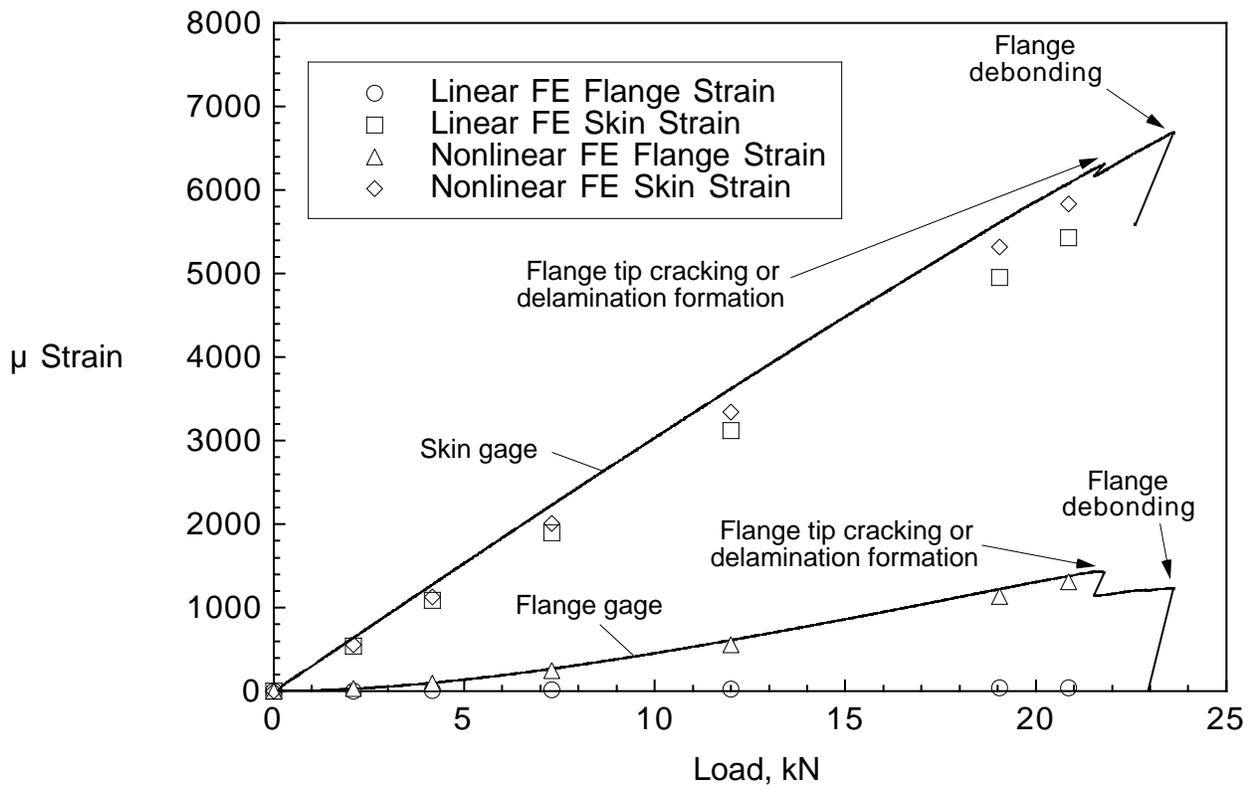
Figure 7. Typical Strain-Load Plot for Tension Tests.

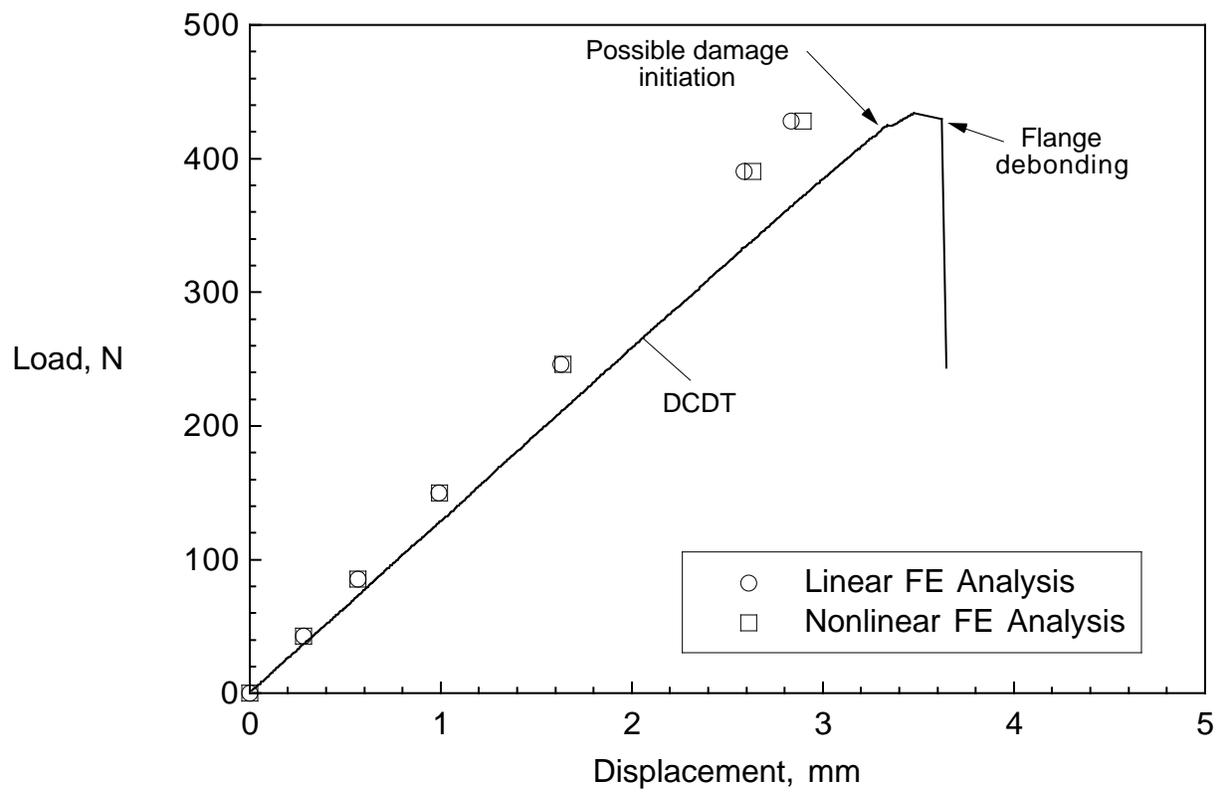
Figure 8. Typical Load-Displacement Plot for Three-Point Bending Tests.

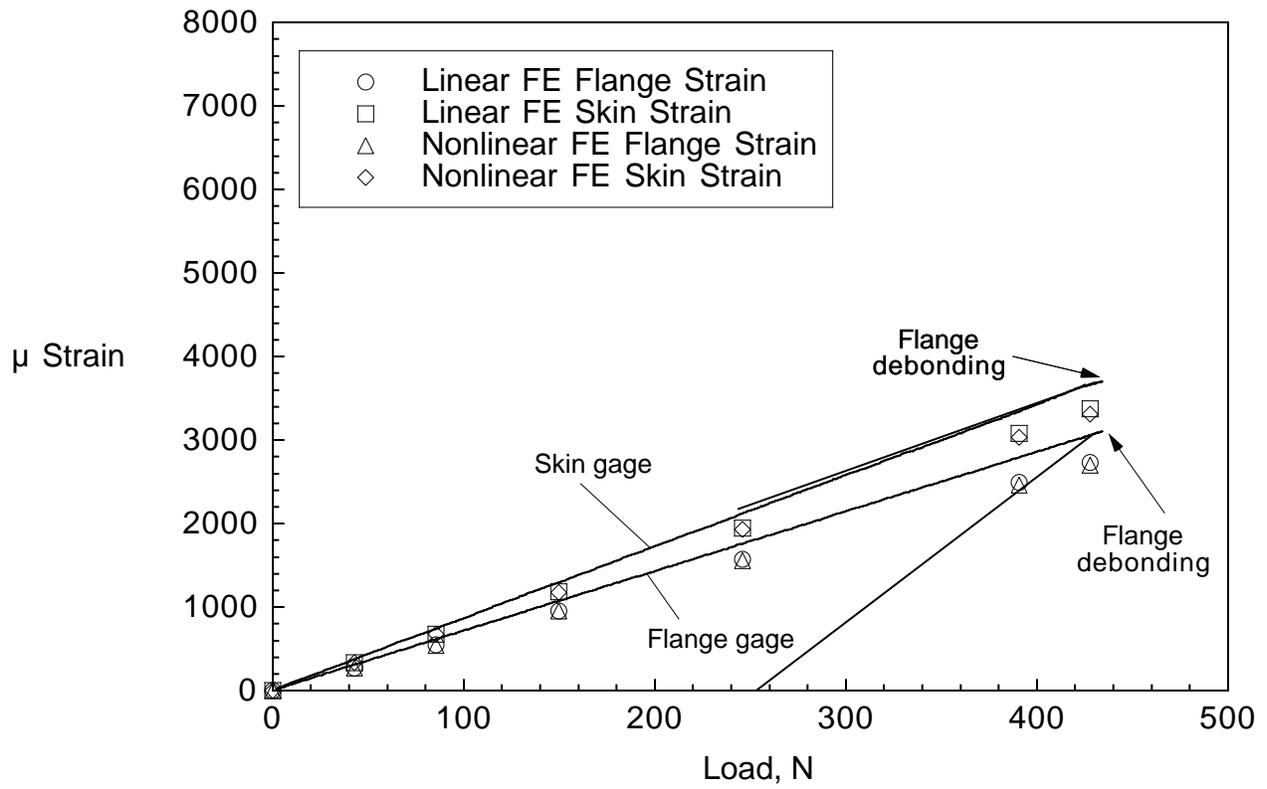
Figure 9. Typical Strain-Load Plot for Three-Point Bending Tests.

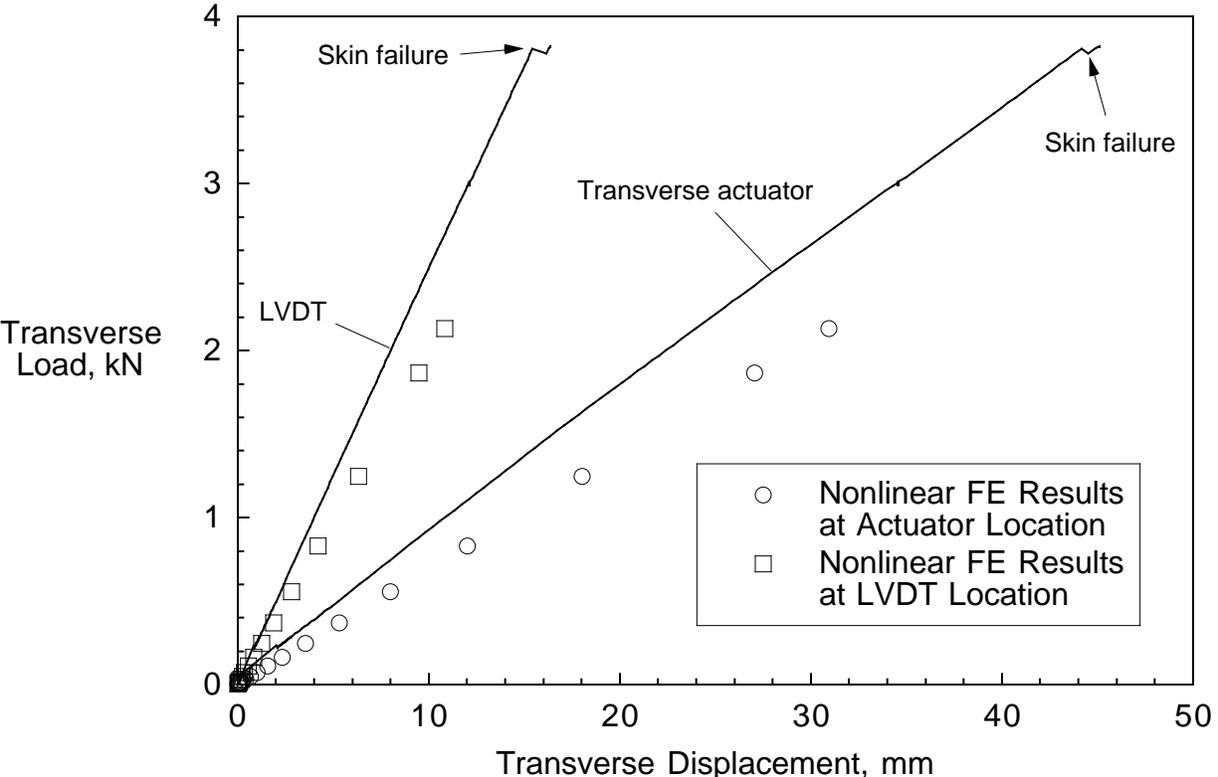
Figure 10. Typical Load-Displacement Plot for ATB Tests.

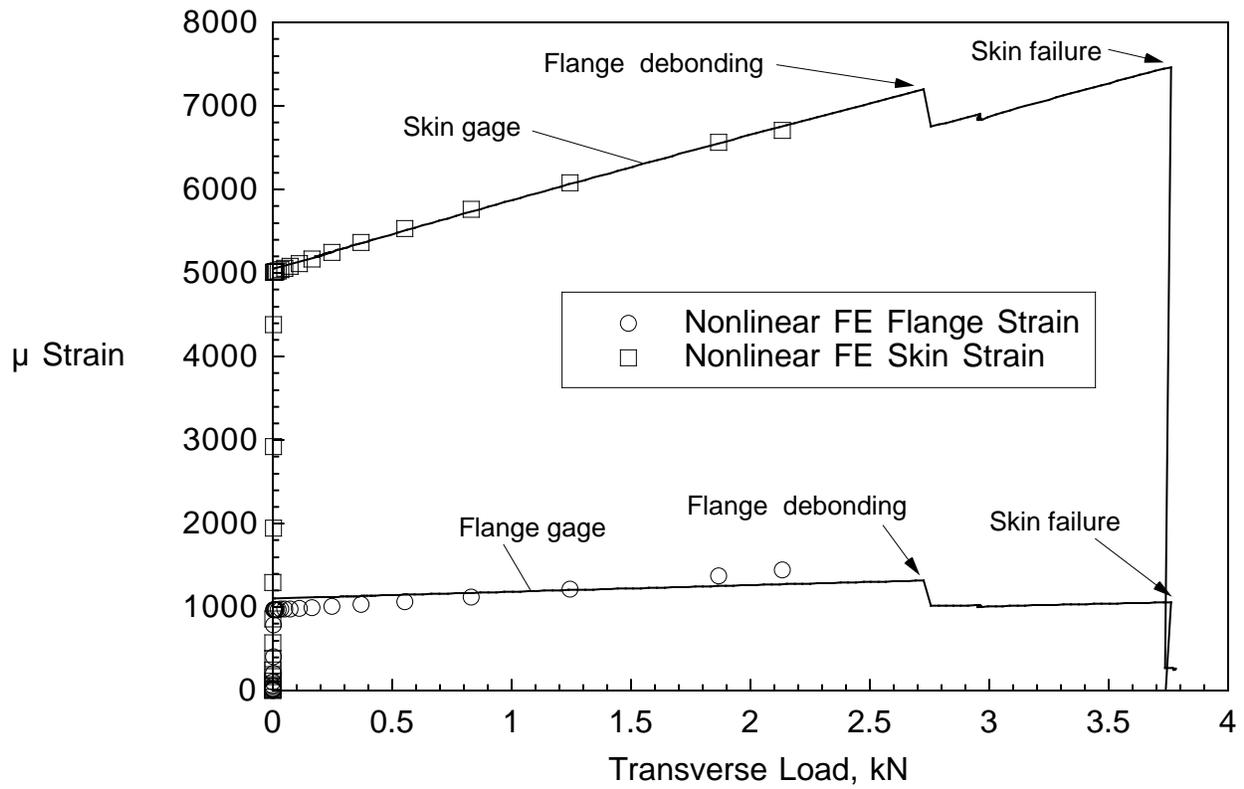
Figure 11. Typical Strain-Load Plot for ATB Tests.

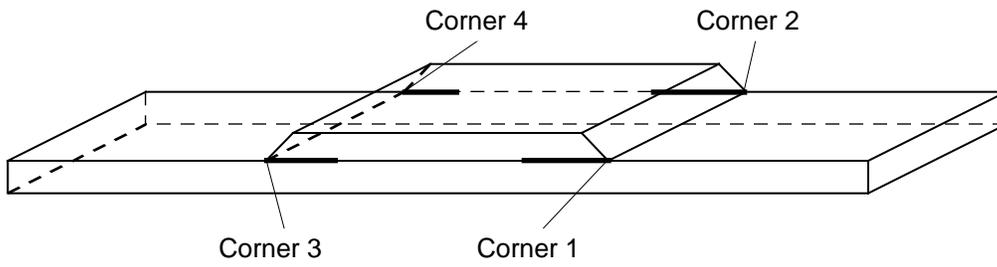
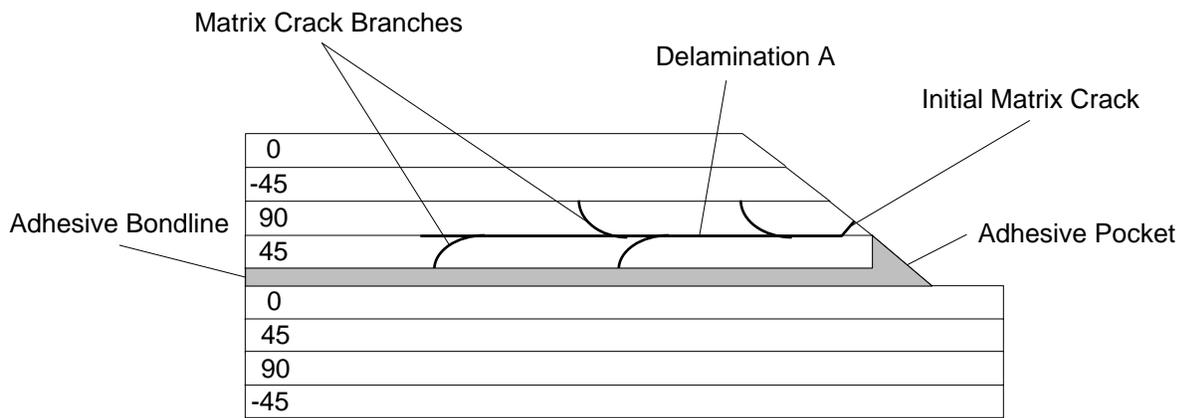
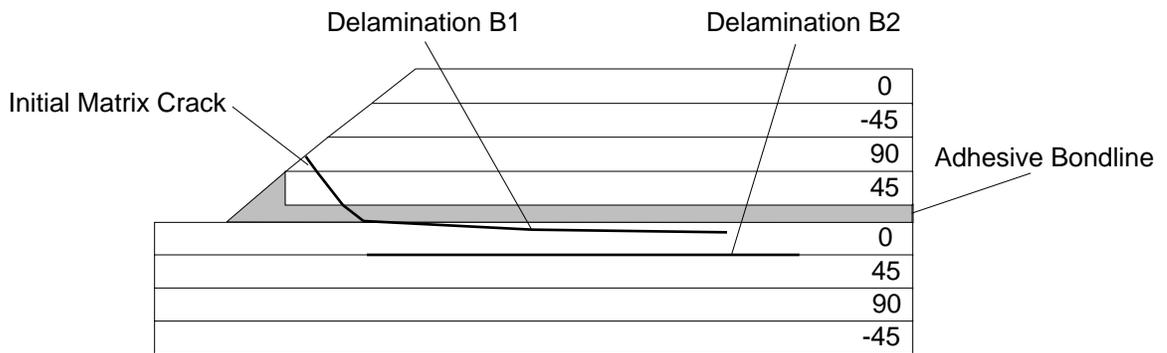
(a) Specimen with Crack Locations.

(b) Corners 1 and 4

(c) Corners 2 and 3

Figure 12. Typical Damage Patterns.

At corners 1 and 4, a delamination running in the 90°/45° flange ply interface (delamination A) initiated from a matrix crack in the 90° flange ply as shown in Figure 12(b). At longer

The stress analysis was used to study the initial failure in the form of matrix cracks from which delaminations may start to grow. As shown in Figures 12 and 13, the first crack always occurred in the 90° flange ply closest to the skin. Results from previous investigations [2, 3] suggested that the local force and moment resultants, may be used to characterize damage onset. As shown in Figure 20, force and moment resultants per unit width were calculated from the normal stress σ_{xx} at the flange tip. Resultants were computed for damage initiation and flange debond load level based on stresses obtained from linear and nonlinear FE analyses. Results plotted in Figure 21 show that the three-point bending test is free of axial tension as the force resultants N_{xx} are zero as expected. A bending moment is present in the tension specimen caused by the load eccentricity in the flange region and the asymmetric layup of the combined skin and flange laminate with respect to the neutral axis. For the ATB test, calculated force and moment resultants lie between computed pure tension and pure bending values.

reported fracture toughness values as shown in Table 6. It is important to recall that in the experiments the failure was observed as a split in the 0° ply as shown in Figures 12 (c) and 14 (b). This failure was modeled as a delamination propagating between the adhesive film and the top 0° ply of the skin as shown in Figure 15 (b) only in order to avoid skewed elements. Hence, for predicting growth of the split in the 0° ply it is appropriate to compare energy release rates computed for the 0° skin ply/adhesive film interface with fracture toughness values obtained from standard tests. Unstable propagation is likely since the calculated G_T -values remain above the mixed-mode fracture toughnesses over the entire simulated length as shown in Figures 27 to 29. This assumption is confirmed by the experimental results of this study.

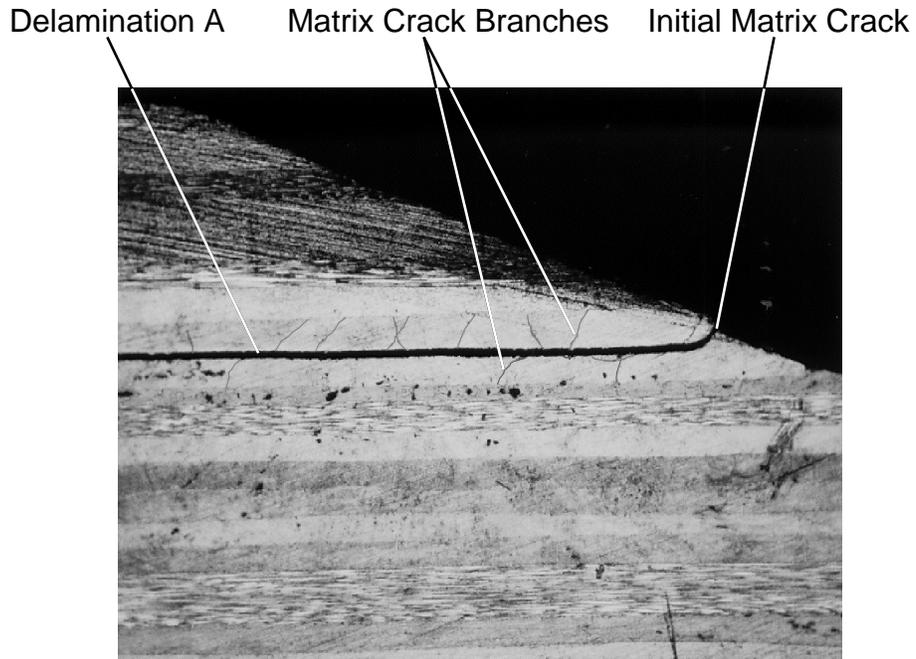
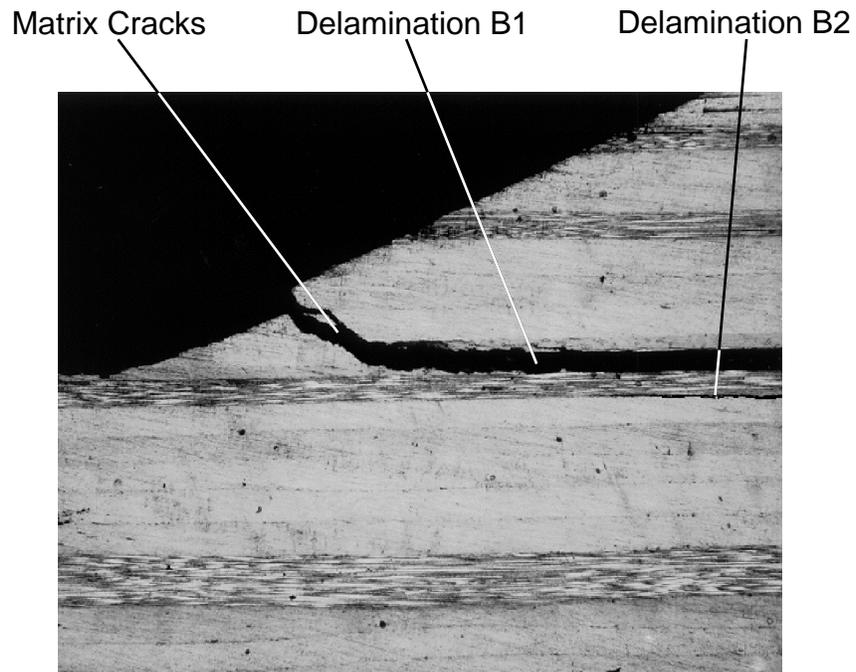
(a) Delamination A in the 90°/45° Flange Ply Interface at Corner 4

(b) Delamination B1 in the Top 0° Skin Ply and Beginning of Delamination B2 in The top 0°/45° Skin Ply Interface at Corner 2

Figure 13. Micrograph Showing the Side View of a Failed Three-Point Bending Specimen.

The above findings suggest that once a matrix crack has formed, a delamination (delamination B1 from Figure 13) will also form and grow in an unstable manner between the adhesive film and the top 0° skin ply. The second delamination observed in the $90^\circ/45^\circ$ flange ply interface (delamination A from Figure 13) requires more energy to initiate than available at the load levels used in this FE analysis, i.e., the loads corresponding to possible matrix ply crack initiation. The energy for this second delamination may come from an increase in load or may be caused by an increase in G_T due to the presence of the first delamination in the 0° skin ply/adhesive film interface. These two possibilities are studied in detail in the following paragraphs. The response of the numerical model with respect to the difference in axial moduli measured in tension and bending is discussed in reference 12. This discussion includes the effect of a lowered axial modulus on computed strain energy release rates for specimens subjected to bending and combined tension/bending loading.

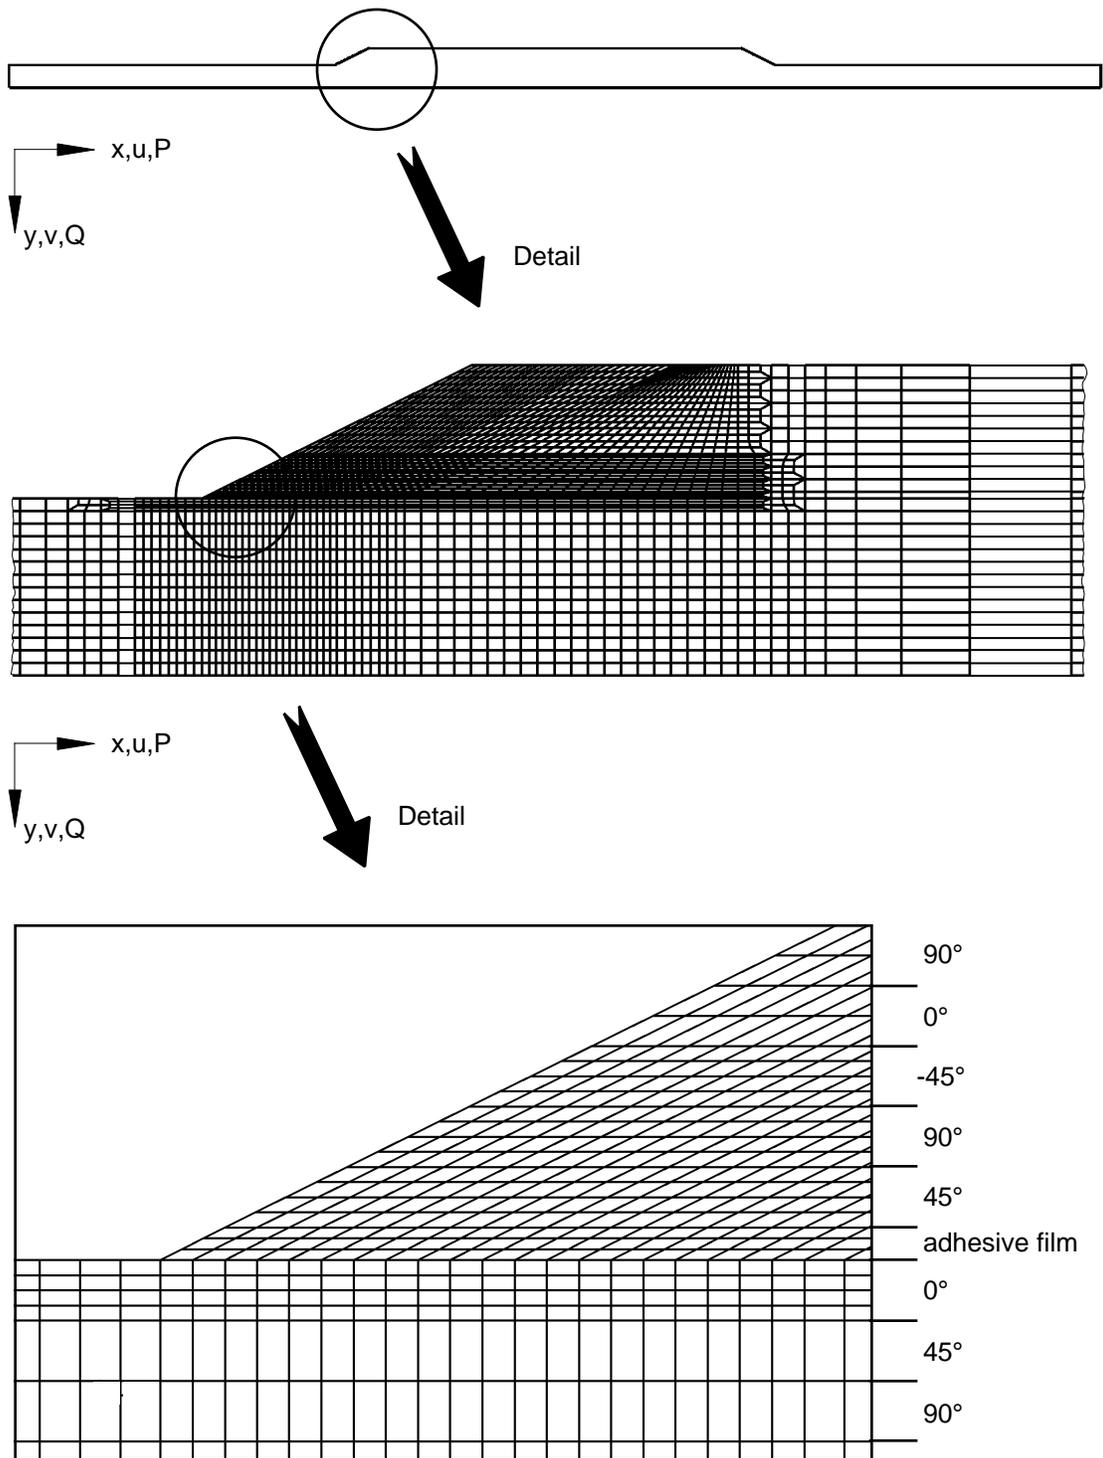
Figure 14. Finite Element Model of an Undamaged Specimen.

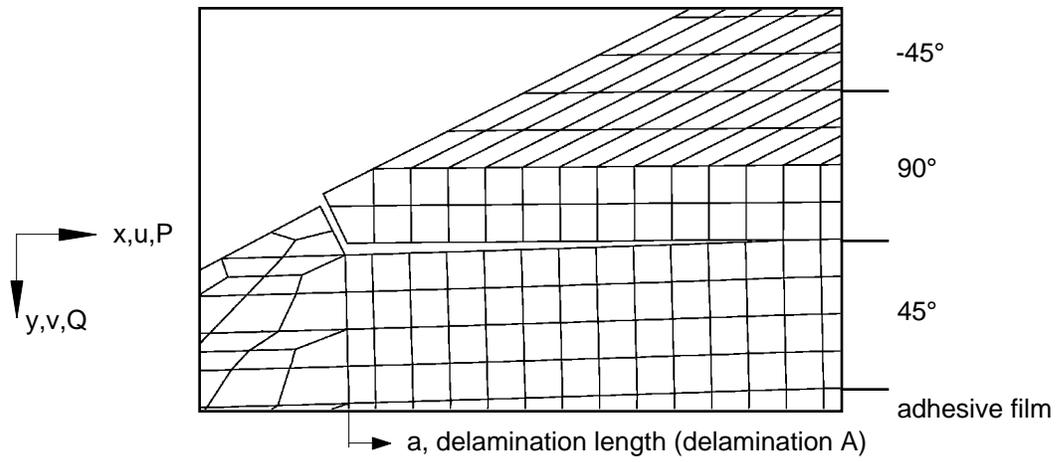
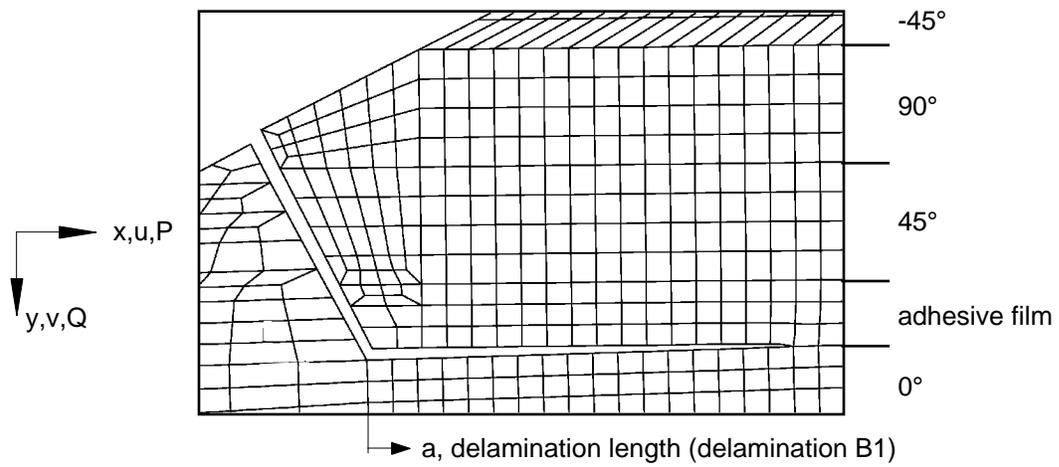
(a) Corners 1 and 4 (deformed geometry)

(b) Corners 2 and 3 (deformed geometry)

Figure 15. Modeled Damage Patterns.

The initial crack was modeled on one flange tip perpendicular to the flange taper as suggested by the microscopic investigation and the stress analysis described in the previous paragraph. Recall that the models of the discrete matrix cracks and delaminations are shown in Figure 15 in the deformed state. During the investigation, the delaminations were extended by adding new nodes at the crack tip and in front of the crack tip. These nodes were then assigned to the elements on one side of the crack thus creating a row of disconnected elements, which simulated the delamination as a discrete discontinuity. During a series of nonlinear finite element analyses, strain energy release rates were computed at each tip location for the flange debond load observed in the experiment. A simplified method was proposed in reference 16. In the current study, the delamination lengths, a , are measured from the end of the initial matrix crack as shown in Figure 15. For corners 1 and 4 (delamination in the 90°/45° flange ply interface), the delamination was extended to 0.6 mm which corresponds to a length where matrix crack branches were observed in the experiments as shown in Figures 12(b) and 13(a). The results are plotted in Figures 24 through 26 for all three loading conditions. Initial mode I and mode II values, computed at delamination onset ($a = 0.034$ mm, i.e., delamination length equal to the length of the first element as shown in Figure 15(a)), are similar for each type of test as shown in Table 5. In Figures 24 through 26, G_{II} for all load cases increases monotonically while G_I begins to level off.

In the current study, computed total strain energy release rates, G_T , were compared to the critical value, G_c , for the appropriate mixed mode ratio (G_{II}/G_T) for each load case in order to determine the potential for delamination growth. Values calculated for delamination onset ($a = 0.034$ mm, i.e., delamination length equal to the length of the first element as shown in Figure 15(a)) in the $90^\circ/45^\circ$ flange ply interface are below the fracture toughness data as shown in Table 5. Consequently, onset is unlikely to occur at the load corresponding to damage initiation for all three tests. Propagation in the 0° skin ply/adhesive film interface, on the other hand, will occur in all three cases as the computed results for delamination onset ($a = 0.04$ mm, i.e., delamination length equal to the length of the first element as shown in Figure 15(b)) are much higher than the

combined tension/bending load case computed values are smaller for the condition where delamination formation was assumed between the adhesive film and the top 0° skin ply. The computed values at delamination onset ($a = 0.034$ mm, i.e., delamination length equal to the length of the first element as seen in Figure 31) are shown in Figure 33 for delamination onset and flange debond load. The values computed previously for the condition without the assumed initial disbond (G_T from Table 5) were included in Figure 33 for comparison. Values for both load levels are again below the fracture toughness data, which suggests that delamination growth in the $90^\circ/45^\circ$ flange ply interface is also unlikely in the presence of a 10 mm long delamination in the 0° skin ply/adhesive film interface. Based upon this study it can be concluded that delamination growth in the $90^\circ/45^\circ$ flange ply interface cannot be explained using strain energy release rates based on two-dimensional plane strain FE analyses. The observed three-dimensional pattern of matrix cracks and delaminations seen in the specimens could not be accounted for with the current simple two-dimensional plane strain FE model. A detailed investigation of the delaminated area should include a local three-dimensional analysis, which allows to model the changing failure patterns across the width of the specimen (as shown in Figures 12 and 13) more realistically. The three-dimensional model therefore would provide additional results with respect to failure interaction and its development across the width of the specimen.

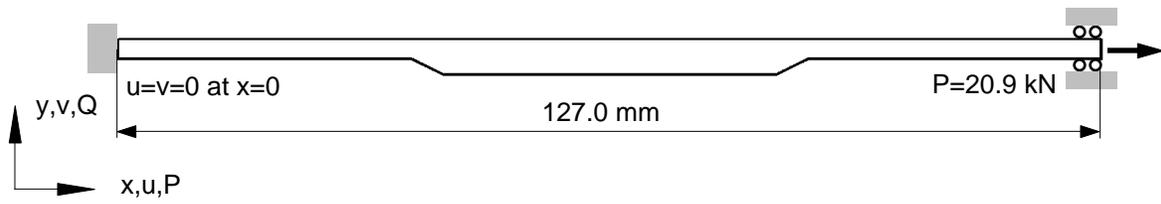
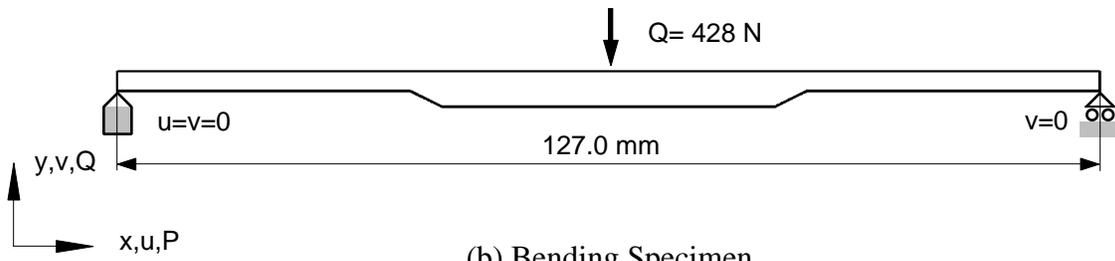
(a) Tension Specimen

(b) Bending Specimen

Figure 16. Loads and Boundary Conditions For Tension and Three-Point Bending Case.

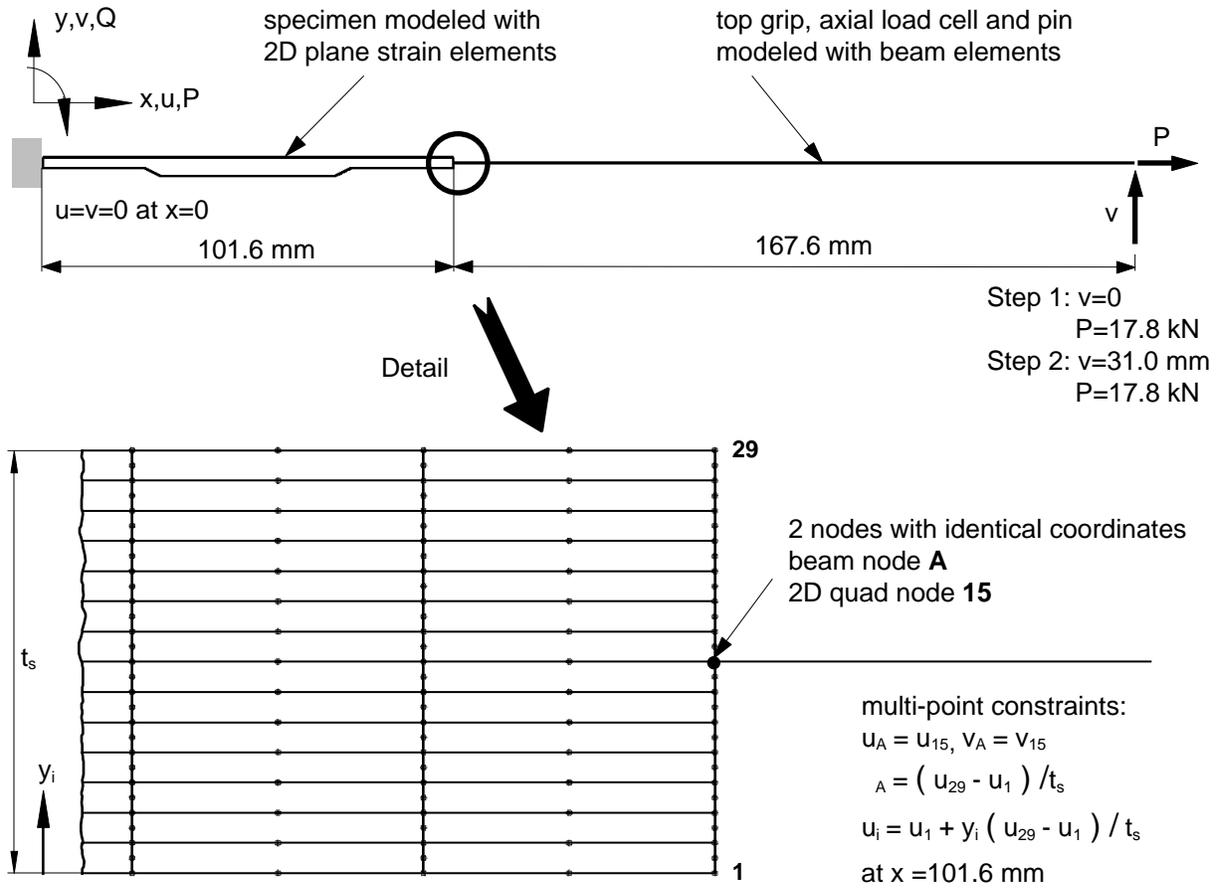
Figure 17. Loads and Boundary Conditions for the Combined Axial Tension and Bending Test.

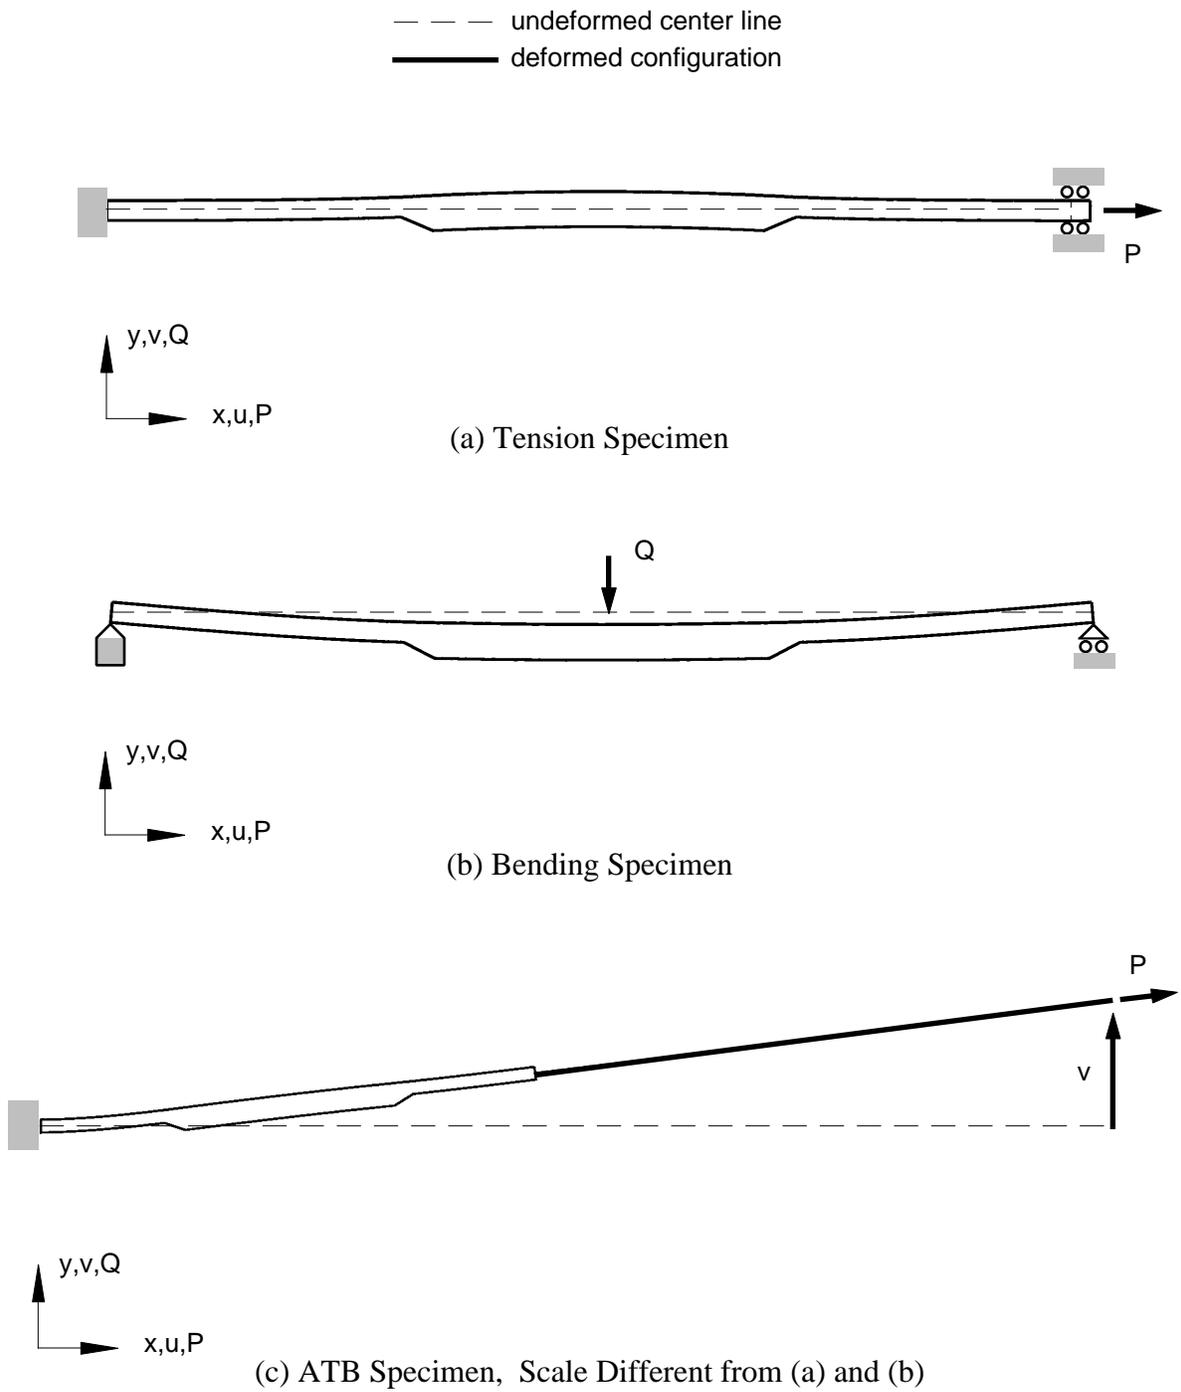
Figure 19. Deformed Test Specimen Geometries
