TESTING AND ANALYSIS OF COMPOSITE SKIN/STRINGER DEBONDING UNDER MULTI-AXIAL LOADING

A consistent step-wise approach is presented to investigate the damage mechanism in composite bonded skin/stringer constructions under uniaxial and biaxial (in-plane/out-of-plane) loading conditions. The approach uses experiments to detect the failure mechanism, computational stress analysis to determine the location of first matrix cracking and computational fracture mechanics to investigate the potential for delamination growth. In a first step, tests were performed on specimens, which consisted of a tapered composite flange, representing a stringer or frame, bonded onto a composite skin. Tests were performed under monotonic loading conditions in tension, three-point bending, and combined tension/bending to evaluate the debonding mechanisms between the skin and the bonded stringer. For combined tension/bending testing, a unique servohydraulic load frame was used that was capable of applying both in-plane tension and out-of-plane bending loads simultaneously. Specimen edges were examined on the microscope to document the damage occurrence and to identify typical damage patterns. For all three load

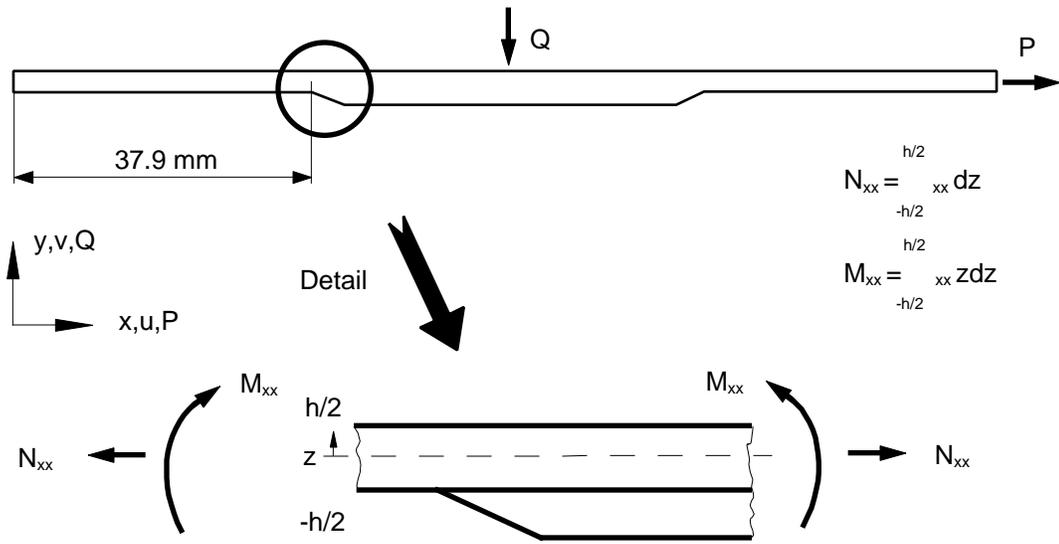
Figure 20. Calculation of Force and Moment Resultants.

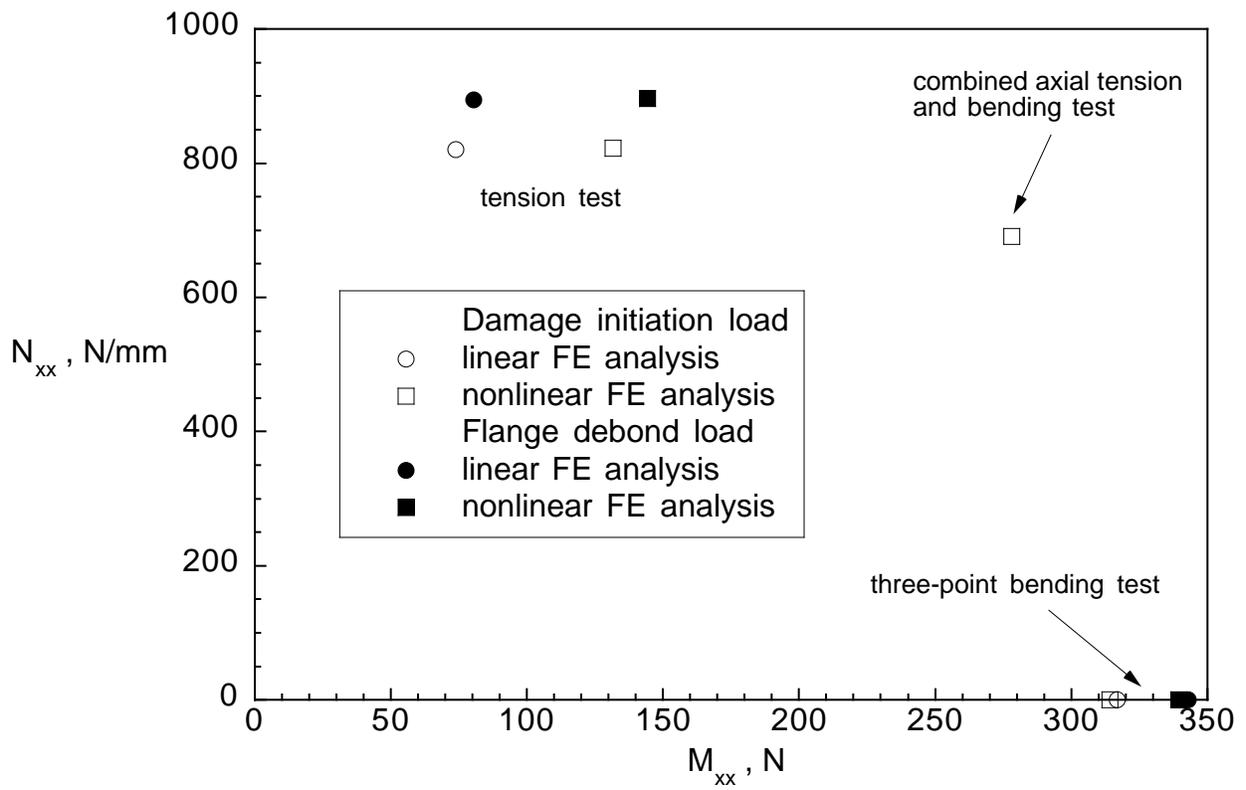
Figure 21. Computed Force and Moment Resultants at Flange Tip.

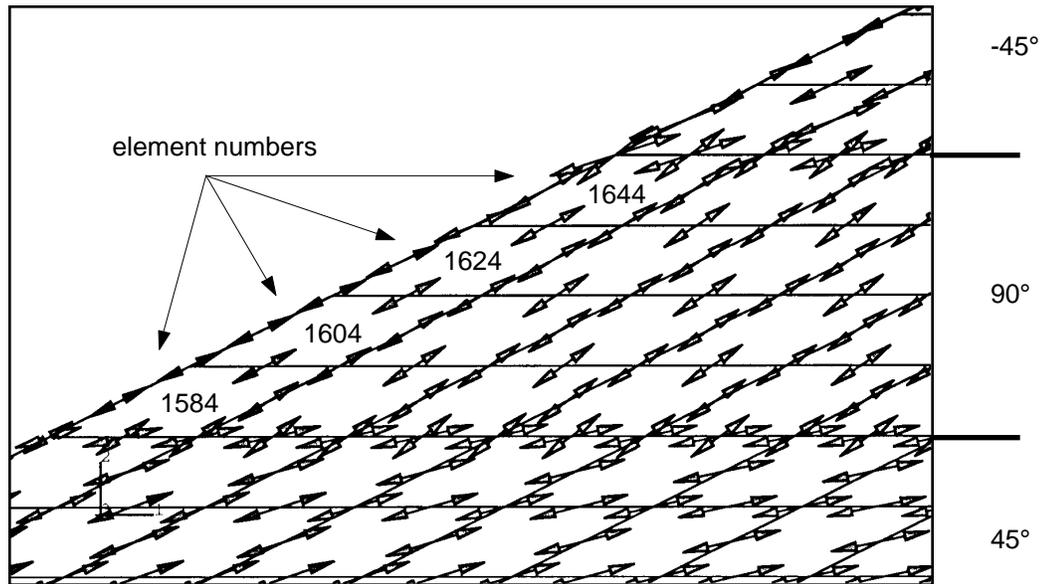
Figure 22. Trajectories of Maximum Principal Stresses.

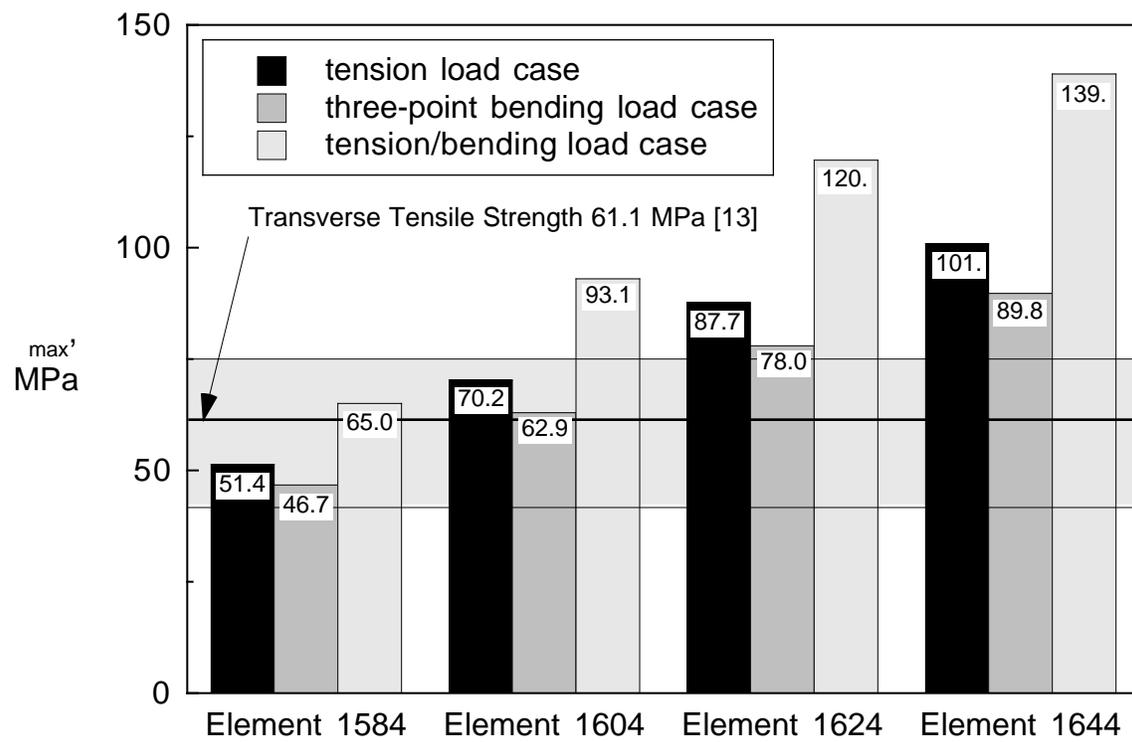
Figure 23. Comparison of Principal Tensile Stresses Computed at Damage Initiation Load.

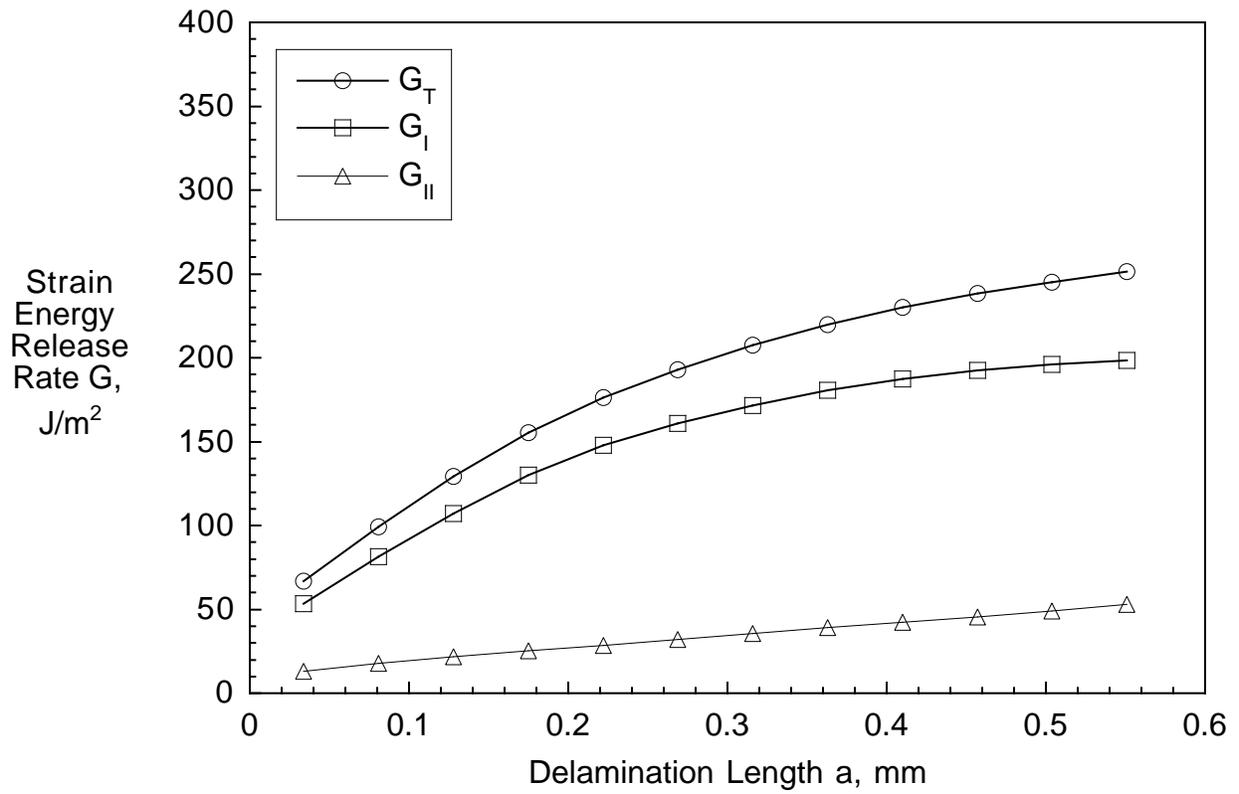
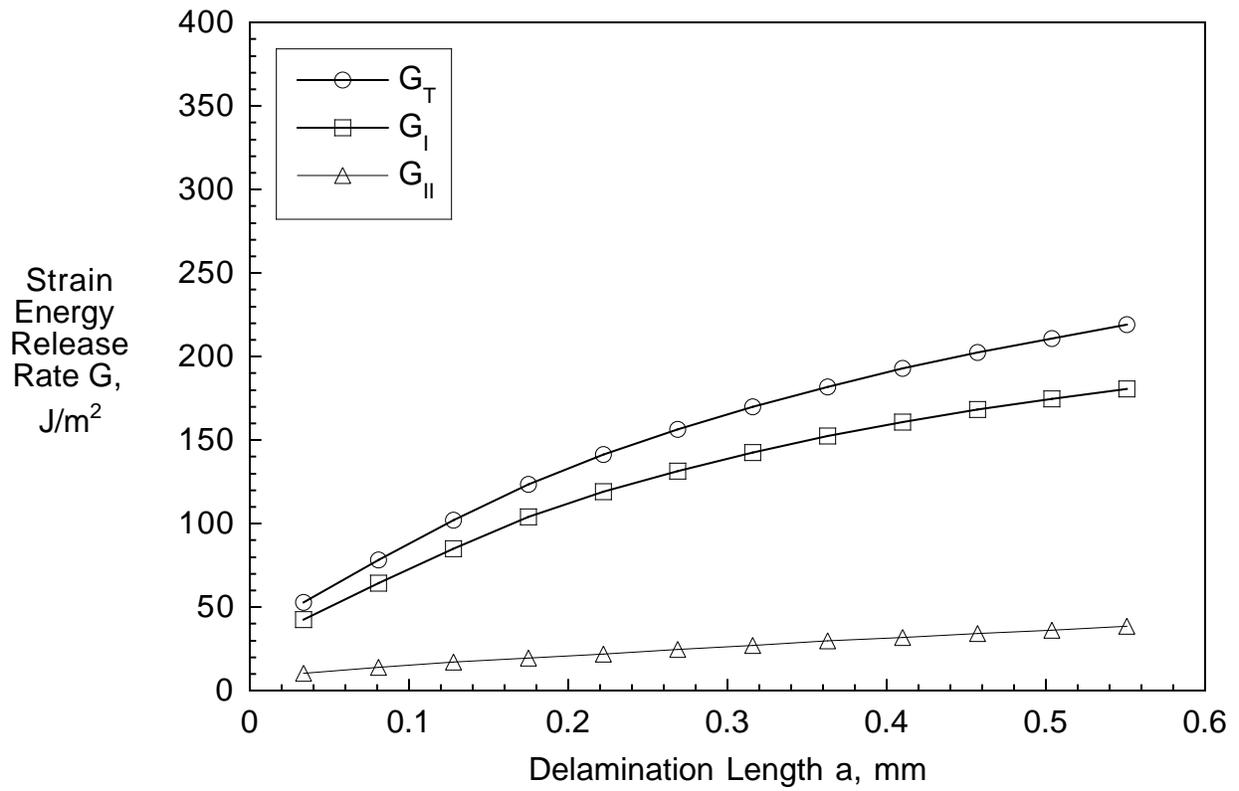
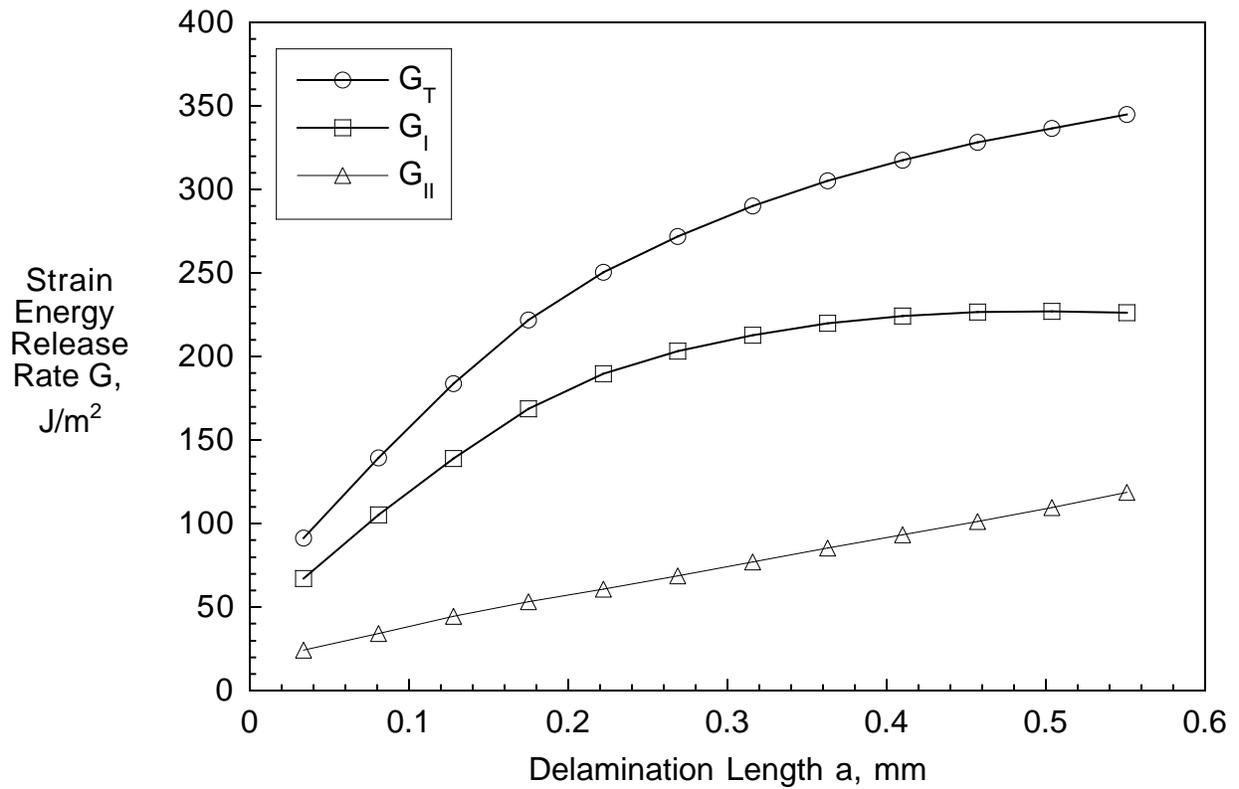
Figure 24. Computed Strain Energy Release Rates for Delamination Growth in a $90^\circ/45^\circ$ Flange Ply Interface for Tension Tests.

Figure 25. Computed Strain Energy Release Rates for Delamination Growth in a $90^\circ/45^\circ$ Flange Ply Interface for Three-Point Bending Tests.

Figure 26. Computed Strain Energy Release Rates for Delamination Growth in a $90^\circ/45^\circ$ Flange Ply Interface for ATB Tests.

The initial crack was modeled on one flange tip perpendicular to the flange taper as suggested by the microscopic investigation and the stress analysis described in the previous paragraph. Recall that the models of the discrete matrix cracks and delaminations are shown in Figure 15 in the deformed state. During the investigation, the delaminations were extended by adding new nodes at the crack tip and in front of the crack tip. These nodes were then assigned to the elements on one side of the crack thus creating a row of disconnected elements, which simulated the delamination as a discrete discontinuity. During a series of nonlinear finite element analyses, strain energy release rates were computed at each tip location for the flange debond load observed in the experiment. A simplified method was proposed in reference 16. In the current study, the delamination lengths, a , are measured from the end of the initial matrix crack as shown in Figure 15. For corners 1 and 4 (delamination in the 90°/45° flange ply interface), the delamination was extended to 0.6 mm which corresponds to a length where matrix crack branches were observed in the experiments as shown in Figures 12(b) and 13(a). The results are plotted in Figures 24 through 26 for all three loading conditions. Initial mode I and mode II values, computed at delamination onset ($a = 0.034$ mm, i.e., delamination length equal to the length of the first element as shown in Figure 15(a)), are similar for each type of test as shown in Table 5. In Figures 24 through 26, G_{II} for all load cases increases monotonically while G_I begins to level off.

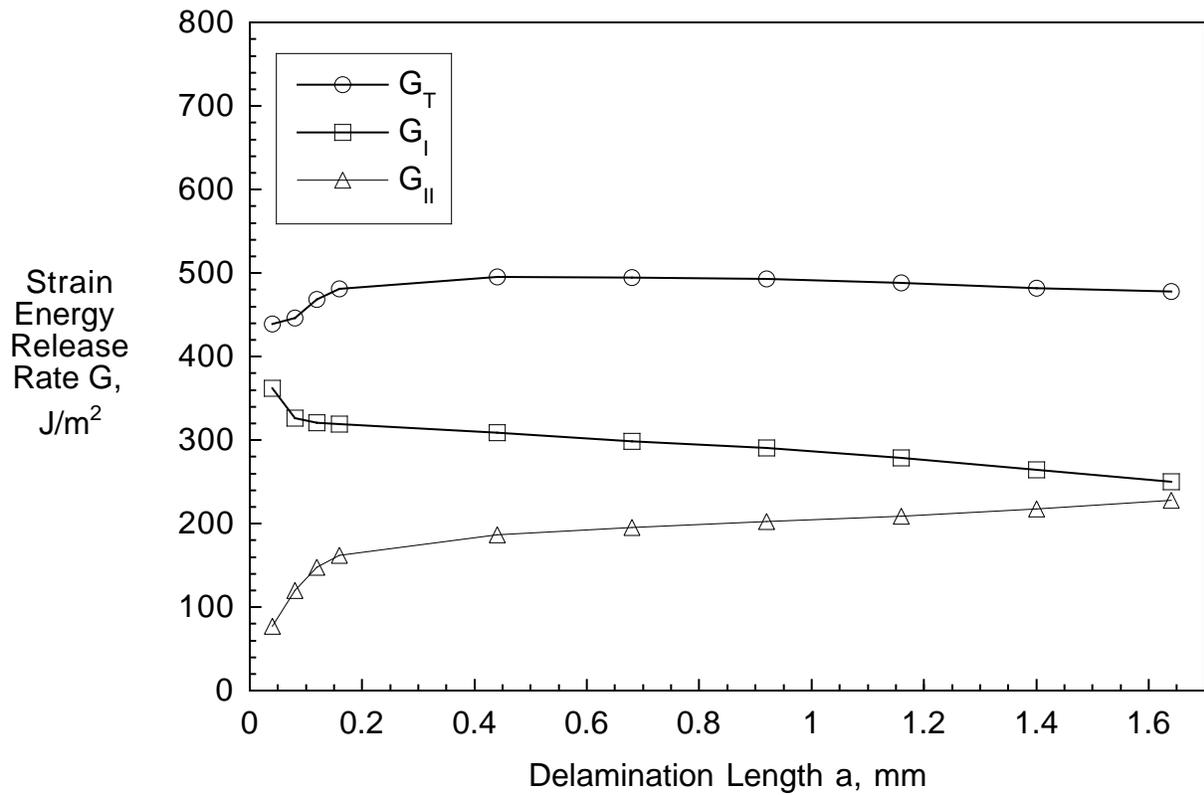
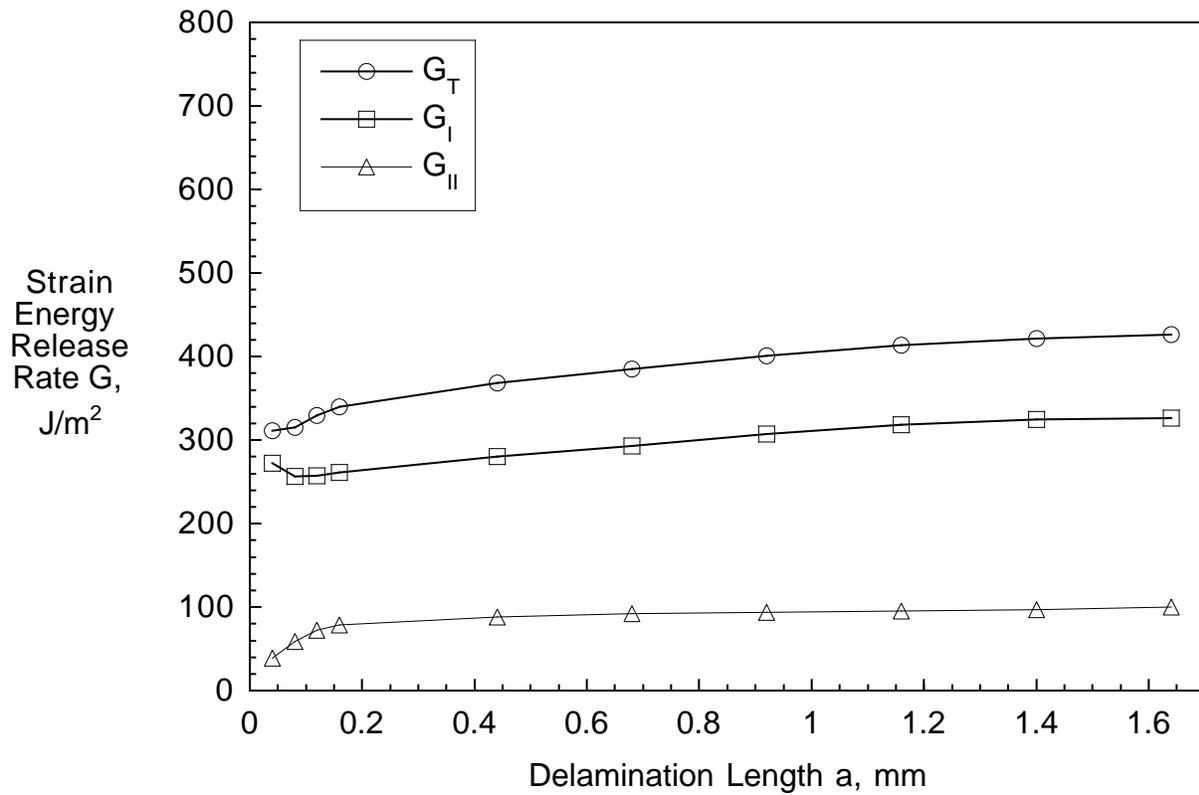
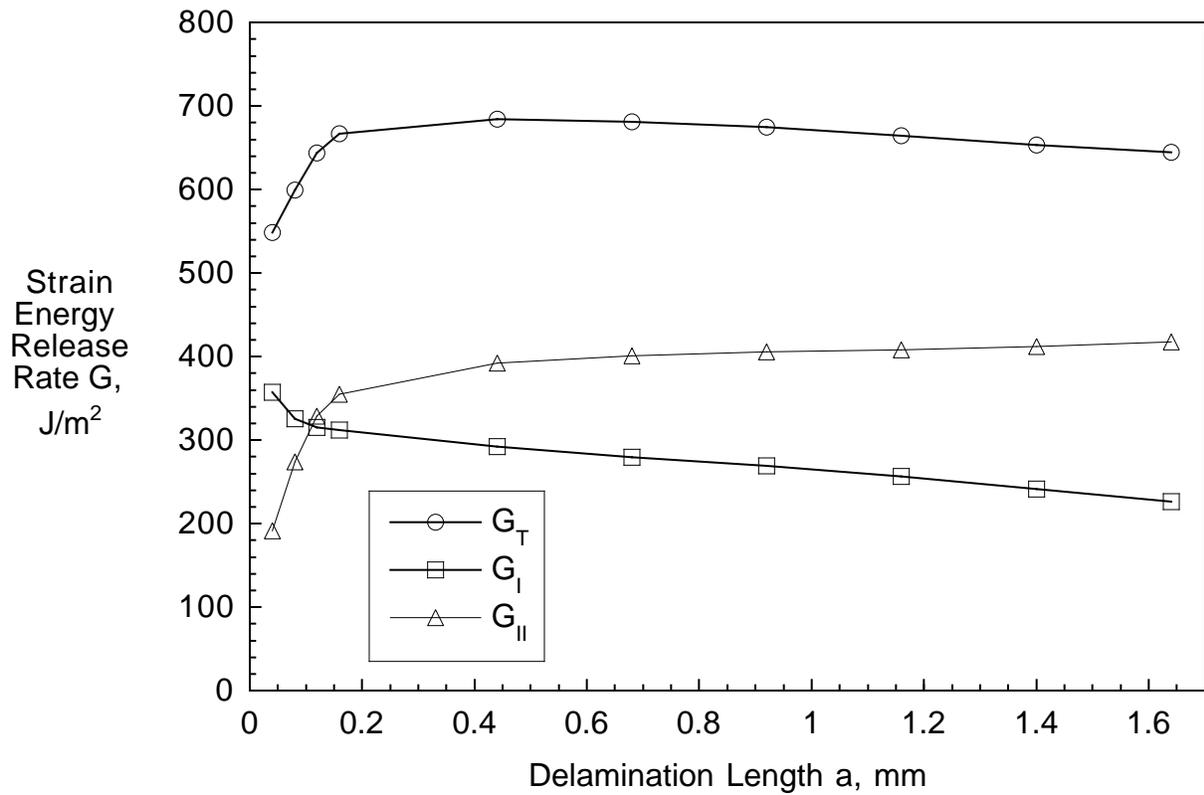
Figure 27. Computed Strain Energy Release Rates for Delamination Growth Between Adhesive and 0° Skin Ply for Tension Tests.

Figure 28. Computed Strain Energy Release Rates for Delamination Growth Between Adhesive and 0° Skin Ply for Three-Point Bending Tests.

Figure 29. Computed Strain Energy Release Rates for Delamination Growth Between Adhesive and 0° Skin Ply for ATB Tests.

For the simulated propagation along the 0° skin ply/adhesive film interface (corners 2 and 3) the delamination was extended to 1.6 mm. Plots of strain energy release rates computed for various delamination lengths are given in Figures 27 through 29. The computed values at delamination onset ($a = 0.04$ mm, i.e., delamination length equal to the length of the first element as shown in Figure 15(b)) are given in Table 6. Comparing all load cases, computed G_I results appear to have similar magnitudes. Mode II values, however, differ noticeably. As shown in Figures 27 through 29, at $a < 0.2$ mm the mode I contribution decreases with increasing

reported fracture toughness values as shown in Table 6. It is important to recall that in the experiments the failure was observed as a split in the 0° ply as shown in Figures 12 (c) and 14 (b). This failure was modeled as a delamination propagating between the adhesive film and the top 0° ply of the skin as shown in Figure 15 (b) only in order to avoid skewed elements. Hence, for predicting growth of the split in the 0° ply it is appropriate to compare energy release rates computed for the 0° skin ply/adhesive film interface with fracture toughness values obtained from standard tests. Unstable propagation is likely since the calculated G_T -values remain above the mixed-mode fracture toughnesses over the entire simulated length as shown in Figures 27 to 29. This assumption is confirmed by the experimental results of this study.

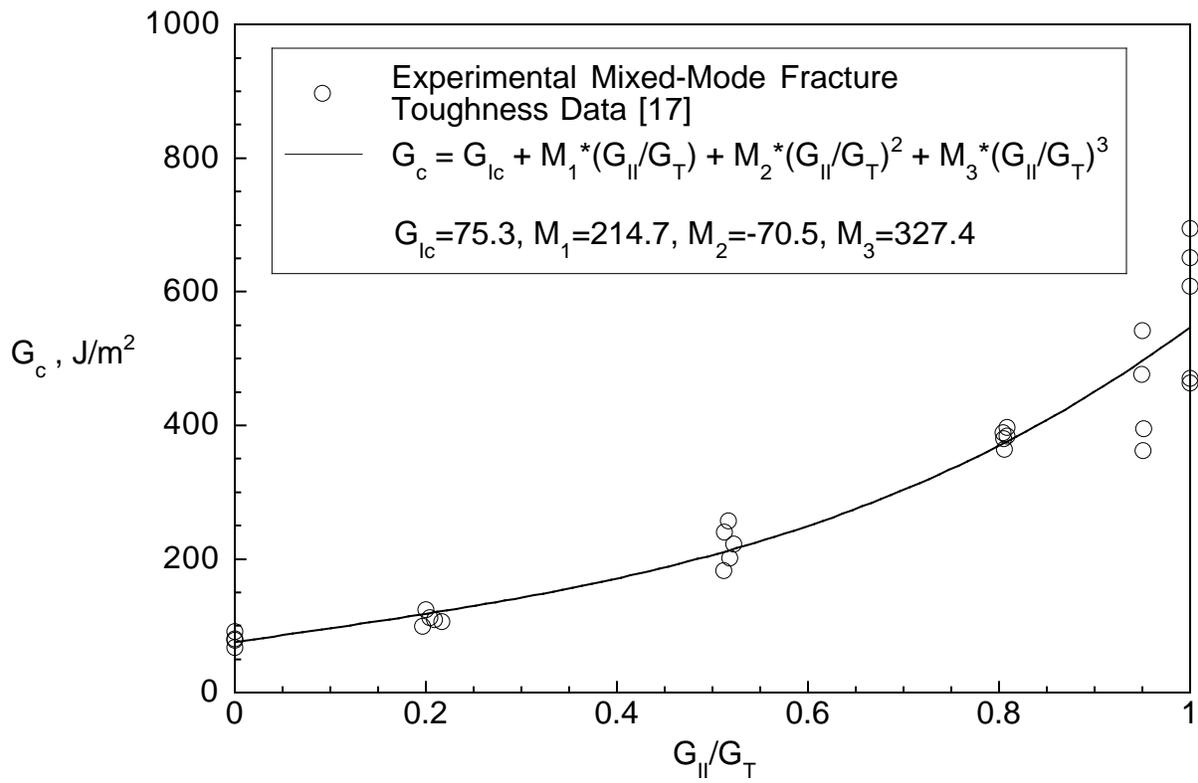
Figure 30. Mixed-Mode Delamination Criterion for AS4/3501-6 [18].

Accurate mixed-mode failure criteria are necessary for the prediction of delamination growth. A bilinear mixed-mode failure criterion was suggested in reference 17 for AS4/3501-6, a material similar to IM6/3501-6. The mixed-mode failure response was presented by plotting the mode I component of the mixed-mode fracture toughness versus the respective mode II component. A different approach to present the data was suggested in reference 18 where mixed-mode fracture toughness values, G_c , were plotted versus the mixed mode ratio G_{II}/G_T (see Figure 30). When this ratio is zero, G_c is simply the mode I fracture toughness, G_{Ic} . Alternatively, G_c becomes the mode II fracture toughness, G_{IIc} , when the mixed-mode ratio equals unity. An equation resulting from a least square regression cubic curve fit to these data defines the mixed-mode delamination fracture criterion for each ratio as:

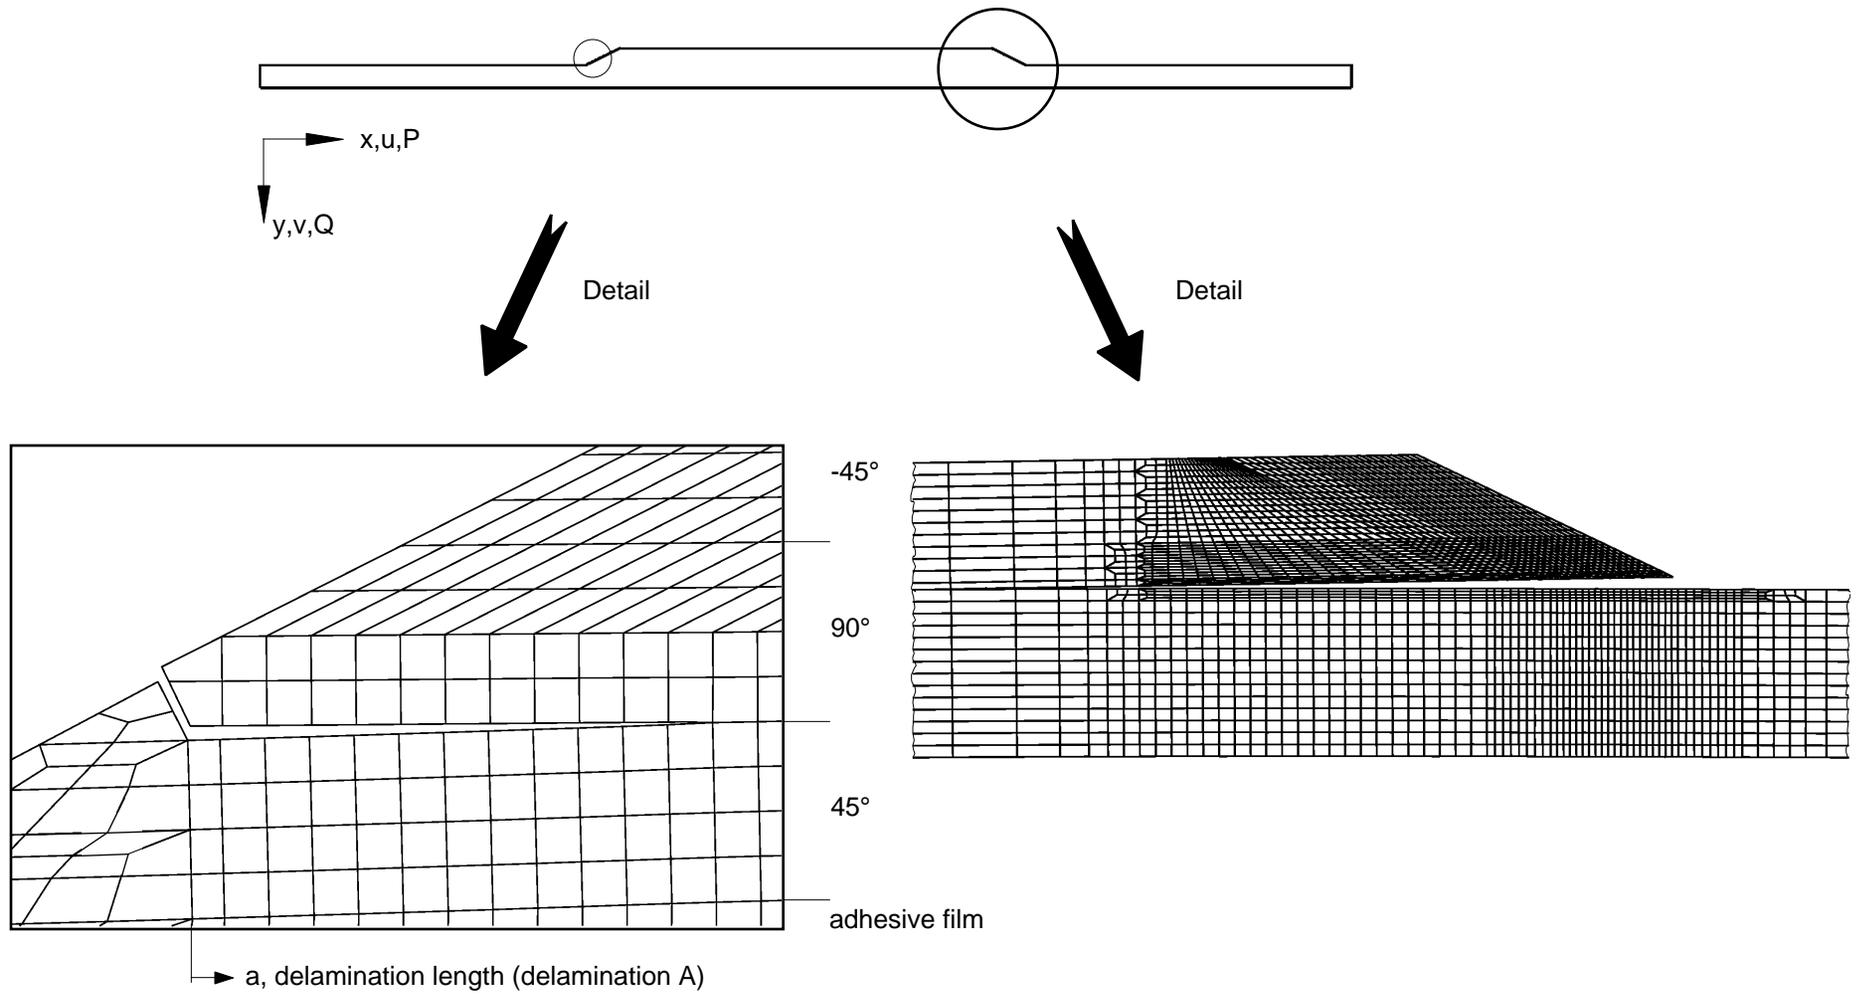
Figure 31. Finite Element Model of a Damaged Specimen.

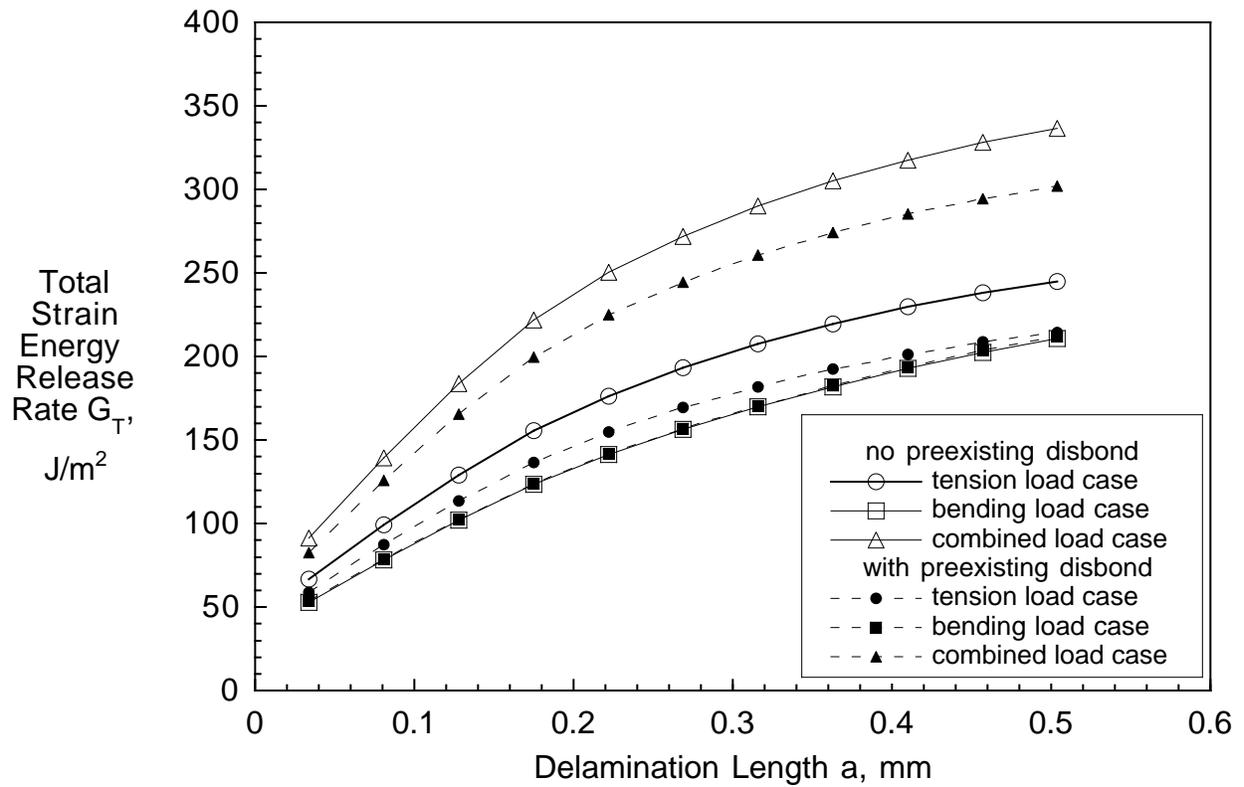
Figure 32. Computed Strain Energy Release Rates for Delamination Growth in a $90^\circ/45^\circ$ Flange Ply Interface with and without a Preexisting Disbond Between Adhesive and 0° Skin Ply.

Second, the possibility of an increase in G_T due to the presence of the first delamination was investigated. On one flange side a delamination of 10 mm was simulated between the adhesive film and the top 0° skin ply as an initial disbond. This length was kept constant during the remainder of the investigation. At the opposite taper, the delamination in the $90^\circ/45^\circ$ flange ply interface was modeled as described in the previous paragraph. The model is shown in Figure 31. Again, the second delamination was extended to 0.6 mm which corresponds to a length where matrix crack branches were observed in the experiments. The total strain energy release rates computed at loads corresponding to possible damage initiation are plotted in Figure 32 for all three loading cases. The values computed previously for the condition without the assumed initial disbond (G_T from Figures 24 through 26) were included in Figure 32 for comparison. For both conditions, G_T increases monotonically with growing delamination length. For the tension and

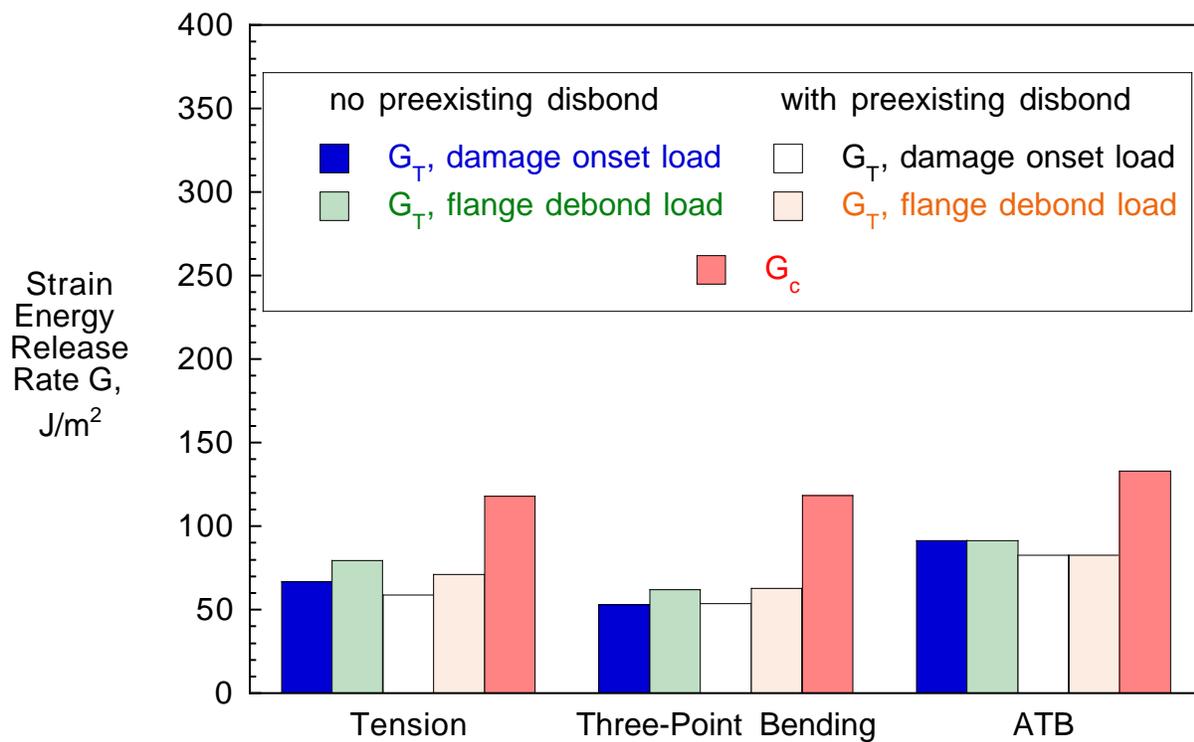
Figure 33. Comparison of Computed Total Strain Energy Release Rates in a $90^\circ/45^\circ$ Flange Ply Interface with Mixed-Mode Fracture Toughnesses.
