Ten-Year Ground Exposure of Composite Materials Used on the Bell Model 206L Helicopter Flight Service Program

Donald J. Baker

September 1994

Donald J. Baker
Vehicle Structures Directorate
U.S. Army Research Laboratory
Langley Research Center • Hampton, Virginia

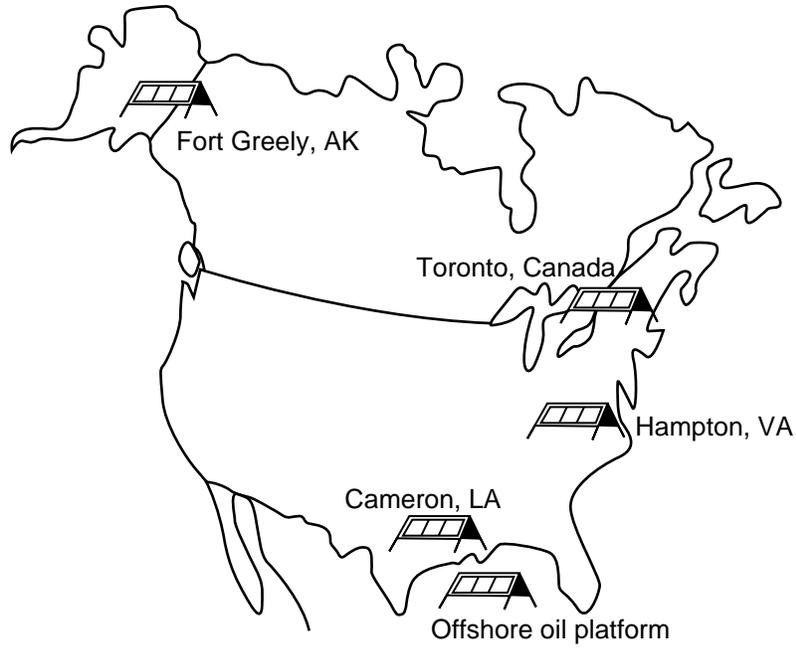
Figure 1. Location of exposure racks.

Coupon specimens have been exposed at five locations on the North American Continent, as shown in figure 1. The selected areas include a hot, humid, salt-spray environment (Cameron, Louisiana, and an offshore oil platform in the Gulf of Mexico), a cold environment (Fort Greely, Alaska); a cold, damp, pollution-prone environment (Toronto, Canada); and a mild, humid environment (Hampton, Virginia). The selected locations are in the general areas where helicopters with the composite components are being flown in service. Each location contains one rack, as shown in figure 2. The racks were installed

The exposure racks at Hampton, Virginia, Toronto, Canada, and Ft. Greely, Alaska (fig. 1), have been exposed to ground conditions for 10 years. The exposure racks at Cameron, Louisiana, and on the offshore oil platform in the Gulf of Mexico were exposed for 3 years before being lost to hurricanes in 1985. All data shown for 1 and 3 years of exposure are from five exposure sites, and data for 5, 7, and 10 years of exposure are from the three remaining sites. The paint on the specimens maintained its integrity for the duration of the program. The baseline strengths for the as-fabricated specimens are given in reference 1.

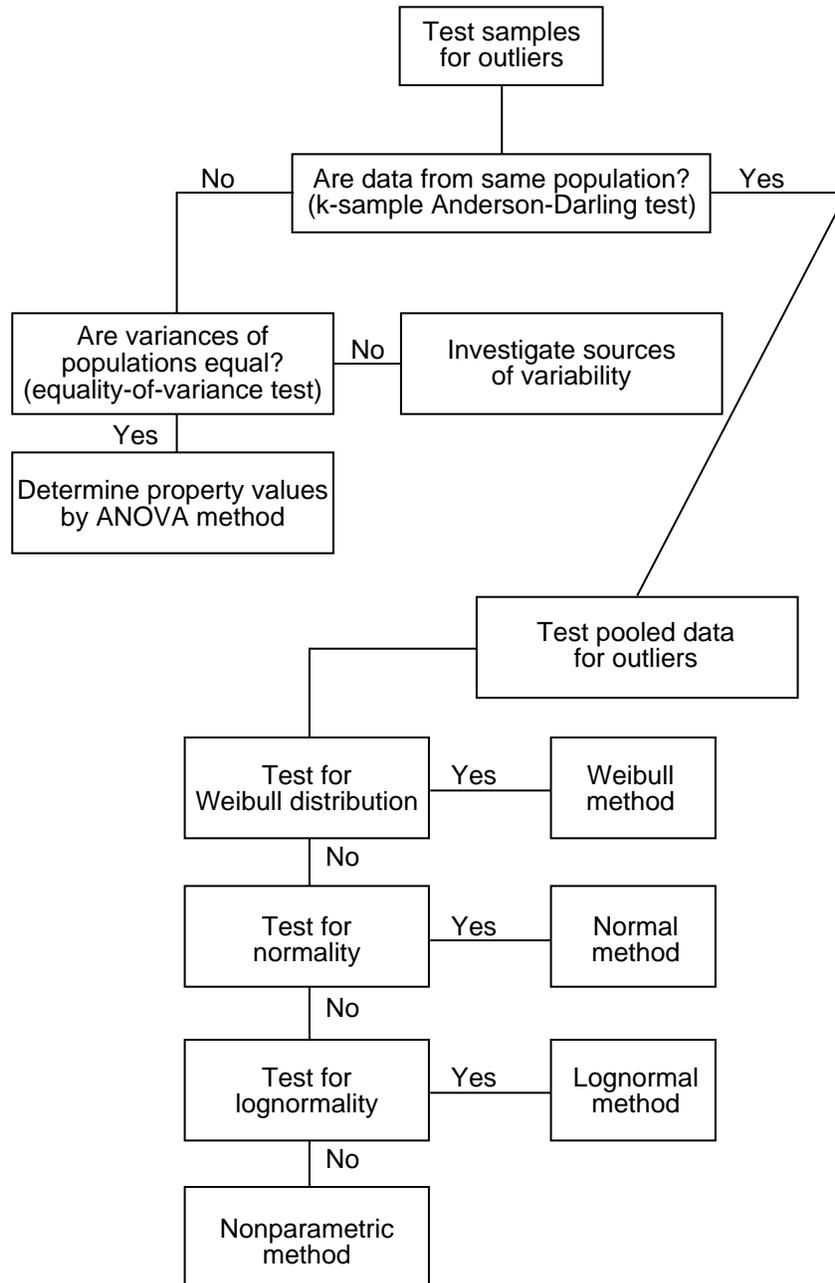
Figure 3. Flowchart of statistical procedure.

5. The pooled data are analyzed to determine the best fit to several statistical distributions. These tests yield an observed significance level (OSL) for each of the distributions. The OSL measures the probability of observing an Anderson-Darling statistic as extreme as the value that is calculated by assuming that the given distribution is the correct one. The test is applied sequentially to the two-parameter Weibull, normal, and lognormal distributions. If the OSL is greater than 0.05, the distri-

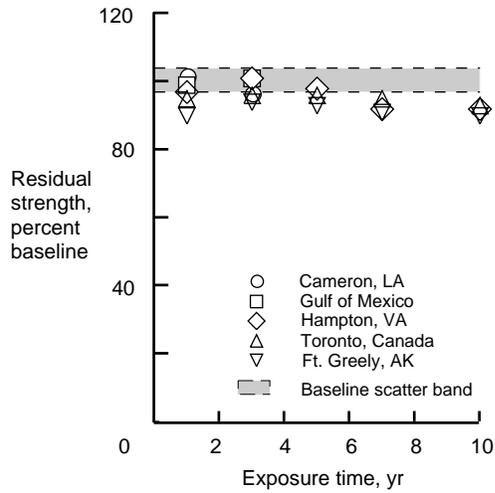
Figure 4. Effect of exposure time and location on residual compression strength of Kevlar-49/F-185.

Compression tests of the composite materials were conducted using the IITRI specimen to determine the effect of exposure and exposure site on the residual compression strength. The mean compression failure strength and the standard deviation for each exposure time and exposure site are given in tables 1 through 4. The residual compression strength as a function of the exposure time and the exposure location are presented in figures 4 through 7. The residual strength shown in the figures is the ratio of the mean failure stress to the mean baseline compressive strength for the material. Each figure also shows the scatter band in baseline strength for each material.

The statistical procedure just noted was applied to all the data for Kevlar-49/F-185 material tested in compression. No outliers were observed in any of the 20 samples. The computed Anderson-Darling statistic of 2.91 exceeded the critical value of 1.28; therefore, the sample distributions differ significantly. The computed test statistic for the equality-of-variance test is 18.88, which is less than the critical value of 30.14. The within-samples variances are not significant for the 0.05 significance level; thus, the ANOVA method was used to compute the B-value of 17.7 ksi. This value and the minimum, maximum, and standard deviation values for the population are given in table 5.

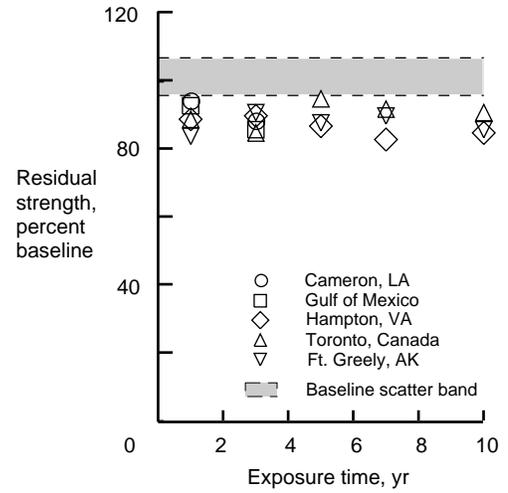
Figure 5. Effect of exposure time and location on residual compression strength of Kevlar-49/LRF-277.

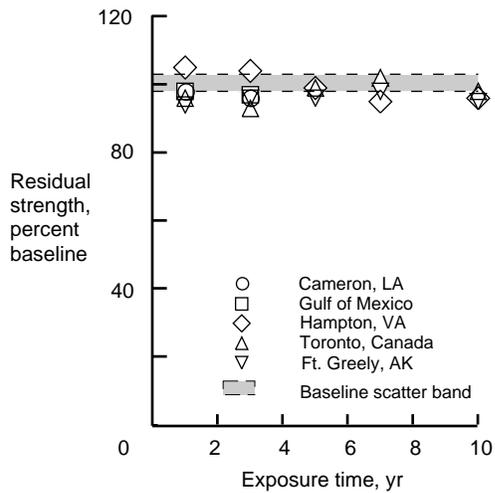
Figure 6. Effect of exposure time and location on residual compression strength of Kevlar-49/CE-306.

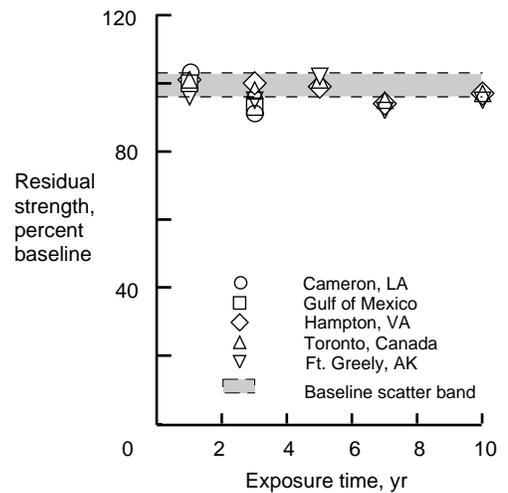
Figure 7. Effect of exposure time and location on residual compression strength of T-300/E-788.

T-300/E-788. Residual compression strength results for the T-300 graphite/E-788 epoxy material are shown in figure 7. The results do not indicate any significant trends with exposure time. The average residual strength loss did not exceed 6 percent. Specimens removed after 3 years of exposure indicated a 10-percent variance caused by exposure location, and the variance of specimens at other exposure times ranged from 2 to 7 percent. The statistical procedure was applied to all the material tested in compression. Two outliers were indicated in two different samples. Further investigation indicated that both outliers were within the minimum and maximum values of the total population. The computed Anderson-Darling statistic of 1.57 exceeded the critical value of 1.28; therefore, the sample distributions differ significantly. The computed test statistic for the equality-of-variance test is 23.04, which is less than the critical value of 30.14. Since the within-samples variances are not significant for the 0.05 significance level, the ANOVA method was used to compute the 111.0 ksi B-value. The B-value and the minimum, maximum, and standard deviation values for the population are given in table 5.

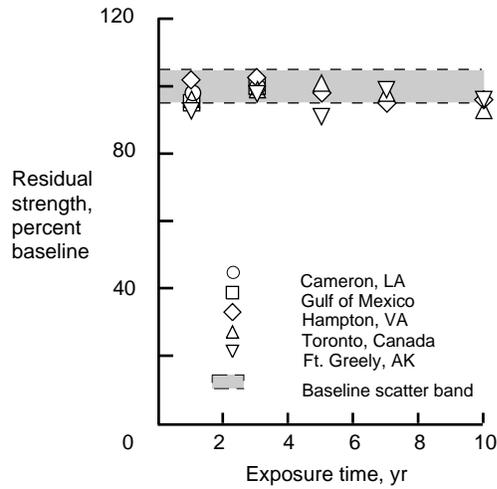
Figure 8. Effect of exposure time and location on residual SBS strength of Kevlar-49/F-185.

Kevlar-49/F-185. Residual SBS strength results for Kevlar-49/F-185 epoxy material are shown in figure 8. The effects of exposure location indicate a 10-percent variation in strength at 1 and 5 years of exposure, while the variability was 3 to 5 percent for the other exposure times. The average loss of strength after 10 years of exposure was 5 percent. No significant trends were observed during the exposure time. The statistical procedure just noted was applied to all the data for Kevlar-49/F-185 material tested for SBS strength. Three outliers were determined in three different samples. Two of the outliers were within the data limits for the population. The other outlier determined the minimum data value for the population, and it is approximately 0.4 ksi lower than the next data value. Review of the test data did not indicate a reason for these data to be excluded from the population. The computed Anderson-Darling statistic of 1.92 exceeded the critical value of 1.28; therefore, the sample distributions differ significantly. The computed test statistic for the equality-of-variance test is 51.28, which is greater than the critical value of 30.14. These data have failed the equality-of-variance test. The within-samples variances are significant for the 0.05 significance level. The MIL-HDBK-17-1C currently does not have an approved method for computing the B-value when the equality-of-variance test fails. Passing the equality-of-variance test is one of the assumptions required for the ANOVA method. The MIL-HDBK-17-1C suggests that the ANOVA method can often be applied successfully when this assumption is not met. Using the ANOVA method, the B-value computed is 5.40 ksi, and it and the minimum, maximum, and standard deviation values for the population are shown in table 10. The computed value of 5.40 ksi is acceptable at 92 percent of the population mean.

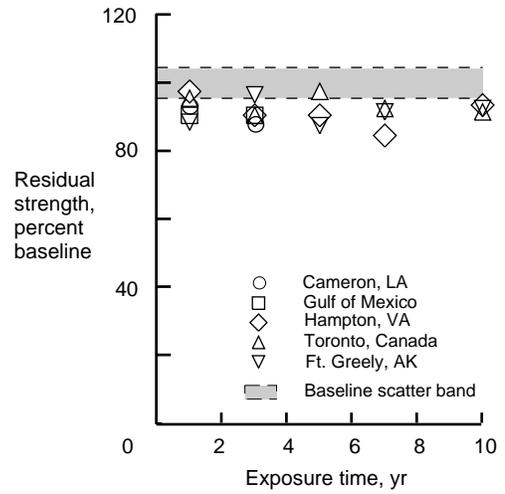
Figure 9. Effect of exposure time and location on residual SBS strength of Kevlar-49/LRF-277.

Short-beam-shear (SBS) tests of the composite materials were conducted to determine the effects of exposure and exposure site on the residual SBS strength. The mean SBS strength and the standard deviation for each exposure time and exposure site are given in tables 6 through 9. The residual SBS strength as a function of the exposure time and the exposure location are presented in figures 8 through 11. The residual strength shown in the figures is the ratio of the mean failure stress to the mean baseline SBS strength for the material type.

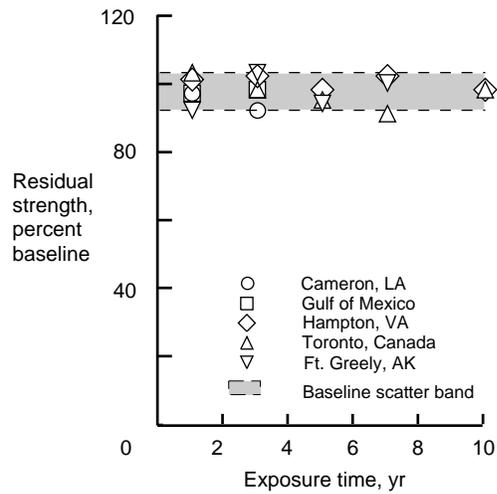
Figure 10. Effect of exposure time and location on residual SBS strength of Kevlar-49/CE-306.

Kevlar-49/CE-306. Residual SBS strength results for Kevlar-49/CE-306 epoxy material are shown in figure 10 as a function of the exposure time and the exposure location. The specimens for 10 years of exposure at Ft. Greely, Alaska, were not returned with the tray of specimens and could not be located. Therefore, this data set contains only 19 samples and 114 specimens. The data indicate an 11-percent variation caused by exposure location for 1, 3, and 7 years of exposure. No significant trends are evident and most of the data fell within the scatter band for the baseline specimens. The statistical procedure was applied to all of the material tested for SBS strength. No outliers were indicated in 19 samples of data. The computed Anderson-Darling statistic of 1.54 exceeded the critical value of 1.29; therefore, the sample distributions differ significantly. The computed test statistic for the equality-of-variance test is 14.42, which is less than the critical value of 28.87. Since the within-samples variances are not significant at the 0.05 significance level, the ANOVA method was used to compute the 4.68 ksi B-value. The B-value and the minimum, maximum, and standard deviation for the population are given in table 10.

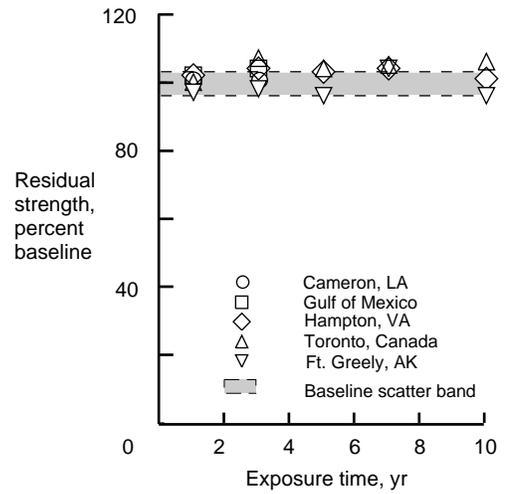
Figure 11. Effect of exposure time and location on residual SBS strength of T-300/E-788.

T-300/E-788. Residual SBS strength results for the T-300/E-788 graphite/epoxy material are shown in figure 11 as a function of the exposure time and the exposure location. The results do not indicate any significant trends with the exposure time or the exposure location. The average residual strength is equal to or exceeds the baseline average strength. The variation caused by location is between 5 and 10 percent. The statistical procedure was applied to all the T-300/E-788 material tested for SBS strength. Two outliers were indicated in two different samples. Further investigation indicated that both outliers were within the minimum and maximum values of the total population. The computed Anderson-Darling statistic of 1.35 exceeded the critical value of 1.28; therefore, the sample distributions differ significantly. The computed test statistic for the equality-of-variance test is 30.49, which is

greater than the critical value of 30.14. These data have failed the equality-of-variance test; therefore, the within-samples variances are significant for the 0.05 significance level. The MIL-HDBK-17-1C does not currently have an approved method for computing the B-value when the equality-of-variance test fails. Passing the equality-of-variance test is one of the assumptions required for the ANOVA method. The MIL-HDBK-17-1C suggests that the ANOVA method can often be applied successfully when this assumption is not met. Using the ANOVA method, the B-value computed is 10.3 ksi, and it is shown in table 10 with the minimum, maximum, and standard deviation values for the population. The computed B-value of 10.3 ksi is acceptable at 88 percent of the population mean.

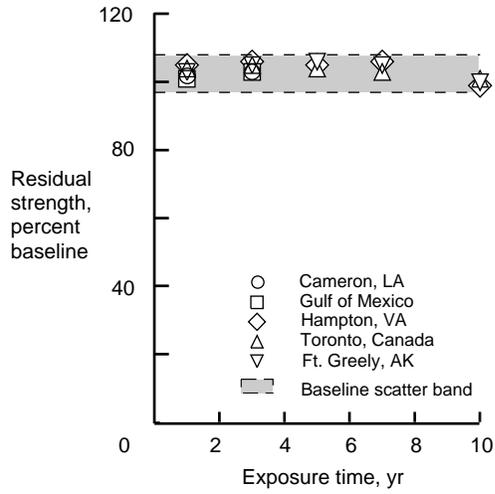
Figure 12. Effect of exposure time and location on residual tension strength of Kevlar-49/F-185.

Kevlar-49/F-185. Residual tension strength results for Kevlar-49/F-185 epoxy are shown in figure 12. All the average strengths of the exposed specimens are within the baseline scatter band. No significant trends were observed during the exposure time. The statistical procedure noted above was applied to all the data for Kevlar-49/F-185 material tested in tension. Four outliers were determined in three different samples. Two of the outliers were within the data limits for the population. The other outliers were the minimum and the next lowest value for the population. Review of the test data did not indicate a reason for these

data to be excluded from the population. The computed Anderson-Darling statistic of 1.67 exceeded the critical value of 1.28; therefore, the sample distributions differ significantly. The computed test statistic for the equality-of-variance test is 65.95, which is greater than the critical value of 30.14. These data have failed the equality-of-variance test. The within-samples variances are significant for the 0.05 significance level. The MIL-HDBK-17-1C does not currently have an approved method for computing the B-value when the equality-of-variance test fails. Passing the equality-of-variance test is one of the assumptions required for the ANOVA method. The MIL-HDBK-17-1C suggests that the ANOVA method can often be applied successfully when this assumption is not met. Using the ANOVA method, the B-value computed is 55.5 ksi, and it and the minimum, maximum, and standard deviation values for the population are shown in table 15. The computed value of 55.5 ksi is acceptable at 94 percent of the population mean.

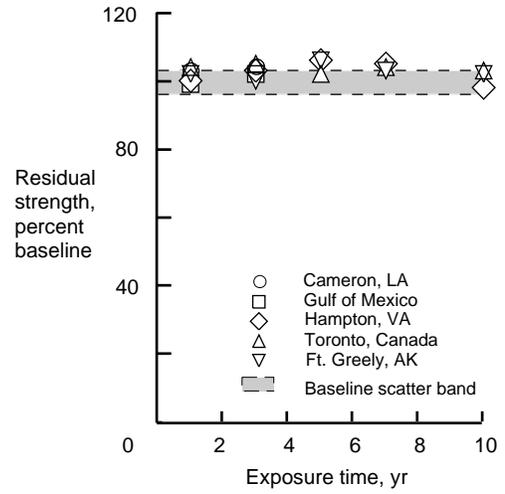
Figure 13. Effect of exposure time and location on residual tension strength of Kevlar-49/LRF-277.

Kevlar-49/LRF-277. Residual tension strength results for the Kevlar-49/LRF-277 epoxy material are shown in figure 13 as a function of the exposure time and the exposure location. No significant trends were observed during the exposure time. The statistical procedure was applied to all the Kevlar-49/LRF-277 material. One outlier was observed in one of the 20 samples. The outlier was within the maximum and the minimum of the population. Review of the test data did not indicate a reason for this outlier to be excluded for this population. The computed Anderson-Darling statistic of 1.12 is less than the critical value of 1.28; therefore, the test is not significant for the 0.05 level. The batch distributions are not significantly different, and the samples should be treated as a single sample. Two outliers were indicated in the pooled data. These outliers are the two lowest values in the pooled data. Review of the pooled data does not indicate a reason that these two points should be excluded from the population. The goodness-of-fit test of the pooled data for the two-parameter Weibull distribution yielded an OSL of 0.839. The computed B-value from the two-parameter Weibull distribution is 79.1 ksi. The B-value and the minimum, maximum, and standard deviation values for the population are given in table 15.

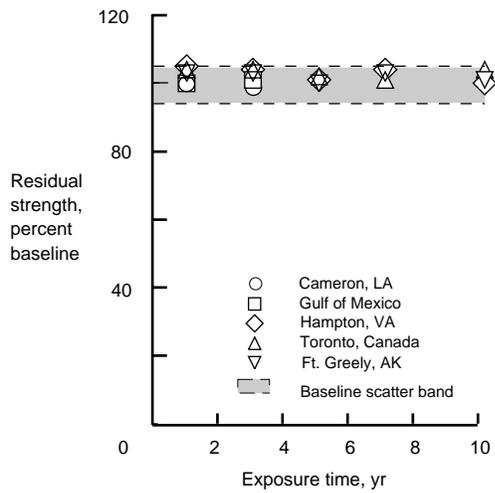
Figure 14. Effect of exposure time and location on residual tension strength of Kevlar-49/CE-306.

specimens. The statistical procedure was applied to all the Kevlar-49/CE-306 material tested in tension. One outlier was indicated in the 20 samples of data. This outlier is within the bounds of the total population of data. The computed Anderson-Darling statistic of 1.45 exceeded the critical value of 1.28; therefore, the sample distributions differ significantly. The computed test statistic for the equality of variance is 30.51, which is greater than the critical value of 30.14. These data have failed the equality-of-variance test; therefore, the within-samples variances are significant for the 0.05 significance level. Using the ANOVA method, as recommended by MIL-HDBK-17-1C, the B-value computed is 58.9 ksi, and it and the minimum, maximum, and standard deviation values for the population are shown in table 15. The computed value of 58.9 ksi is acceptable at 95 percent of the population mean.

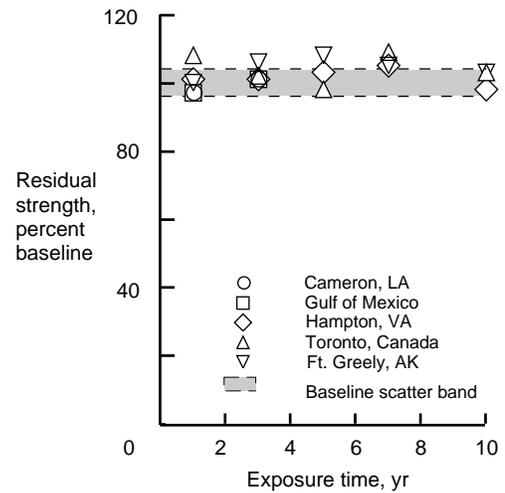
Figure 15. Effect of exposure time and location on residual tension strength of T-300/E-788.

Tension tests were conducted on the composite materials to determine the effect of exposure time and exposure site on the residual tension strength. The mean tension strength and the standard deviation for each exposure time and exposure site are given in tables 11 through 14. The effect of exposure location and the exposure time on the residual tension strength of each material is presented in figures 12 through 15. Each figure also includes the scatter band for the specimens tested to determine the baseline strength. The residual strength shown in the figures is the ratio of the mean failure stress to the mean baseline tension strength for the material type.

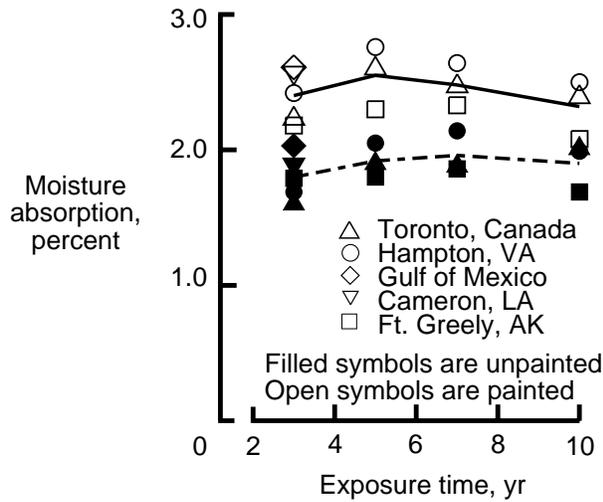
Figure 16. Moisture absorption of Kevlar-49/
F-185 composite material.

A summary of the moisture absorption for unpainted material specimens is given in table 17 and shown in figures 16 through 19. Each data point (filled symbol) for the unpainted material is from a single specimen. A dashed line connects the average moisture absorption data points for the unpainted specimens for each exposure time. The Kevlar-49/F-185 material absorbs approximately 0.5 percent more moisture when painted. Paint on the other Kevlar-49 material systems does not have a significant effect on the moisture absorption. The painted T-300/E-788 graphite/epoxy material absorbs approximately 0.1 percent more moisture than the unpainted system.

The Kevlar-49/F-185 material absorbs approximately 0.5 percent more moisture when it is painted. Paint on the other Kevlar-49 material systems does not have a significant effect on moisture absorption. The painted T-300/E-788 graphite/epoxy absorbs approximately 0.1 percent more moisture than the unpainted system.

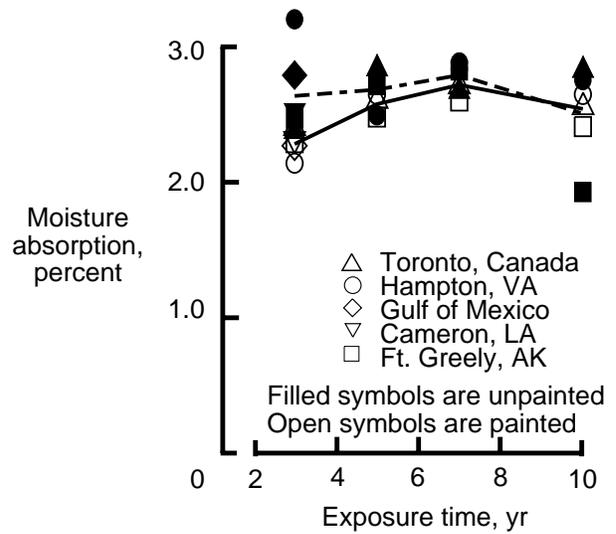
Figure 17. Moisture absorption of Kevlar-49/
LRF-277 composite material.

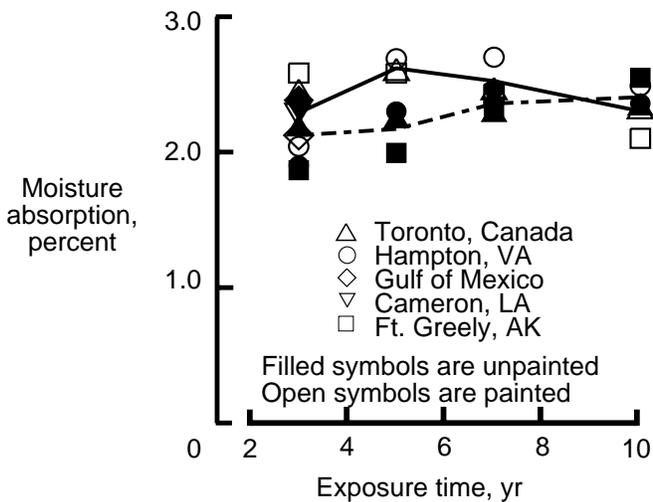
Figure 18. Moisture absorption of Kevlar-49/
CE-306 composite material.

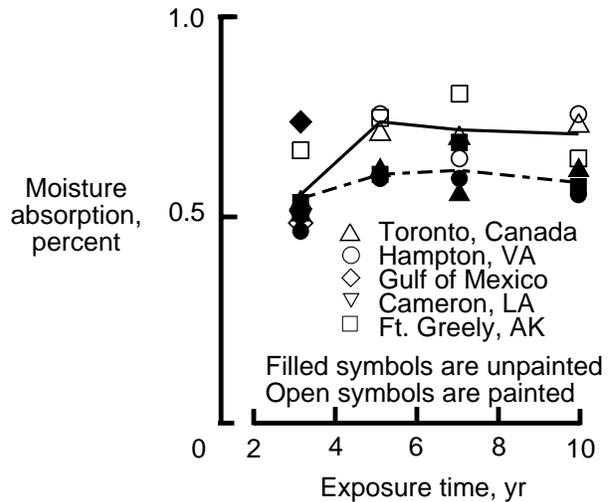
Figure 19. Moisture absorption of T-300/E-788
composite material.

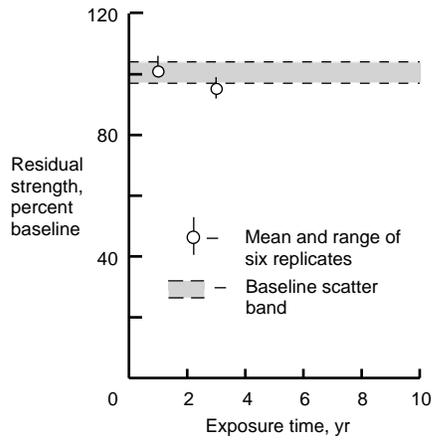
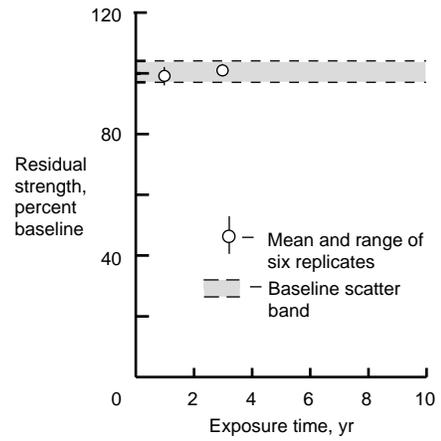
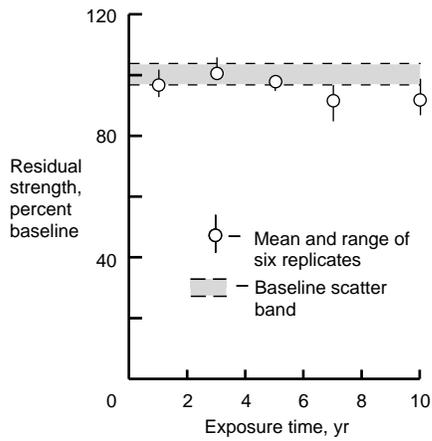
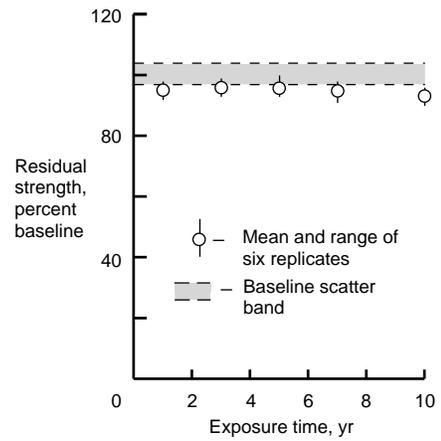
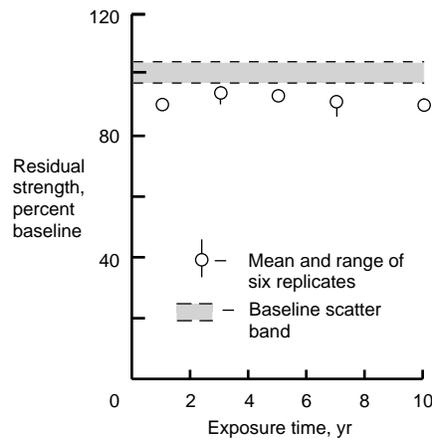
Figure A1. Residual compression strength of Kevlar-49/F-185 epoxy specimens exposed at locations shown.

The residual strength tables A1 through A12 in this appendix include exposure time, specimen size, failure load, and computed failure stress. The residual strengths for each material as a function of exposure time for each exposure location are added to the figures shown in reference 1 and are provided in this appendix.

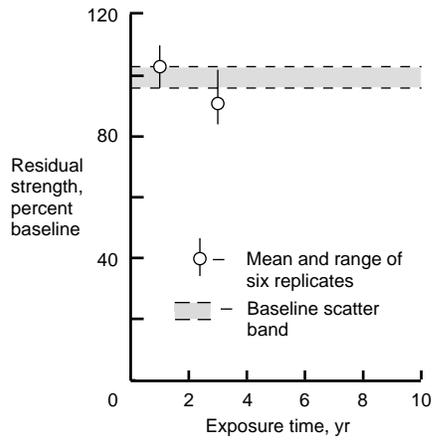
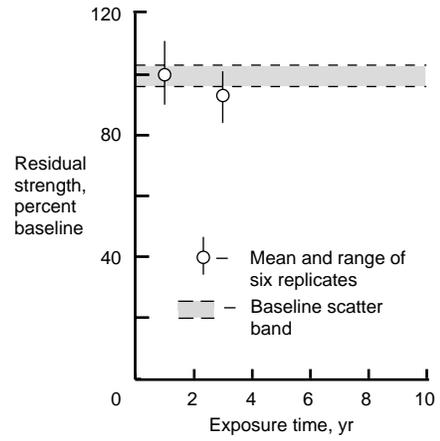
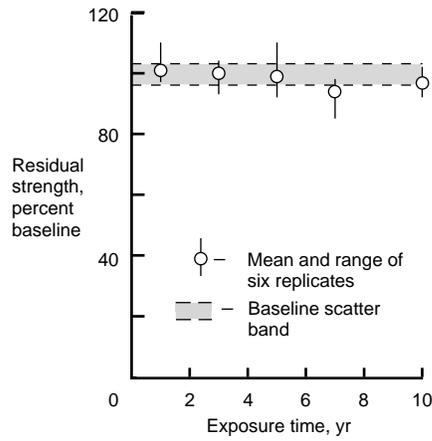
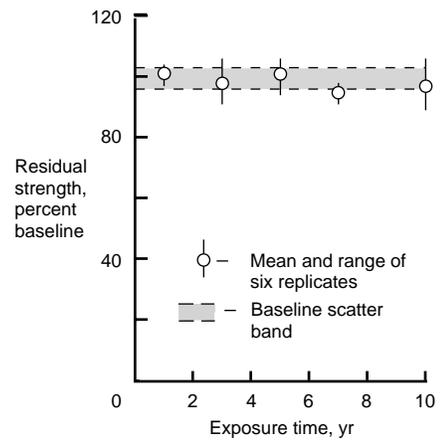
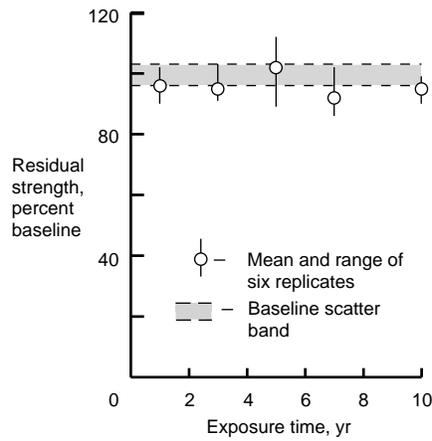
Figure A4. Residual compression strength of T-300 graphite/E-788 epoxy specimens exposed at locations shown.

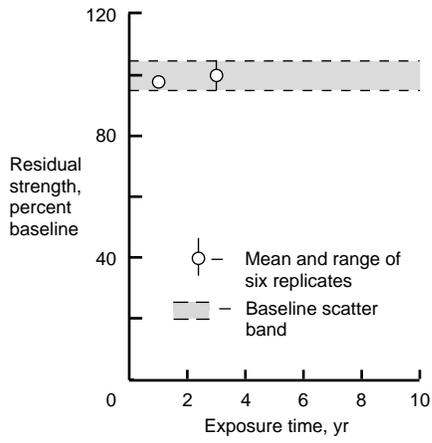
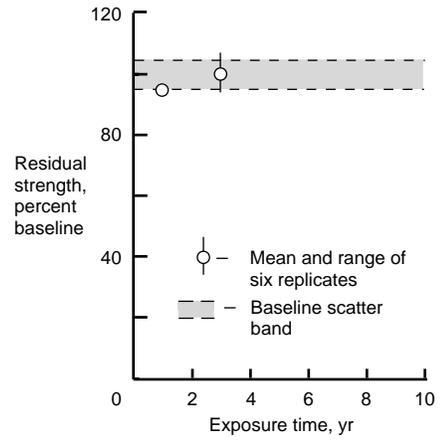
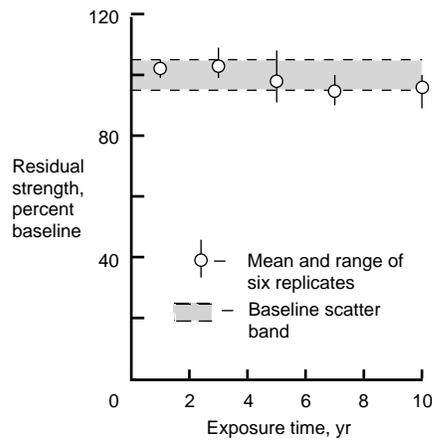
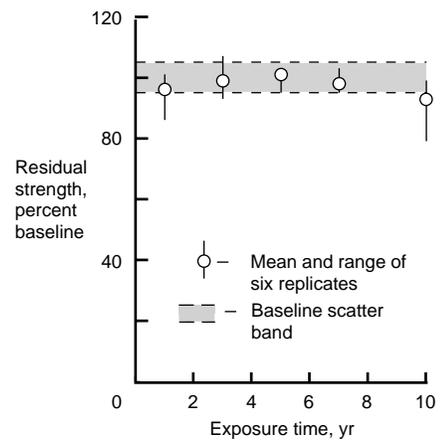
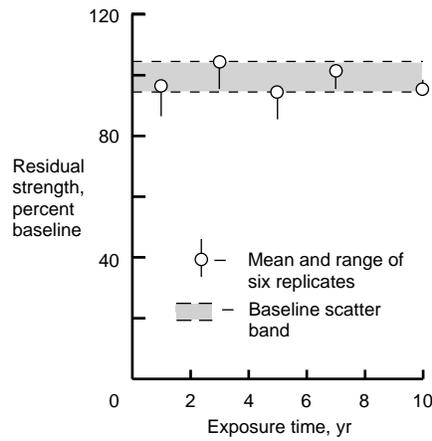
Figure A5. Residual SBS strength of Kevlar-49/F-185 epoxy specimens exposed at locations shown.

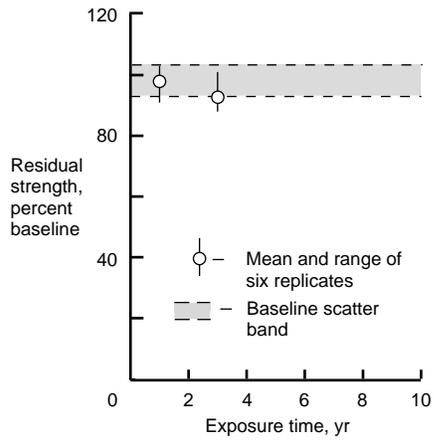
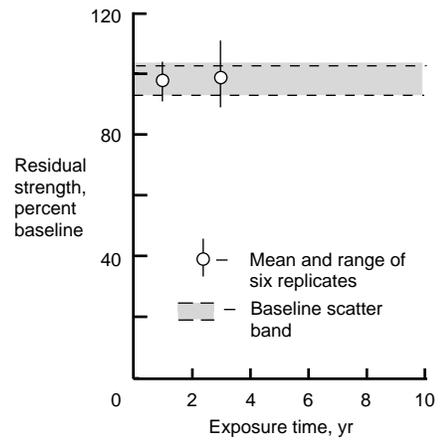
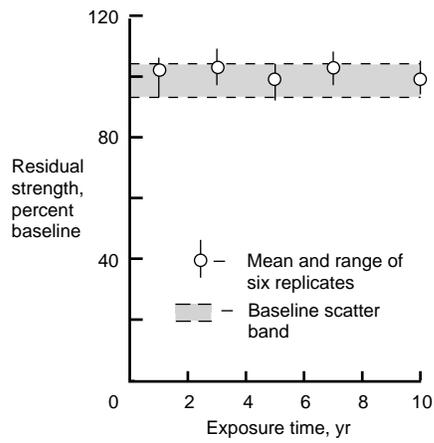
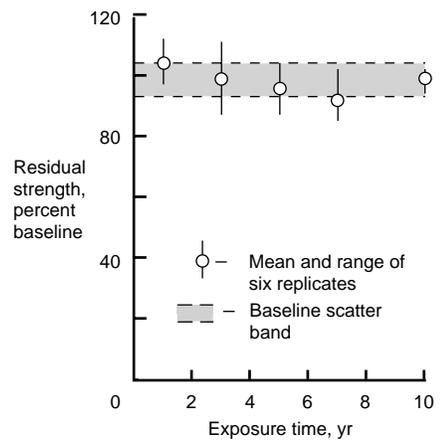
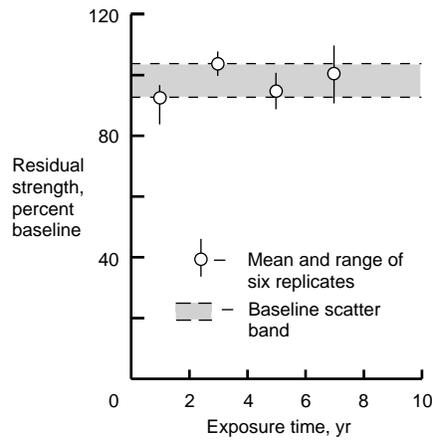
Figure A6. Residual SBS strength of Kevlar-49/CE-306 epoxy specimens exposed at locations shown.

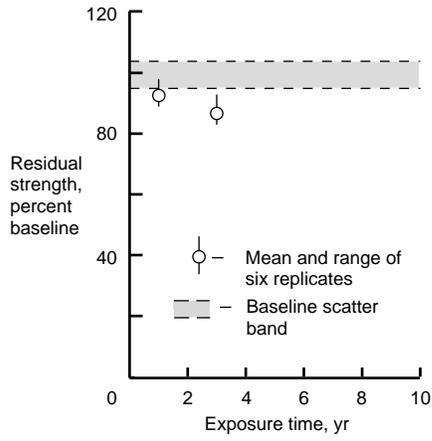
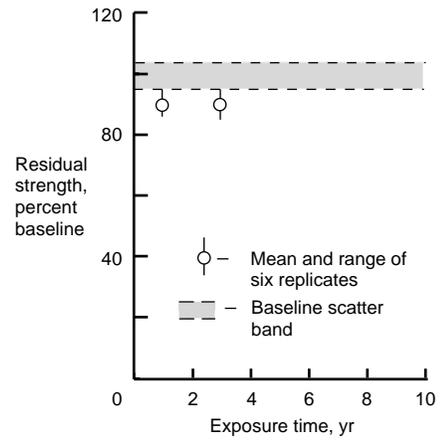
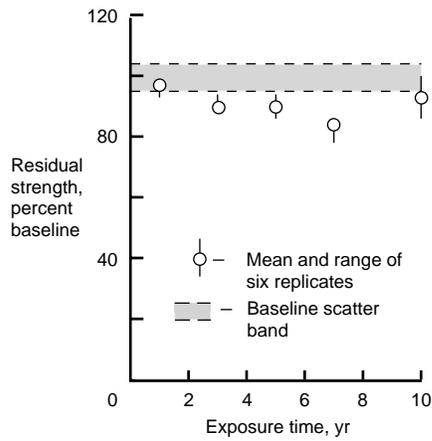
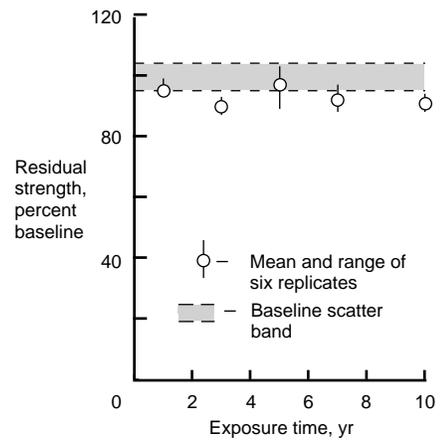
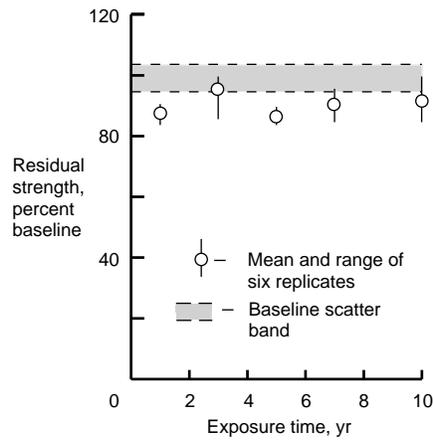
Figure A7. Residual SBS strength of Kevlar-49/LRF-277 epoxy specimens exposed at locations shown.

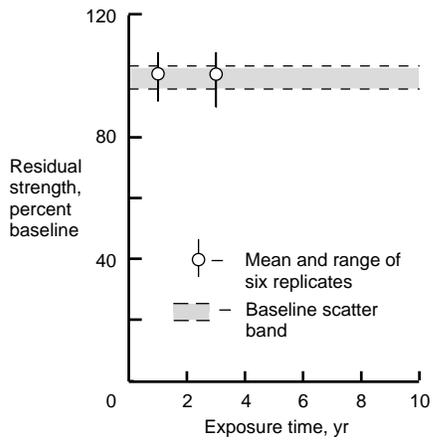
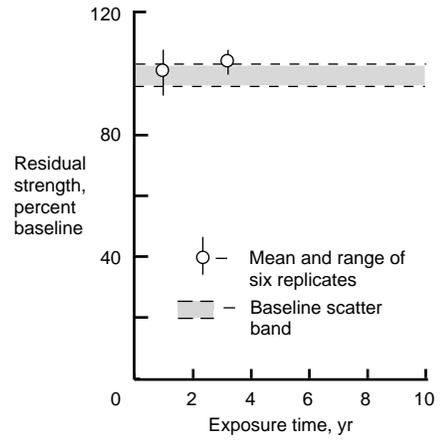
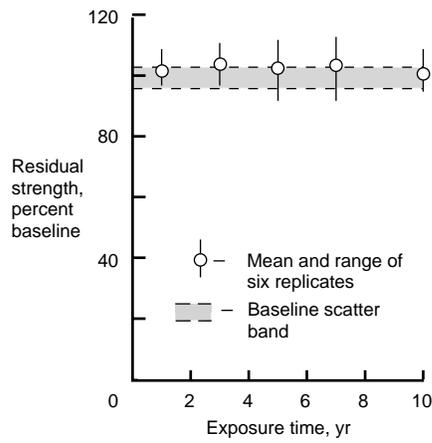
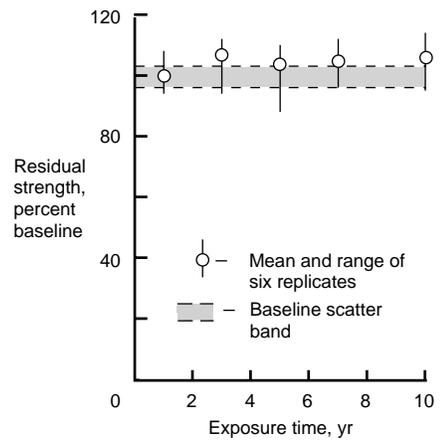
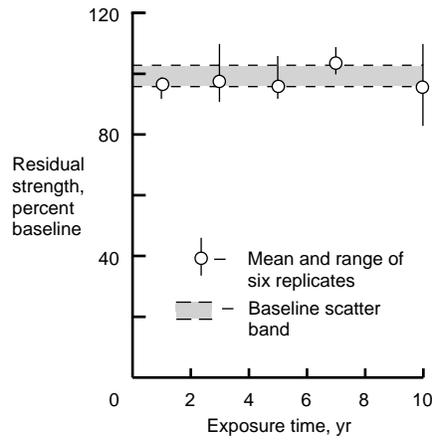
Figure A8. Residual SBS strength of T-300 graphite/E-788 epoxy specimens exposed at locations shown.

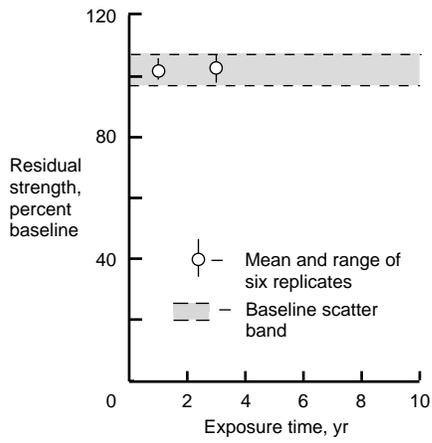
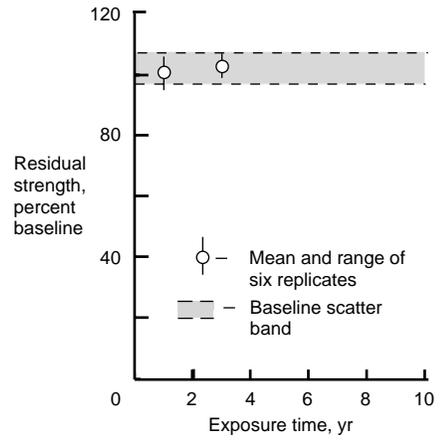
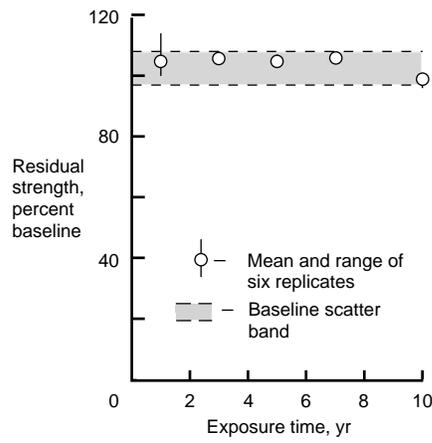
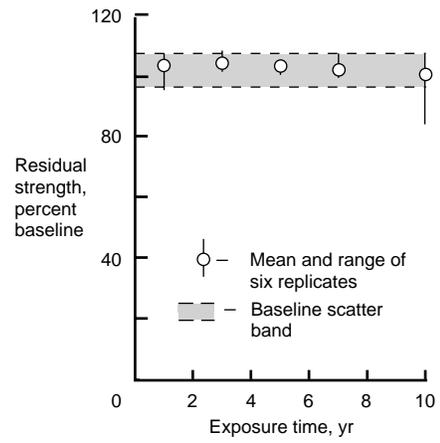
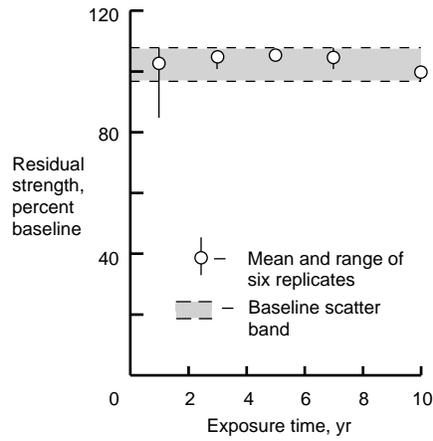
Figure A9. Residual tension strength of Kevlar-49/F-185 epoxy specimens exposed at locations shown.

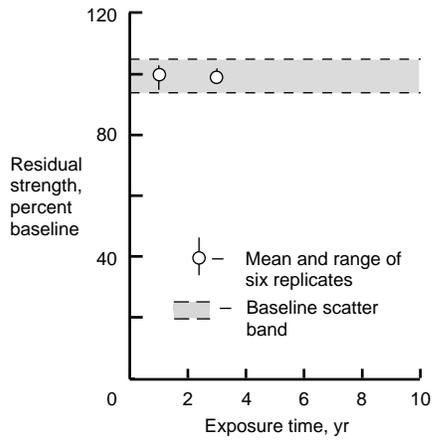
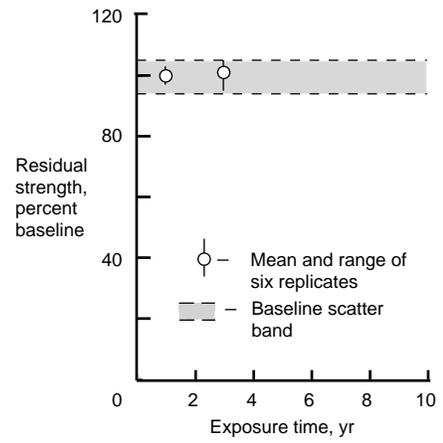
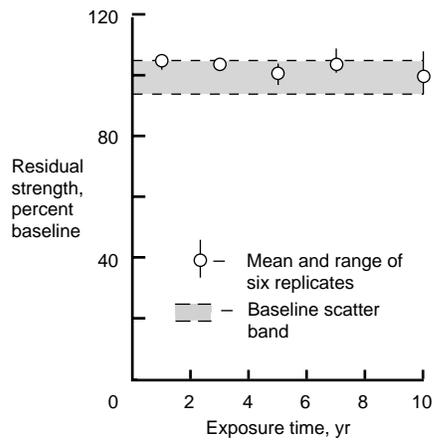
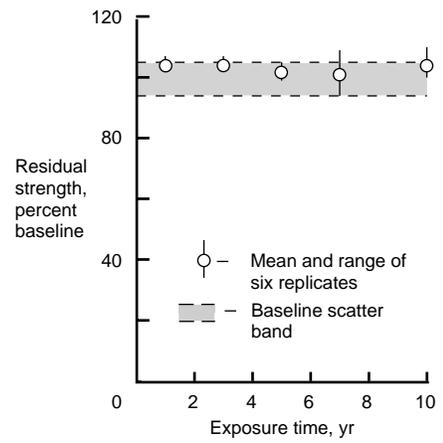
Figure A10. Residual tension strength of Kevlar-49/CE-306 epoxy specimens exposed at locations shown.
